A FIELD NOTE ON THE RECONNAISSANCE STUDY OF ROCKSLIDE  
INCIDENCE OF 11/08/2021 AT NH-05, NEAR NIGULSARI VILLAGE, TEHSIL  
NICHAR, DISTRICT KINNAUR, HIMACHAL PRADESH  
(SoI Toposheet No.: 53E/14)  
[ADDITIONAL WORK]  
(Mission - IV Field Season: 2021-22)

**A FIELD NOTE ON THE RECONNAISSANCE STUDY OF A ROCKSLIDE INCIDENCE OF  
11/08/2021 AT NH-05, NEAR NIGULSARI VILLAGE, TEHSIL NICHAR, DISTRICT  
KINNAUR, HIMACHAL PRADESH  
(Toposheet No.: 53E/14)  
[ADDITIONAL WORK F.S. 2021-22]**

**By:**  
**S.R.Mohapatra<sup>1</sup>, Atul Kohli<sup>1</sup>, Vijit Thakur<sup>2</sup> and Abhinav Poonia<sup>3</sup>**  
**1: Director, 2: Geologist, 3: Assistant Geologist**  
**Geological Survey of India (Northern Region)**

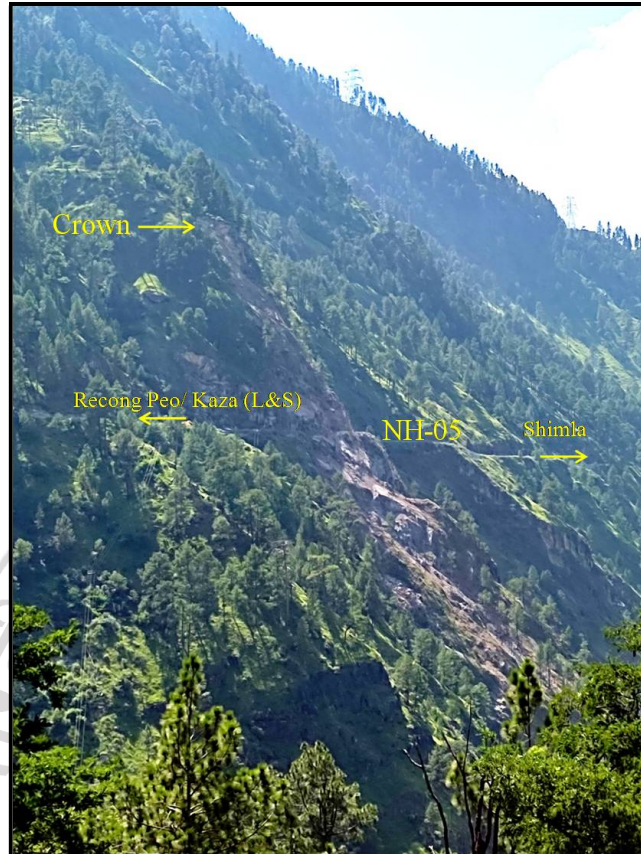
Fig. 2: Distal view of Nigulsari landslide, Kinnaur District

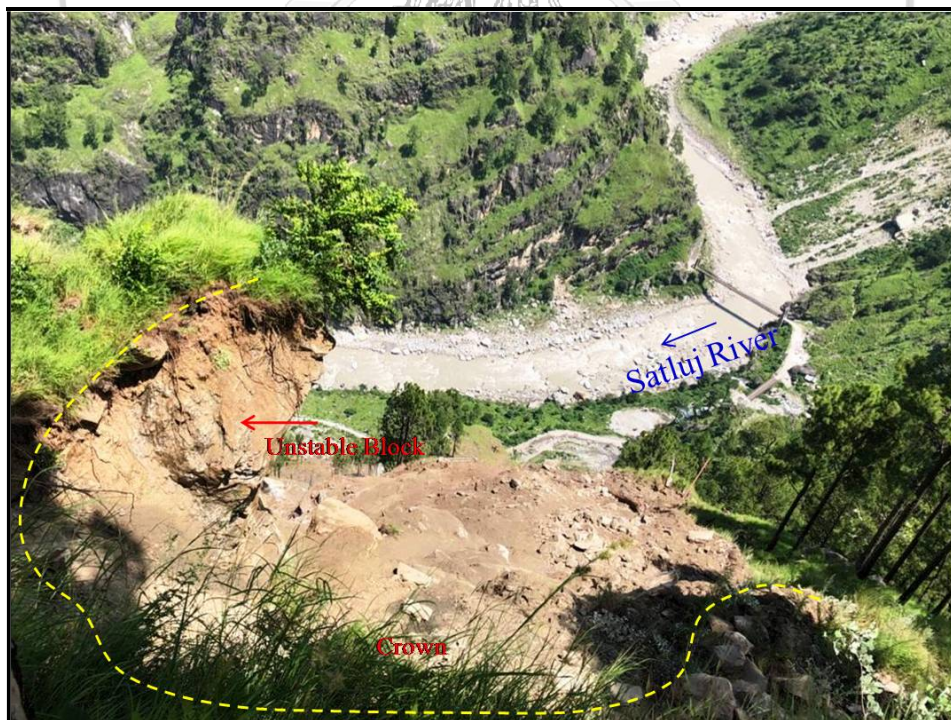
- 18) A rock block with some in-situ soil developed over it was observed protruding valley-ward, slightly towards left side of crown, which appears to be highly vulnerable based on field observation. In addition, several insecurely positioned blocks on cut slope were observed.

Fig. 3: Valley side view (looking from crown) of Nigulsari landslide, Kinnaur District

- 02) **Identification and removal of rock blocks that are insecurely positioned and are likely to fall on the road alignment:** As far as possible, blasting should be avoided for carrying out the removal of such blocks. This include a vulnerable block ready to fall above the crown (Fig. 3).

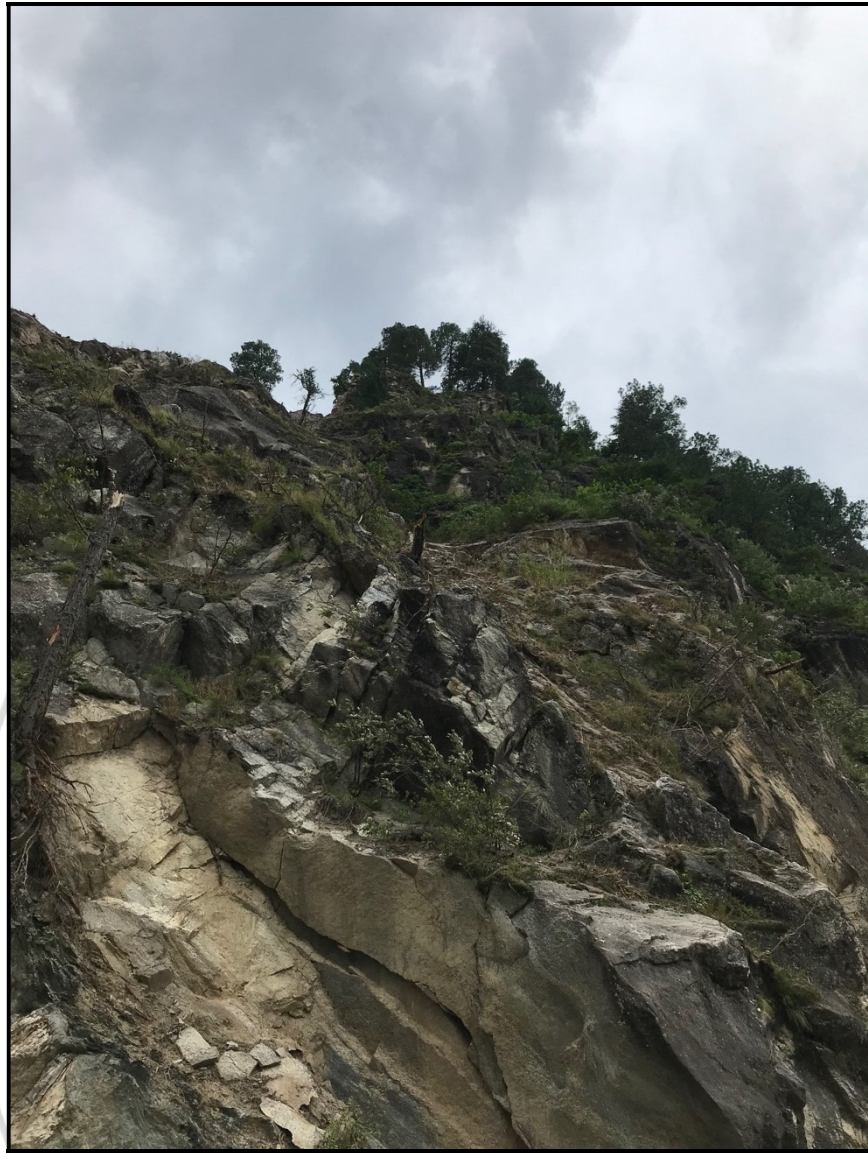
- 06) From the field traverse also, the site appears to have been perceived as a location vulnerable to landslide hazard as the same is characterized by the presence of moderately to steeply inclined and dissected hill slopes, bottomed by steeper cut slopes and further bottomed by steeper natural slopes. The rocks exposed are highly foliated and jointed, with open joints at several places (Fig. 4; Annexure-I).

Fig. 4: Highly jointed rock mass exposed along cut slopes in Nigulsari landslide area, Kinnaur District

- 04) **Immediate filling of tension cracks:** with suitable impervious material.
- 05) **Protective measures for cut slope:** Possibility of double layer shotcrete or wire mesh can be explored for the cut slope section as several loose rock blocks are appearing that may fall at any point of time, especially during the course of incessant or perennial rainfall spells. Detailed studies, however, may pl. be carried out for the same.

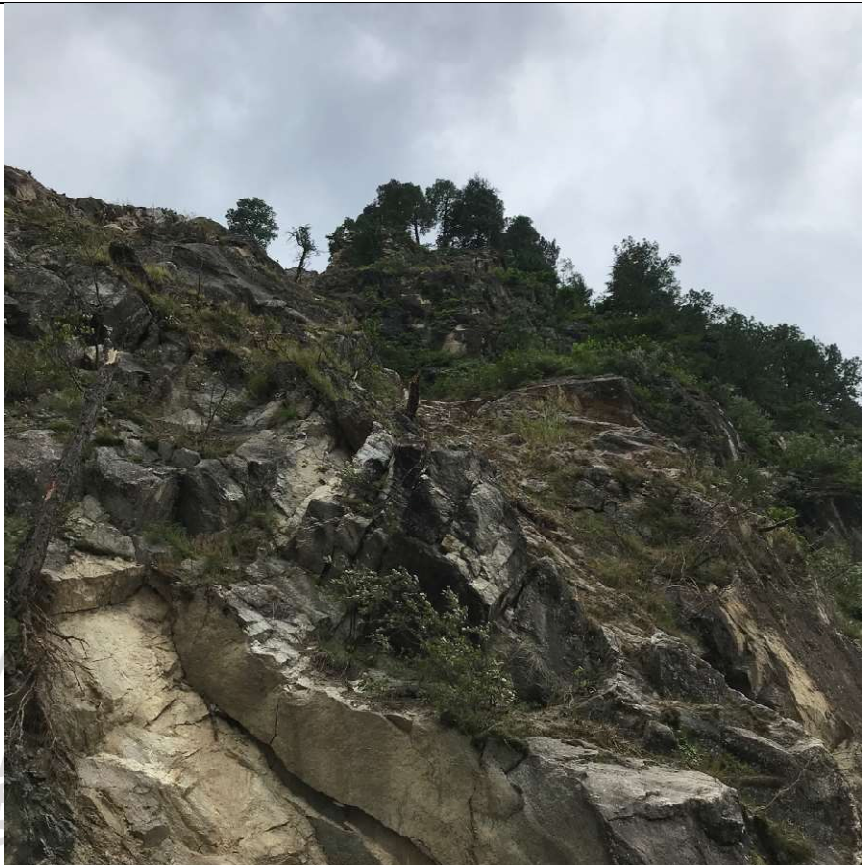
| | Fig. 2: Highly jointed rock mass exposed along cut slopes in Nigulsari landslide area, Kinnaur District | | |
