**Himachal Pradesh State Disaster Management Authority**

**District Disaster Management Authority Kullu**

**KULLU DISTRICT DAMAGE REPORT:  
TECHNICAL ASSESSMENT AND SUGGESTIONS**

**October 2023**

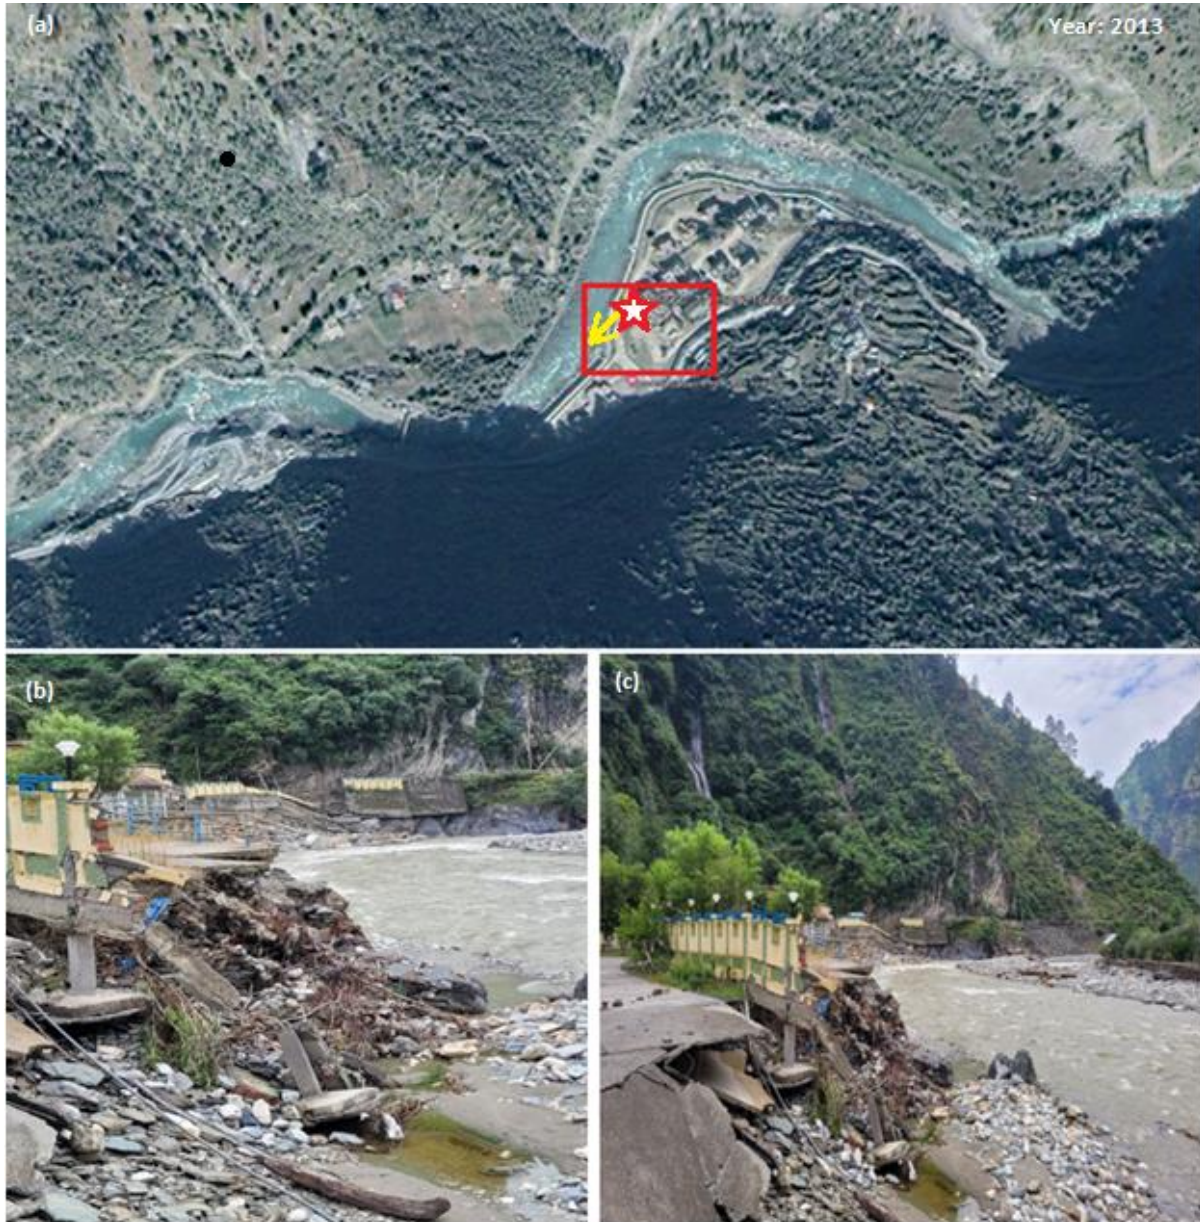
The damage was also amplified due to the cumulative effect of multiple compounding factors. For instance, at Spangani village - the subsidence of roads occurred not only due to floods washing away retaining walls, but also because the village is situated on an unstable slope. Similarly, at

**Fig. 13:** Extensive damage to road infrastructure and collapse of retaining walls near NHPC residence at Spangani village caused by severe flash flooding. Major landslide visible on the opposite riverbank covering a span of around 100 meters.

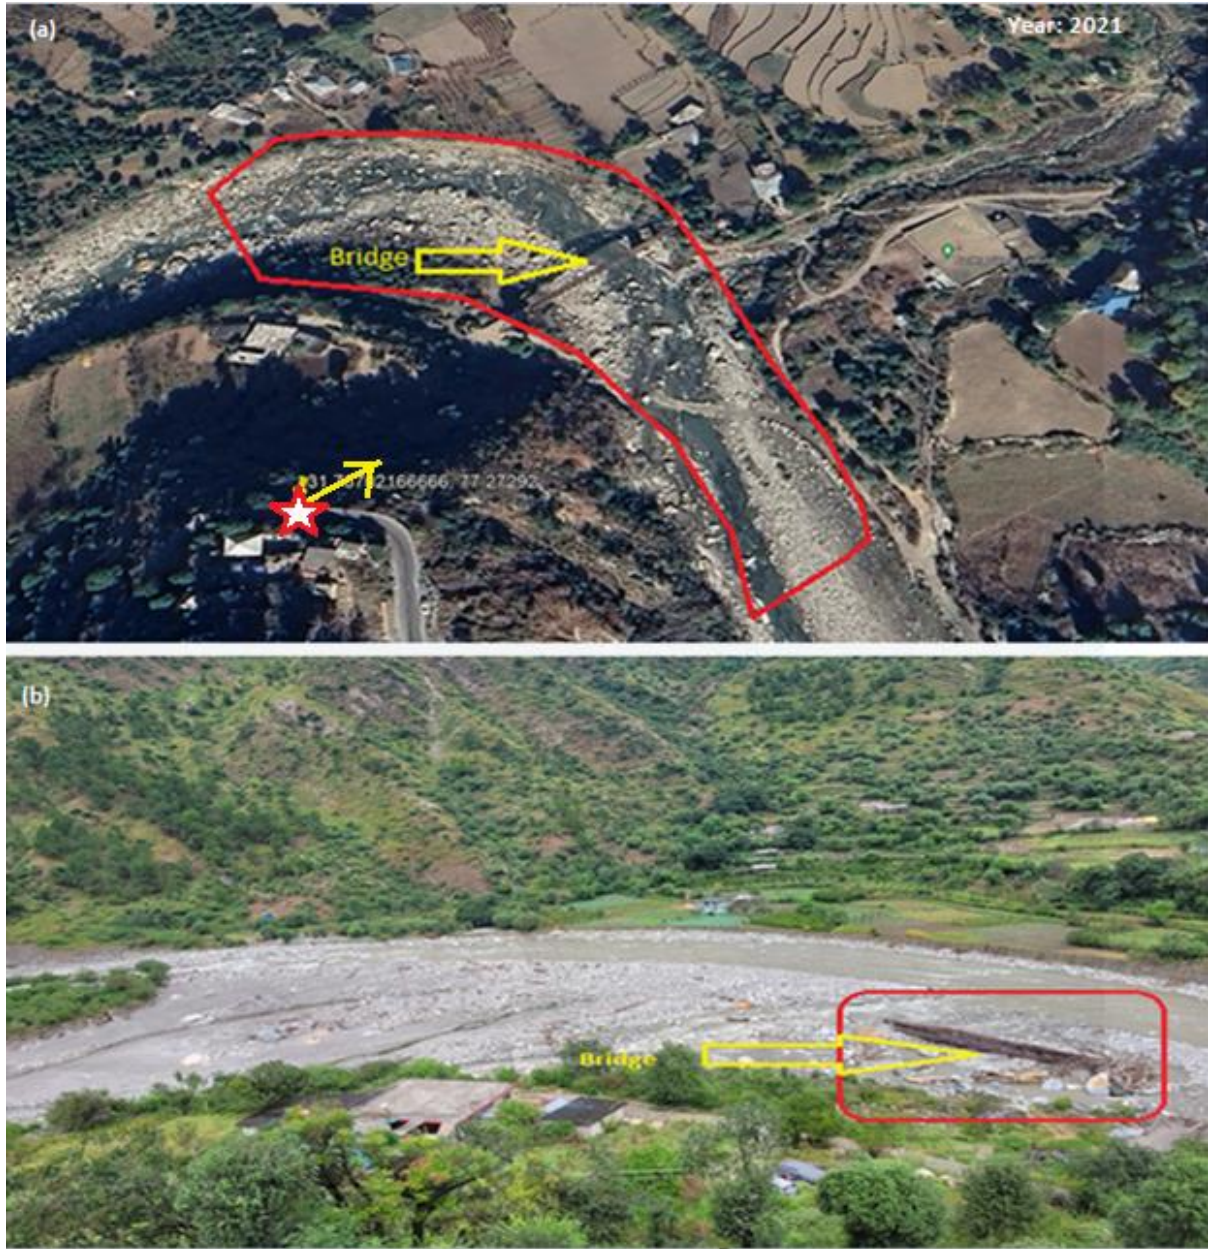
**Fig. 14.** The main vehicular bridge providing connectivity at Tareda village has been completely washed away by the high-intensity flash flood event. Additionally, 2-3 houses situated precariously along the edges of the river were also swept away.

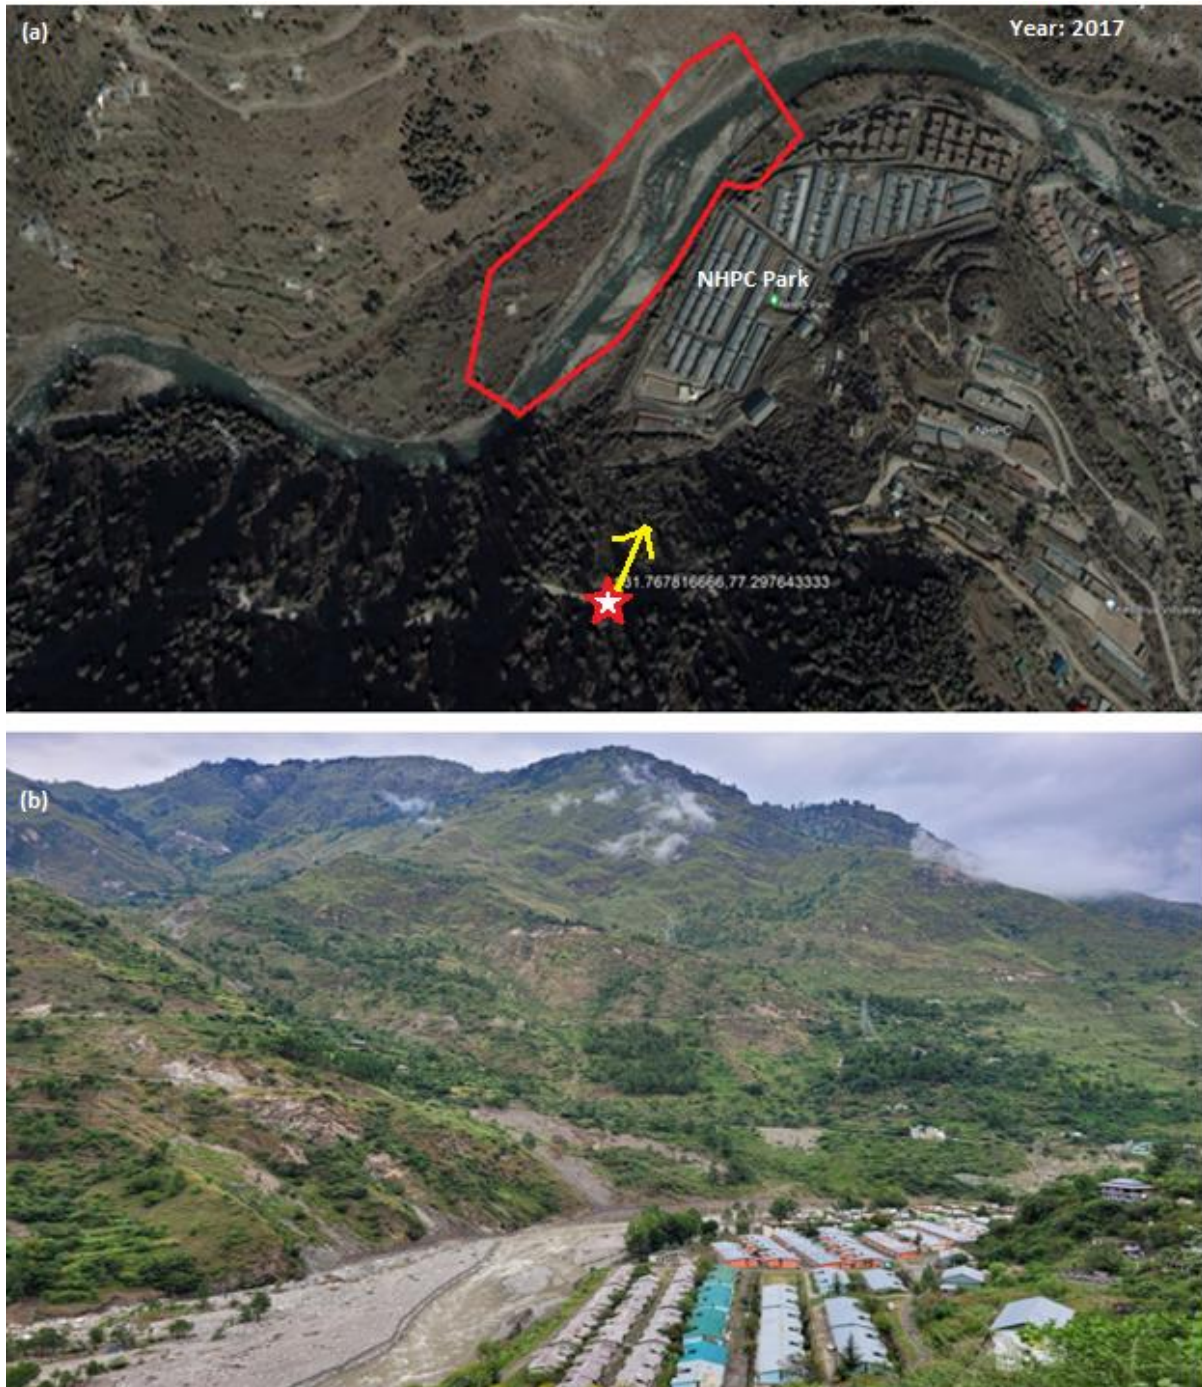
**Fig. 15.** The flash floods coupled with the erosion of banks due to changes in the river's natural meandering pattern led to the complete destruction of farmland spanning over 300 acres and the loss of 3 houses at Bakshal village.

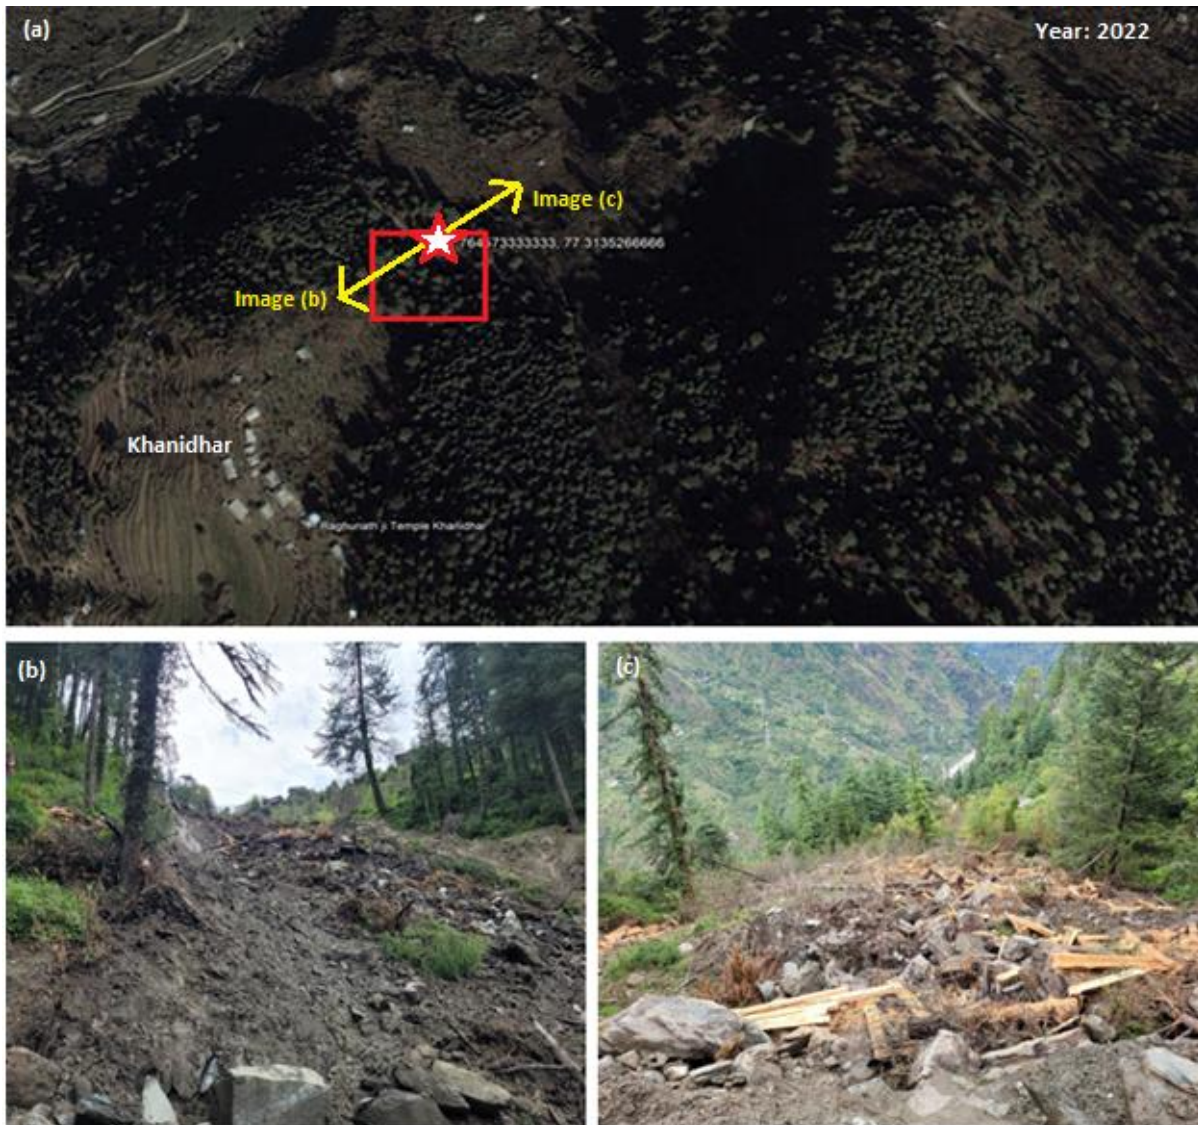
**Fig. 16.** A major landslide spanning approximately 200 meters wide has occurred at Khanidhar village, leading to destruction of several old growth deodar and apple orchards on the hillside.

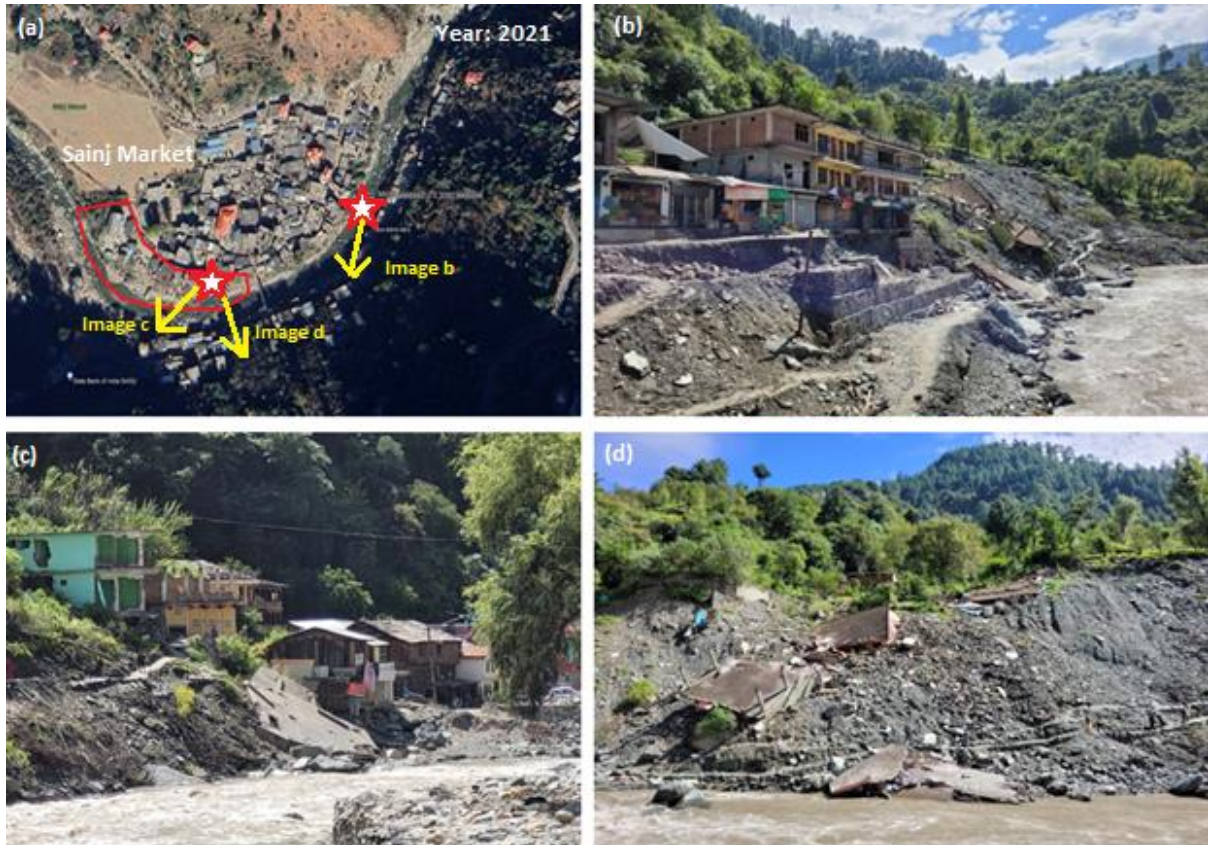
**Fig. 17.** Near Sainj Market, a landslide caused subsidence of ground by around 1.5 meters over a 50 meter area, resulting in displacement of the retaining wall intended to provide slope stability. The root zone stability of the orchards has been impacted.

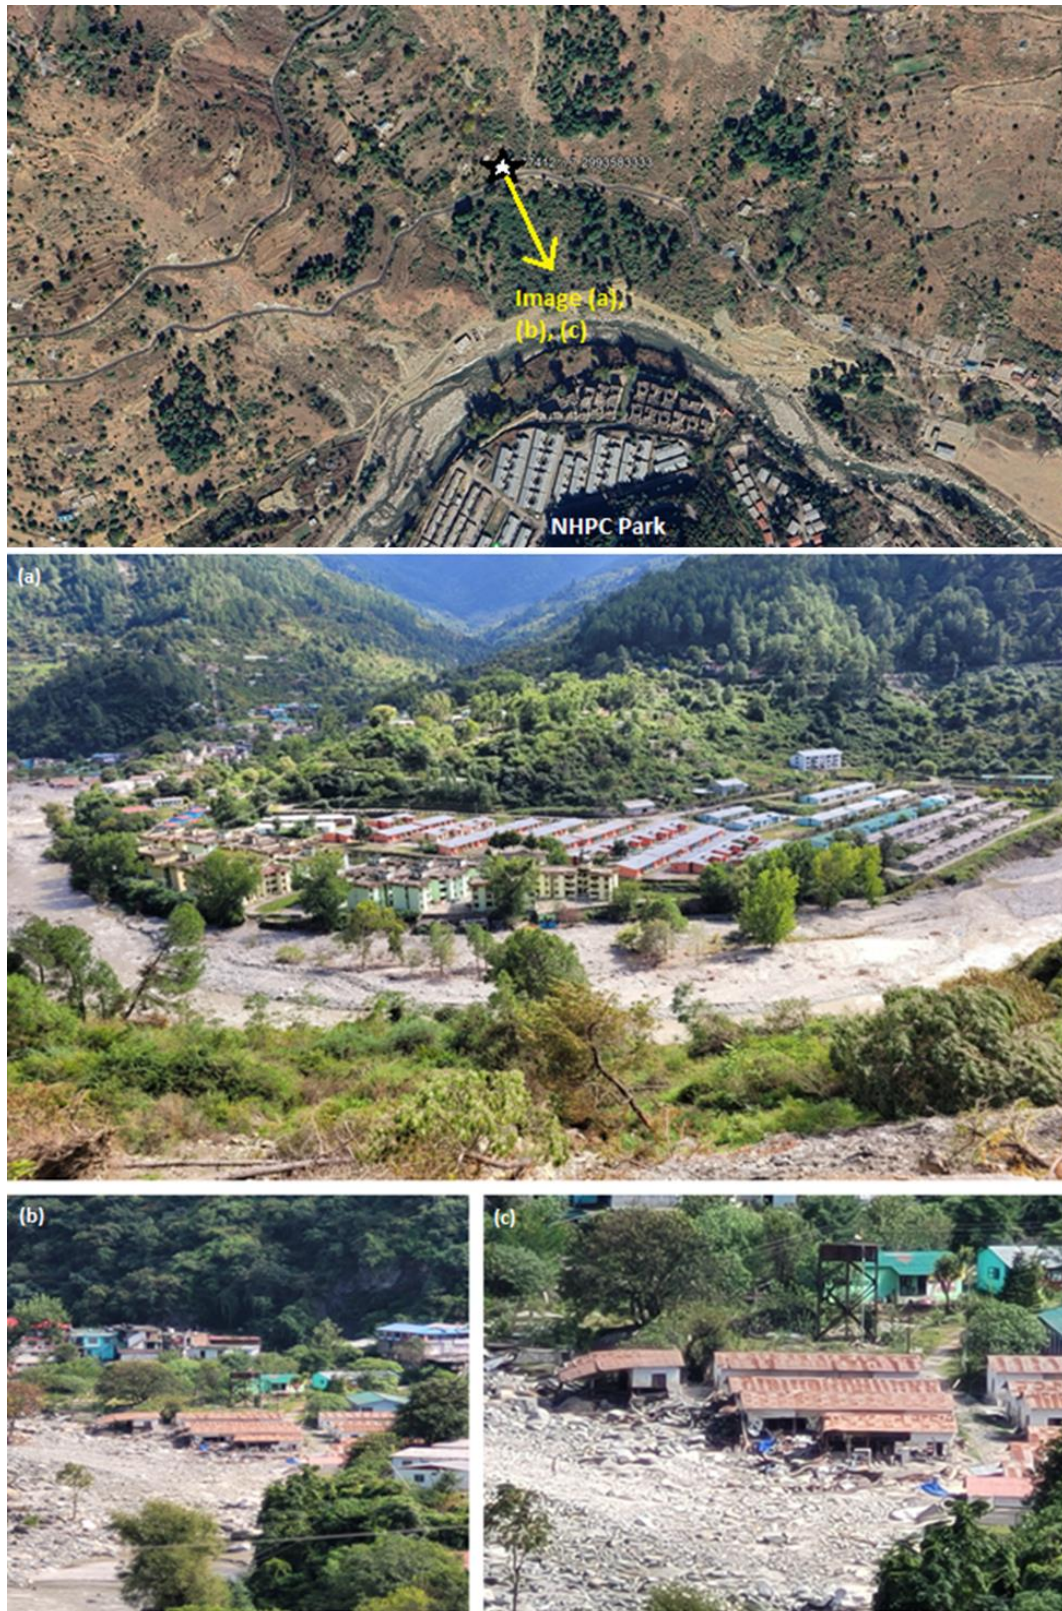
**Fig. 18.** At Sainj Machina Nala, several houses were completely destroyed and access roads were blocked due to damage by flash floods and a landslide caused by instability of the hill slope base.

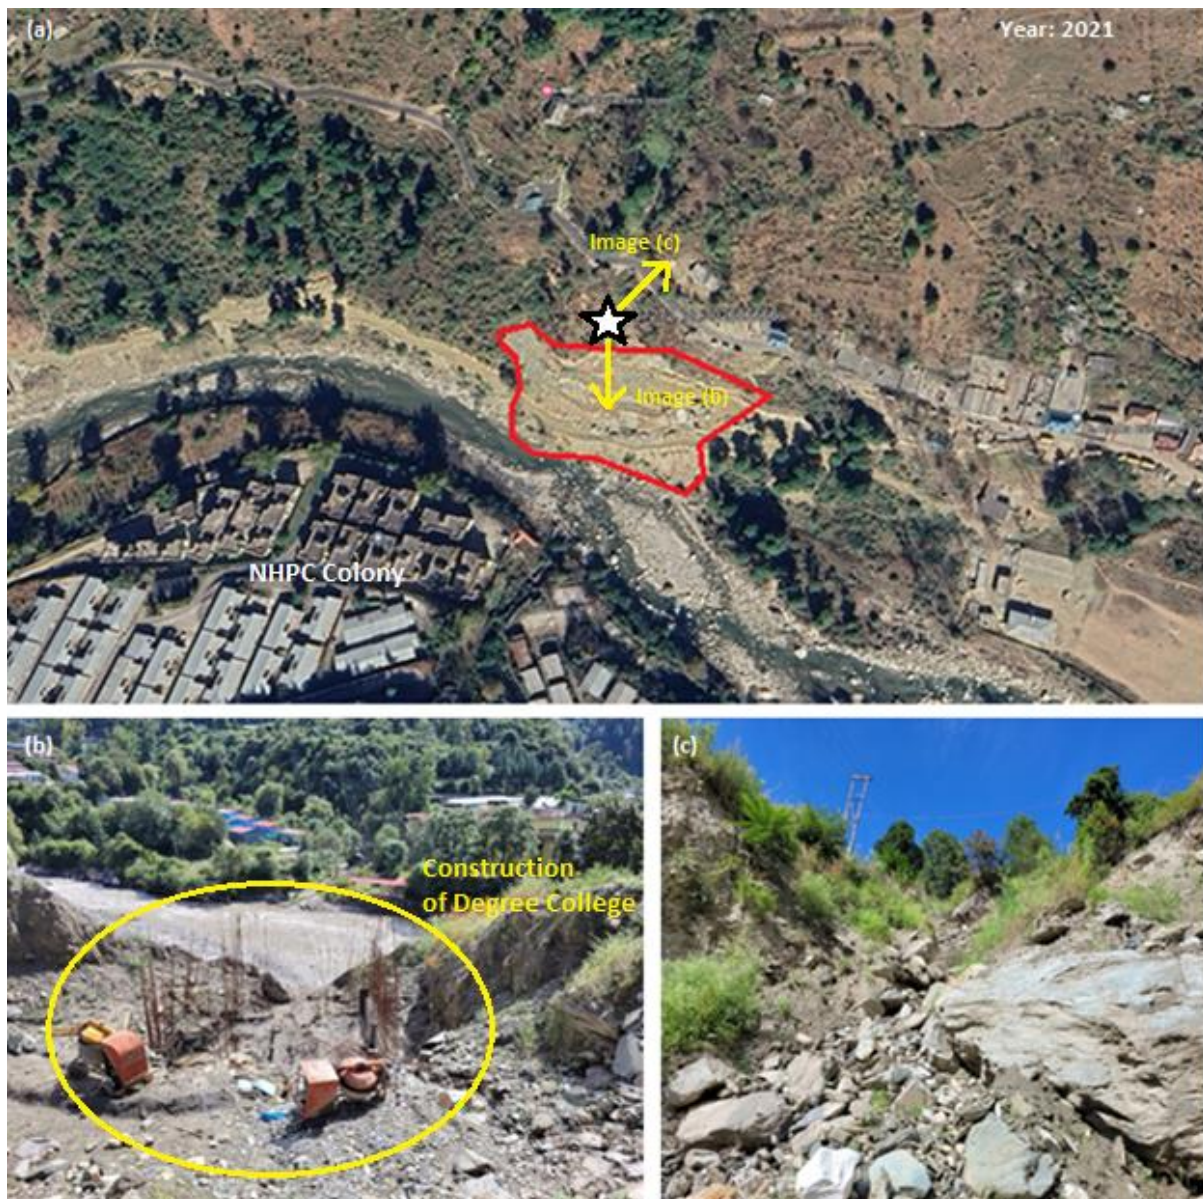
**Fig. 19.** Near the site for proposed Sainj Degree College, a 45-meter length of the road has been washed away. An adjacent landslide above the road led to collapse of retaining walls intended to provide slope stability.

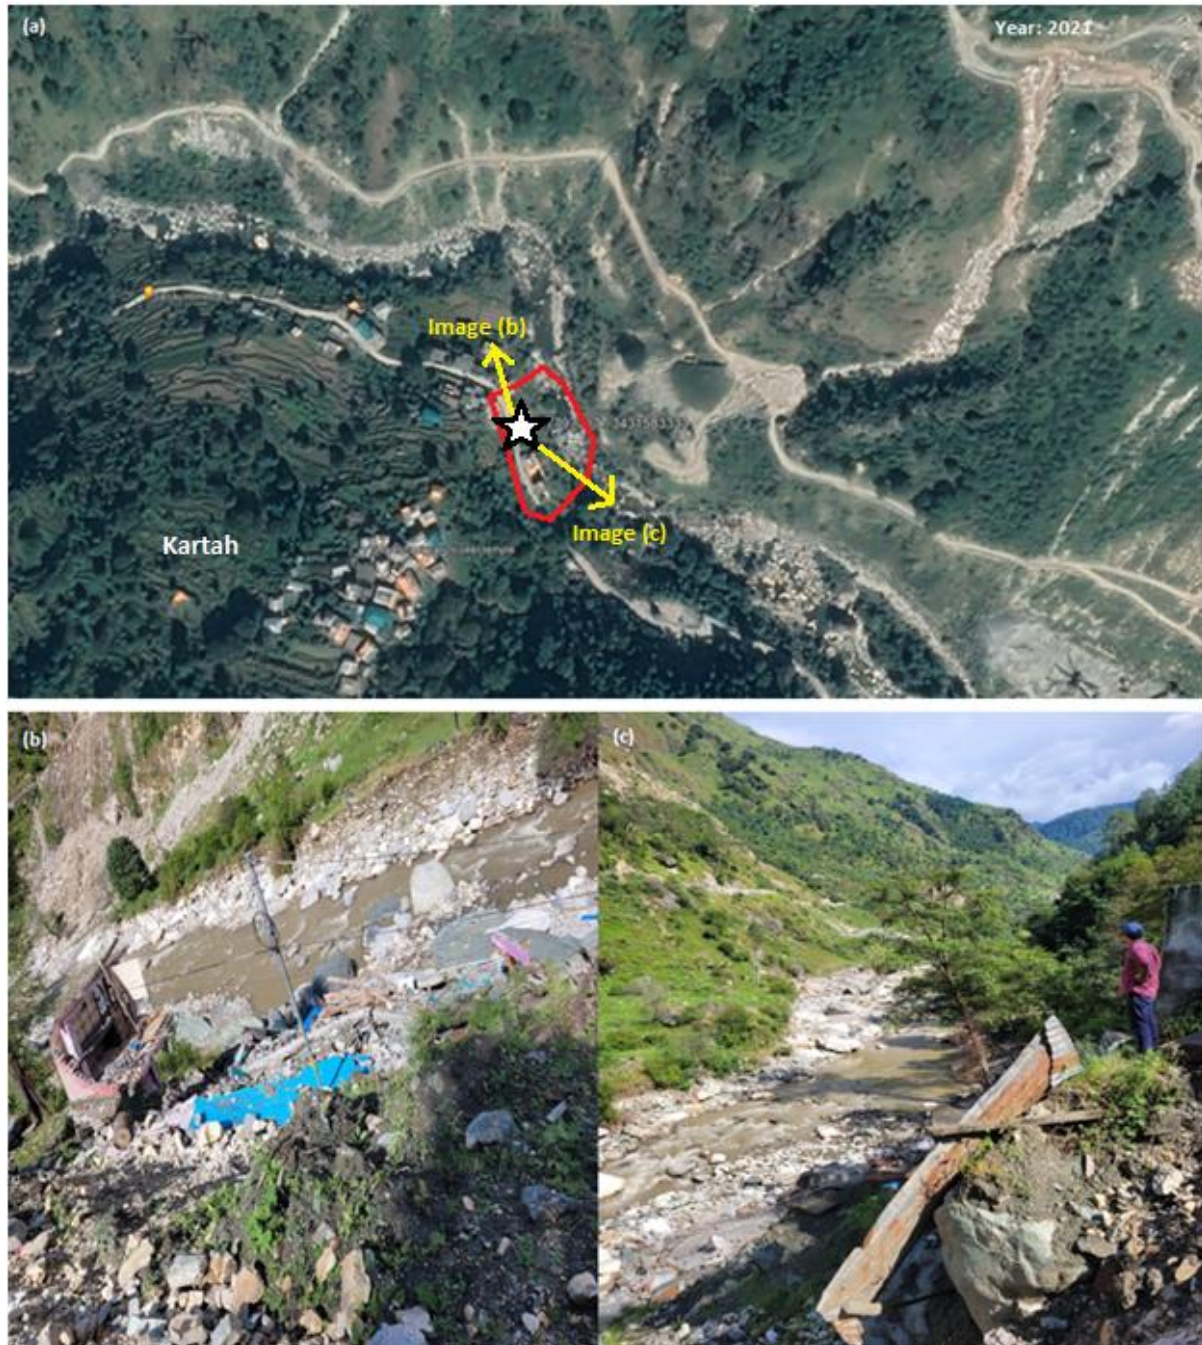
**Fig. 20.** In Kartoh village, approximately 5 houses constructed at the base of a hill were completely buried under debris due to a major landslide spanning over 150 meters wide. Tension cracks were visible on the slope.

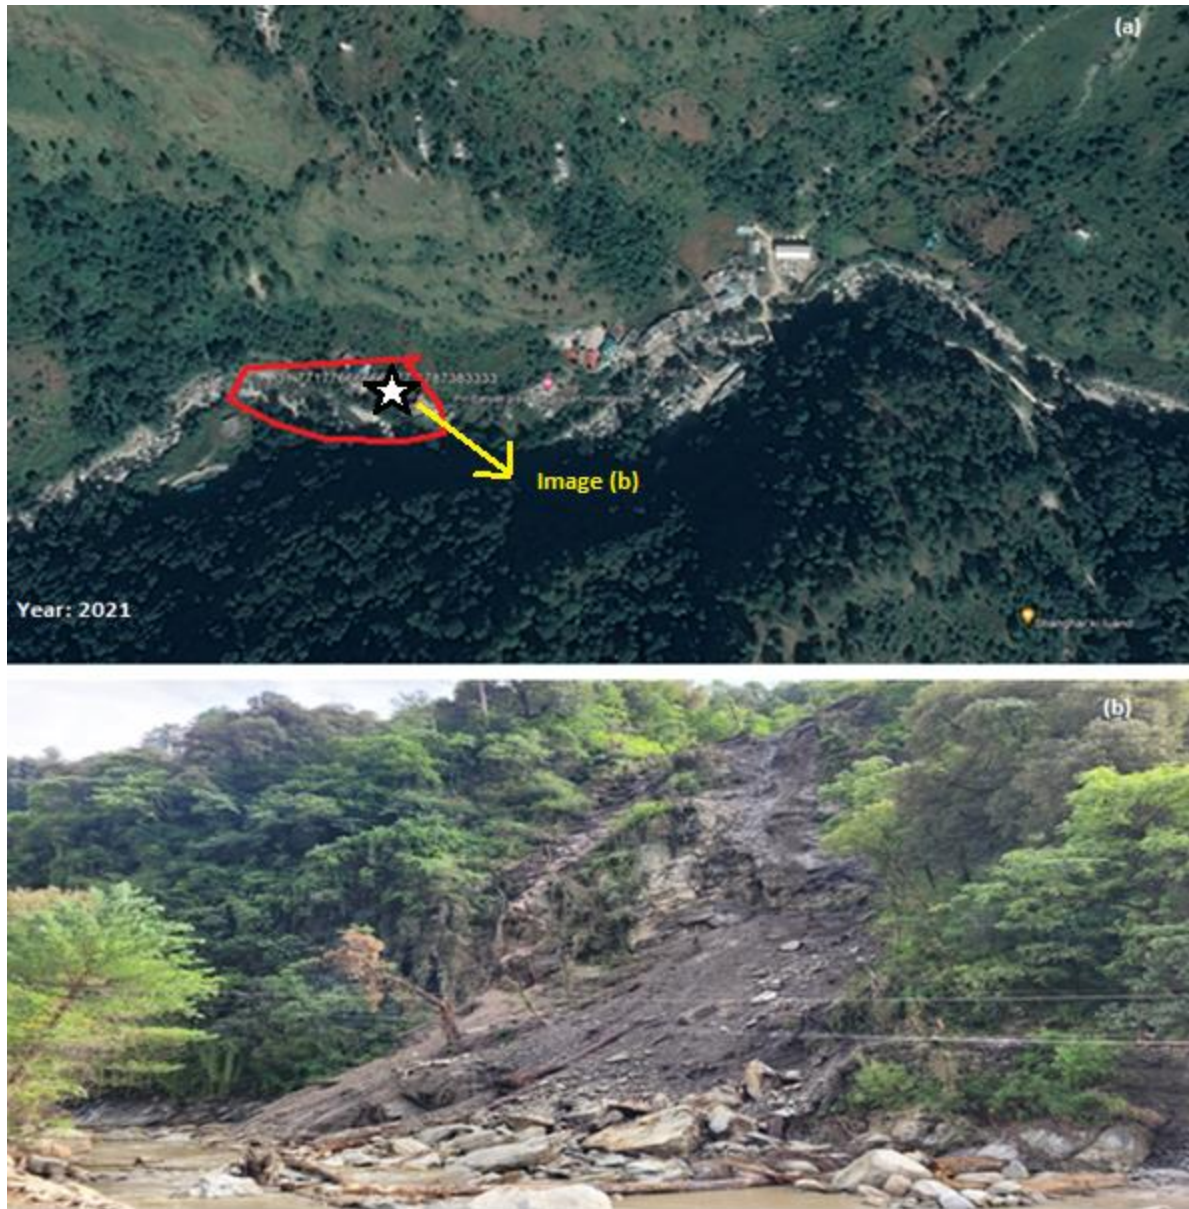
Neuli village - the bridge destruction resulted from both the landslide material debris and the flash flood currents. A single extreme event led to cascading failures due to existing vulnerabilities across the natural and built environment.

**Fig. 21.** A massive landslide extending over 40 meters vertically has occurred at Neuli village, fully destroying a connectivity bridge. The landslide has blocked access across 4-5 panchayats, requiring a makeshift crossing.

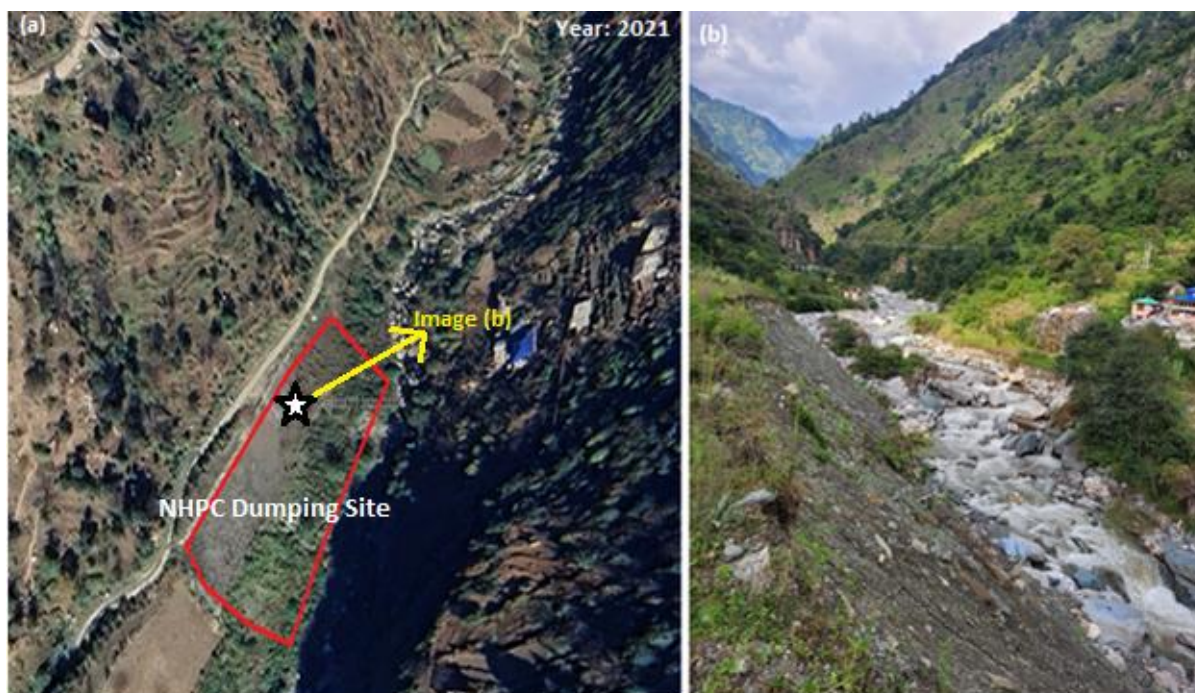
Anthropogenic factors like improper waste disposal created secondary hazards that amplified the damage. At Jiwa and Sharan villages, construction waste material carelessly dumped along the riverbanks without providing proper slope stability measures by a hydropower company was washed downstream by the floods, destroying the properties of the neighbouring village. Such irresponsible waste disposal along rivers is an unsafe practice. It indicates a lack of environmental monitoring and regulation for construction projects.

**Fig 22.** At Jiwa & Sharan villages, improper waste disposal along the riverbanks by NHPC got washed downstream during the floods, causing damage to properties of the neighboring village.

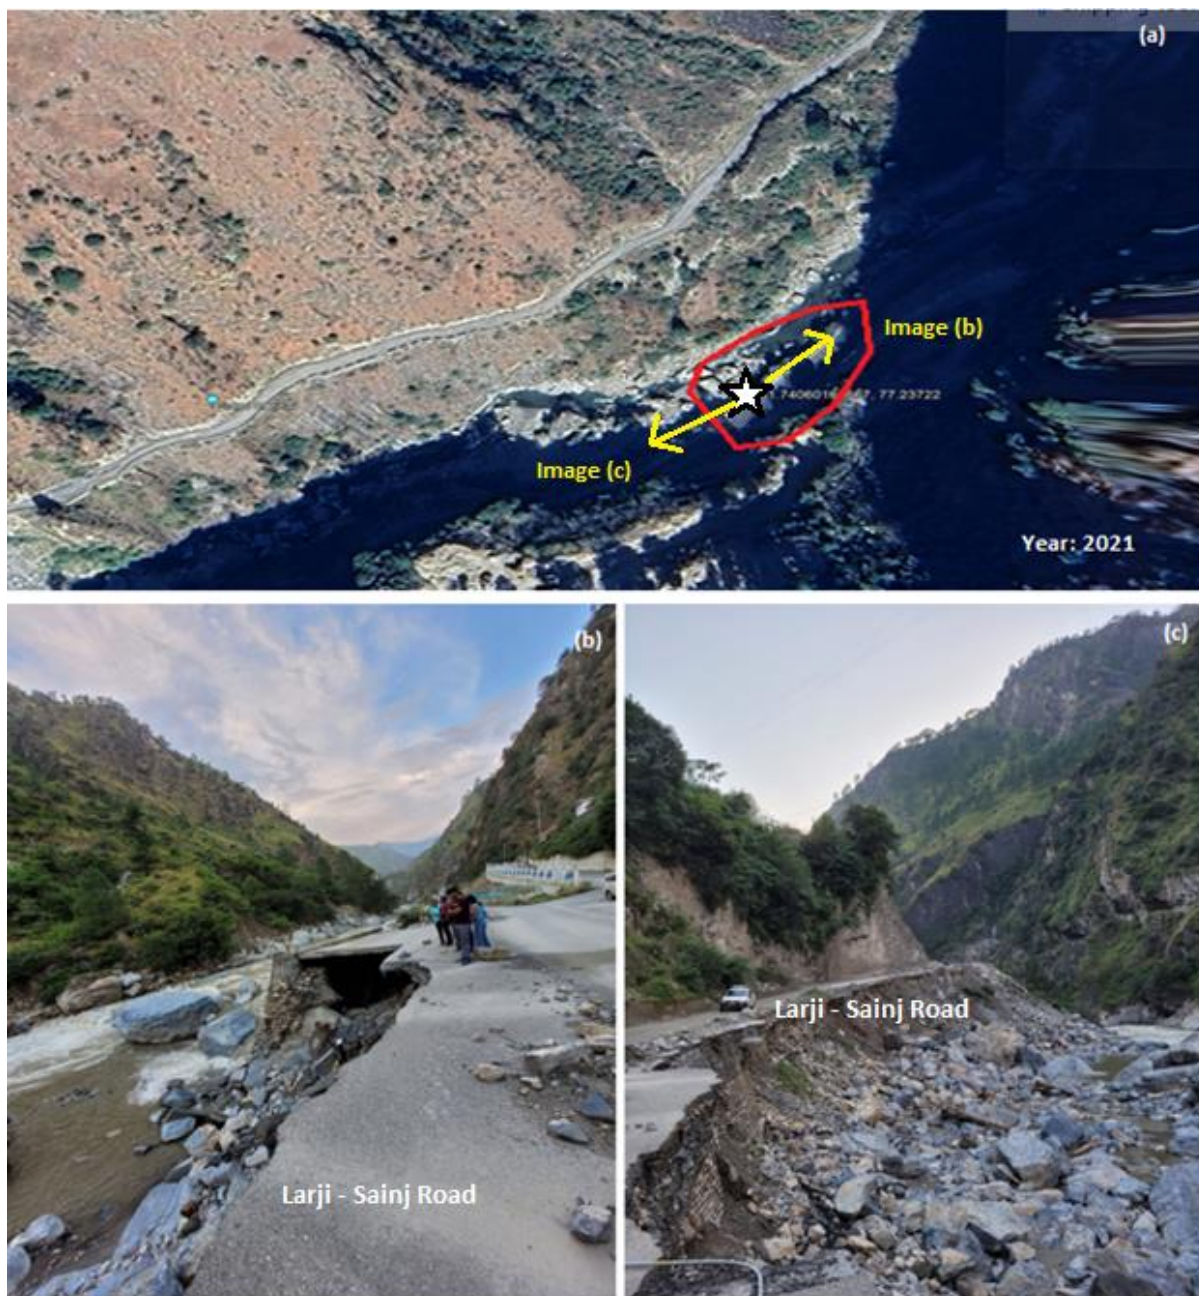
**Fig. 23.** In Bihali village, the paved road stretching approximately 300 meters constructed along the riverbank has been completely washed away due to flash floods eroding away the banks.

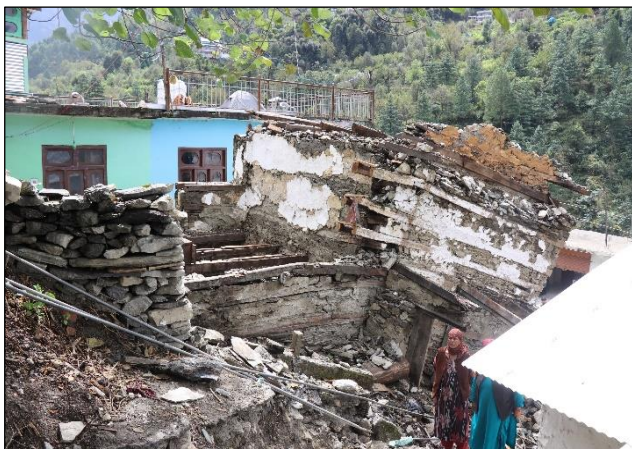
1. Around 7 houses in the area were completely or partially damaged. A house above the roadside made of wood and stone, which was around 90 years old, was completely damaged due to the settlement in the region (Fig.24). Buildings have tilted in the sliding zone of around 100 meters and have developed huge cracks in the walls (Fig. 25).

**Fig. 24.** Damaged house made of wood and stone.

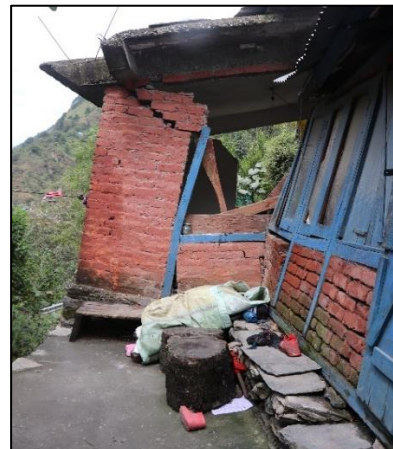
**Fig. 15.** Tilted house with large cracks.

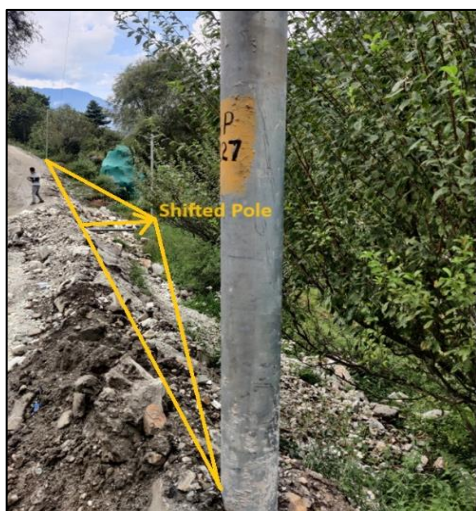
2. At another location, the road was shifted around 2 to 3 meters due to subsidence that resulted from the continuous rainfall in July 2023. Fig. 26 shows a pole aligned before subsidence and now shifted downwards and sideways. Further, the damaged road has been temporarily repaired using locally available material.

**Fig. 26.** Shifted pole due to subsidence.

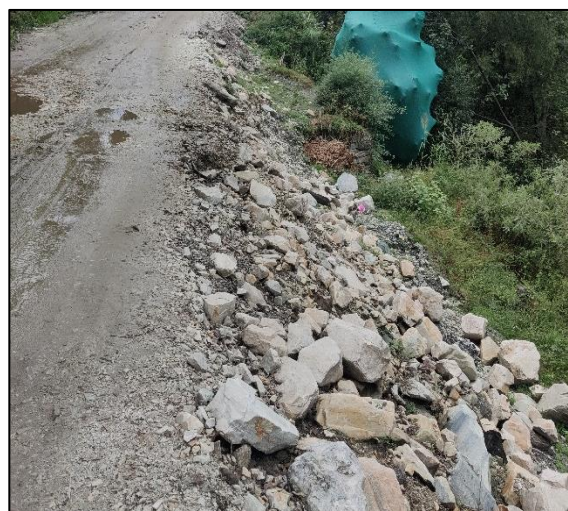
**Fig. 27.** Damaged Road filled with local material.

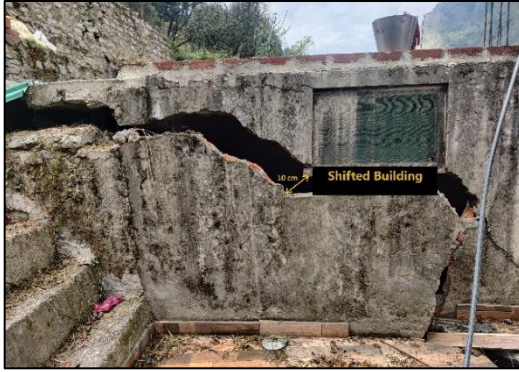
3. Slow progressive damage was observed in Bandal village due to the development of a subsidence zone affecting the entire valley. Around 28 buildings were damaged in this village, and people currently reside in tents. Major damage occurred during the rainfall events of July 8 to July 12. People have been displaced from their homes to temporary tent settlements, schools have been damaged, and there is a risk of further damage to infrastructure.

**Fig. 28.** Visible gap due to settlement of the building

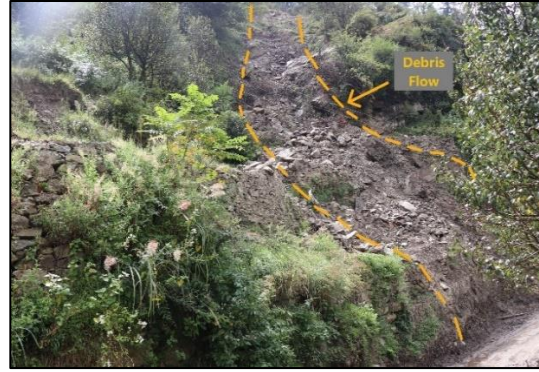
**Fig. 29.** Debris Flow.

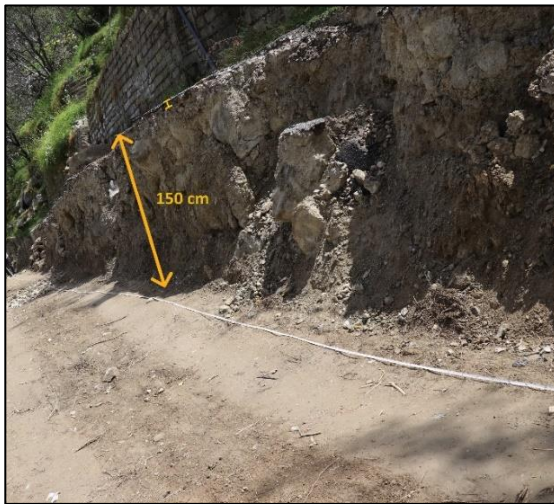
4. A large settlement of around 150 cm was observed in a 135 m stretch of road (Fig. 30). From the exposed part of the road, it was clear that the road was poorly constructed and did not comply with guidelines provided by IRC: SP:48-1998. The inspection of a recently constructed retaining wall revealed that it is bulging in some places and is at risk of collapse (Fig.31). Further, the old retaining wall has already been damaged due to earth pressure (Fig. 32).

**Fig. 30.** Large settlement in the road.

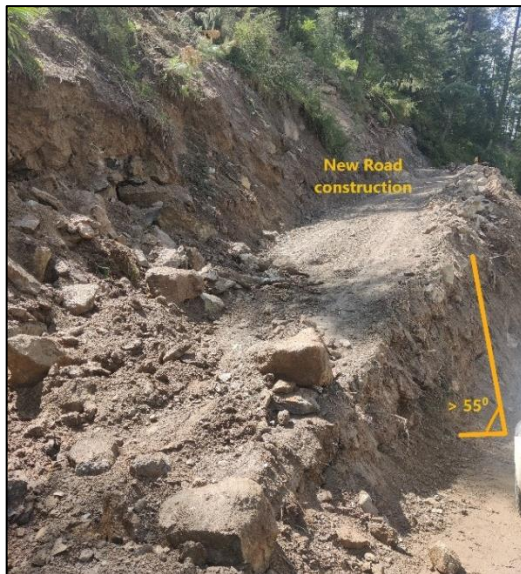
5. Another subsidence zone of around 300 meters has been identified where the road was shifted down by 3 meters and is now being reconstructed. The newly constructed road has an average slope angle of more than  $55^{\circ}$ , and no proper guidelines are being followed for its reconstruction (Fig. 33). There was no proper provision for drainage. The drains present along the older road have grown vegetation, resulting in the clogging of drains (Fig. 34). During the rain period of 8 July to 12 July, a bridge on the Thirtan River washed away due to river meandering, isolating only the school present from rest of the village. For 52 days, the school remained closed until a temporary wooden bridge was constructed (Fig. 35), which seemed unsafe for children and other commuters. Another significant concern was that the newly constructed school building has started to develop cracks, indicating the presence of a slow subsidence in the region.

**Fig. 33.** New Road construction with large slope angle.

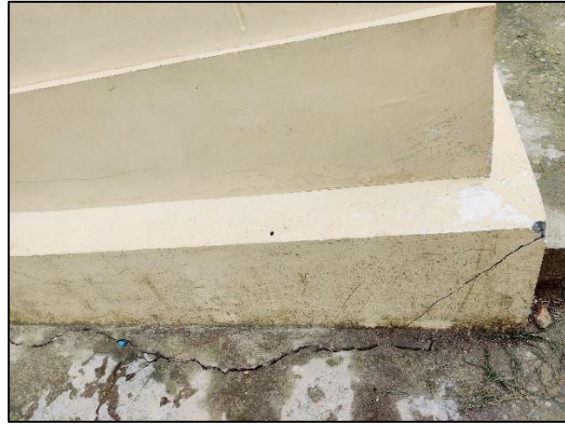
**Fig. 36.** Cracks developed in the newly constructed school building (just before monsoon).

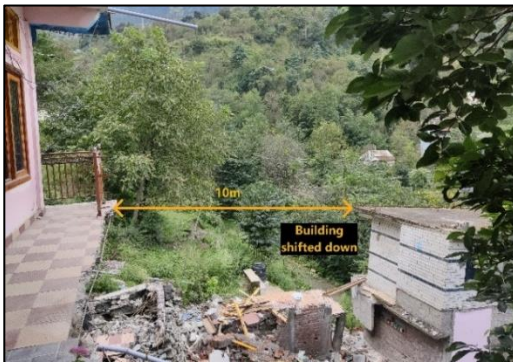
6. Inspection of the area near Banjar revealed another subsidence zone, where four houses situated above the road and one below it suffered damage. Nearby shops also developed cracks due to the settlement. One of the houses showed a vertical displacement of about 3 meters and a horizontal displacement of about 3.5-4 meters. According to the owner, this displacement began following heavy rainfall on July 26.
7. Also, masonry buildings of the school named Saraswati Vidhya Mandir that were once connected have now shifted around 10 meters apart, indicating progressive damage (Fig.37). Even though the school building has tilted columns and developed cracks, it is still in use posing a threat to the lives of children (Fig. 38).

**Fig. 37.** Building shifted down due to subsidence.

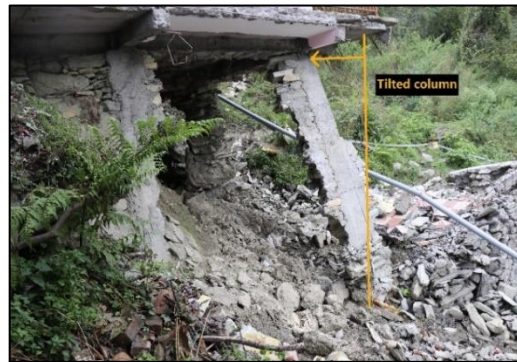
**Fig. 38.** Tilted column of school building.

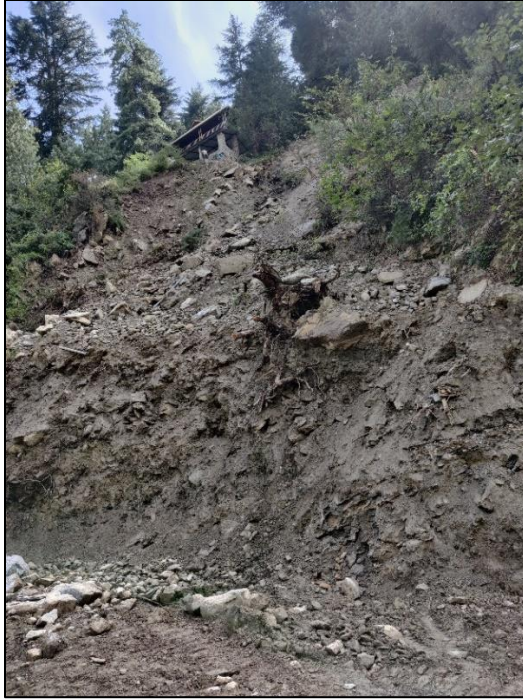
9. The type and characteristics of the rocks or soils comprising the slope play a critical role in the stability of slopes. The slope material was observed to be composed of a combination of soil and weathered rock. The breakdown of rocks into fragments over time due to physical, chemical, or biological processes has weakened slopes. In addition to it the gradual removal of soil or rock particles by wind, water, or ice has eroded the slope's stability over time. The presence of geological features such as faults, fractures, or bedding planes has created zones of weakness that serve as potential slip surfaces.

**Fig. 39.** Slope material composed of fragmented rock and soil.

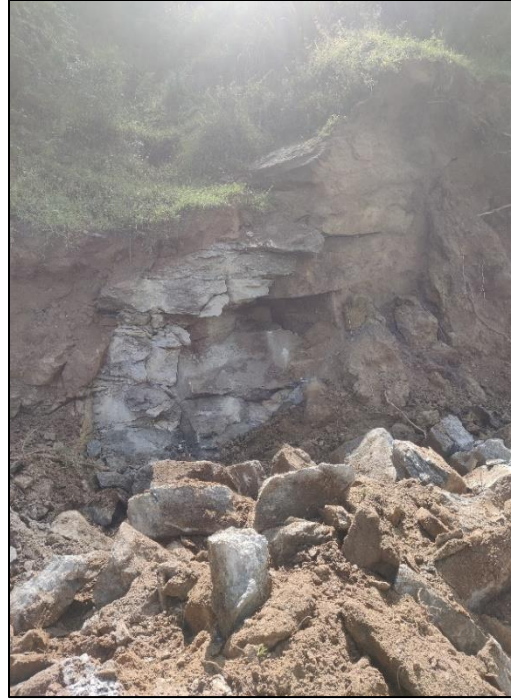
**Fig. 40.** Heterogeneous nature of slope material

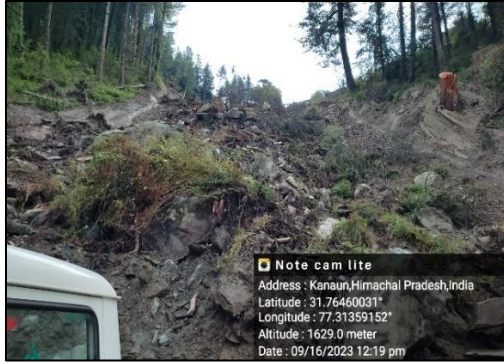
10. Janakhla-Khani Dhar, witnessed a massive debris flow (Fig. 41, 42). The event was triggered by the subsidence of a bawari (water storage structure) on the hilltop, leading to water leakage and soil instability. Additionally, soil mass movement, including the displacement of enormous boulders, was caused by erosion and contact loss of a nala (stream) flowing from the mountaintop. Deodar trees, apple orchards, and the road partially have all been destroyed by the debris flow.

**Fig. 41.** Debris flow at Janakhla- Khani Dhar.

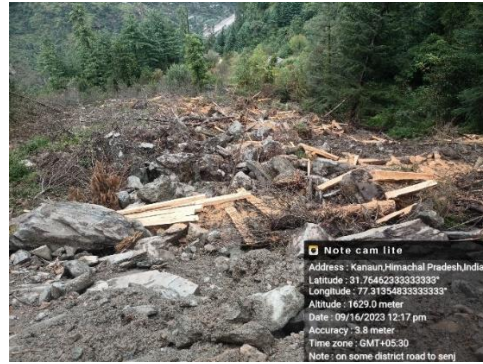
**Fig. 42.** Damaged orchards downhill.

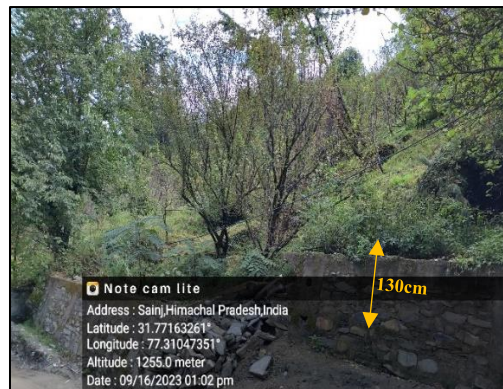
11. The flash flood near HDFC Bank Sainj significantly altered the river's course, creating a new flow line that led to toe erosion of soil at the base of the hill. As per observations, up to 130 cm of land have been subsided (Fig. 43), affecting a 150-meter stretch of the hill, which includes apple and fig orchards, causing soil cracks and impacting houses situated above the affected area.

**Fig. 43.** Land subsidence, Sainj

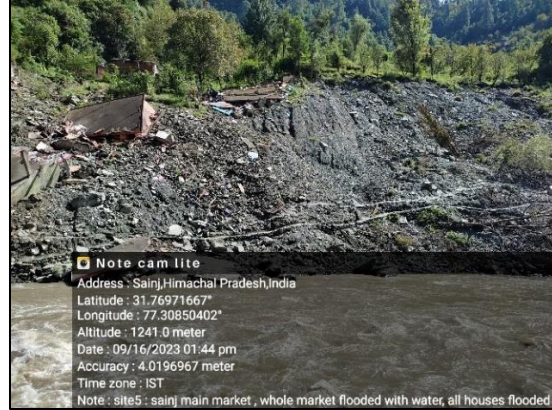
**Fig. 45.** Damaged houses.

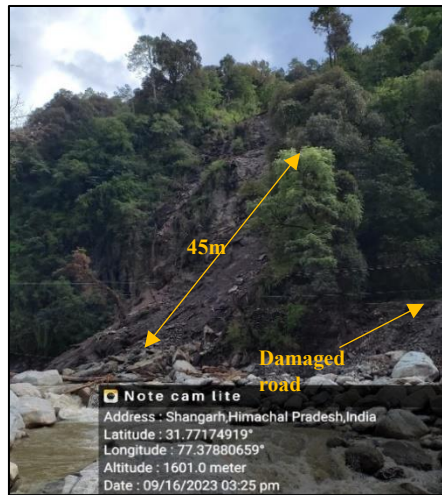
14. During heavy rains, Neuli experienced a massive landslide spanning approximately 40-45 meters from the hilltop. The landslide involved the displacement of rocky boulders and water flow from the hill's upper reach. The event resulted in the complete damage of the road along this stretch, leading to the loss of connectivity (Fig. 47).

**Fig. 47.** Road damage due to landslide, Neuli

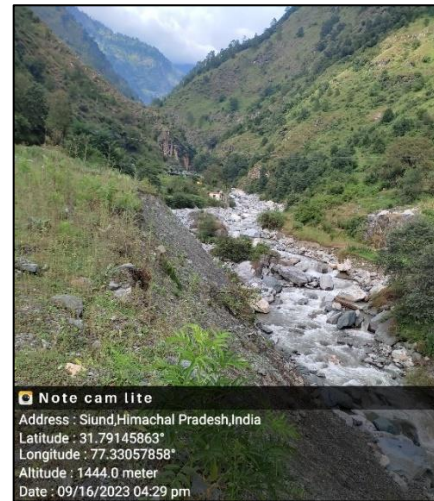
**Fig. 48.** Dumping site without safety walls, Sharan Bihali-Rela

15. The site, Sharan Bihali-Rela is associated with an NHPC (National Hydroelectric Power Corporation) hydropower project, where the muck was dumped (Fig. 48) without the construction of proper safety walls. Subsequently, heavy rainfall and high river flow caused the dumped muck to displace and resulted in significant damage downstream area, including infrastructure and the environment.
16. At Bihali, the rigid pavement has experienced significant damage, including breakage (Fig. 49) and the loss of pavement material (Fig. 50). The primary cause of pavement damage is attributed to erosion resulting from heavy river flow, which has exposed and displaced pavement materials.
