**Himachal Pradesh State Disaster Management Authority**

**District Disaster Management Authority Kullu**

**KULLU DISTRICT DAMAGE REPORT:  
TECHNICAL ASSESSMENT AND SUGGESTIONS**

**October 2023**

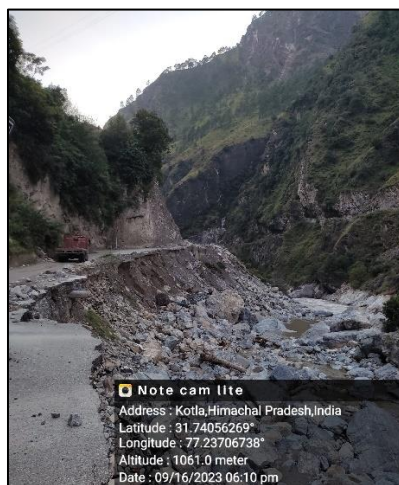
**Fig. 49.** Road cuts at Bihali.

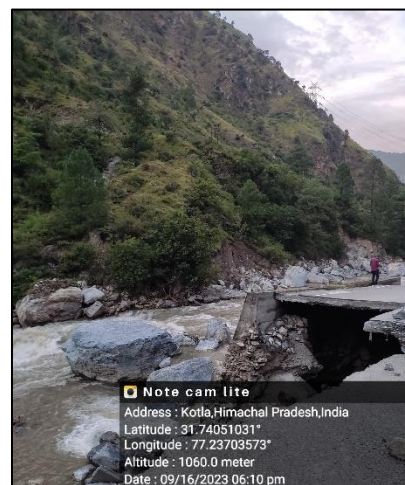
**Fig. 50.** Loss of pavement material due to erosion.

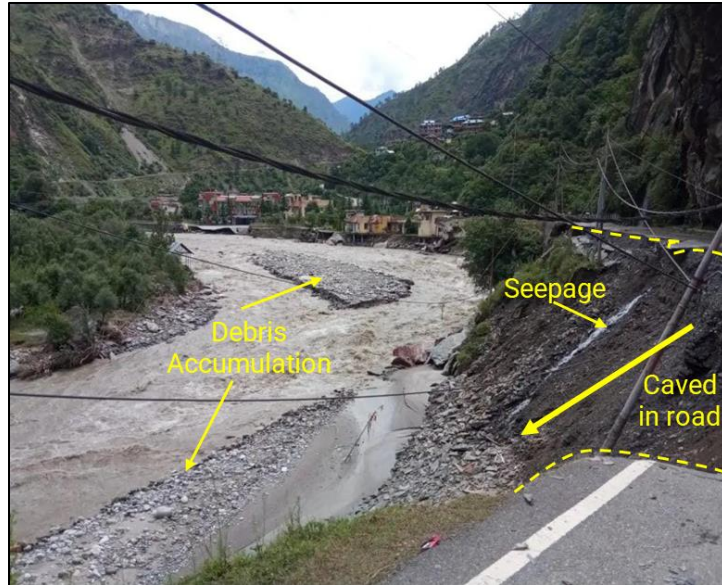
2. Noticeable erosion along the road shoulders was observed, with visible loss of soil and vegetation, underscoring the susceptibility of the roadside terrain to water runoff and undermining road stability. The eroded shoulders indicated a pressing need for effective drainage management and stabilization measures to prevent further degradation of the road infrastructure.

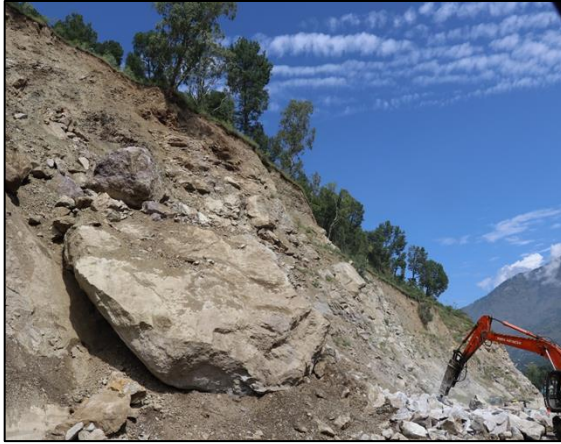
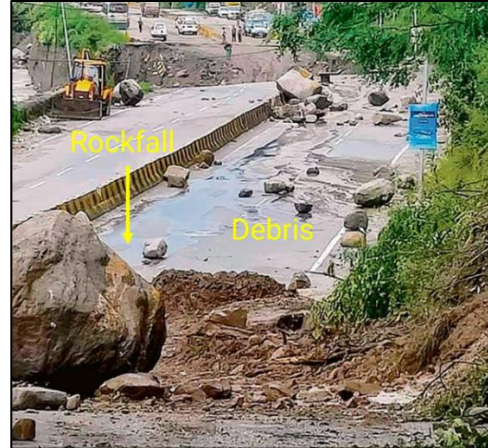
4. Road Subsidence was observed at multiple locations throughout the Highway stretch indicating potential instability of the underlying soil material.
5. Evidence of various types of landslides, with substantial portions of the road being obstructed due to the displacement of earth and rock debris, resulting in both partial and complete blockages. These landslides posed significant challenges to road accessibility, necessitating comprehensive mitigation measures to ensure safe and efficient transportation.

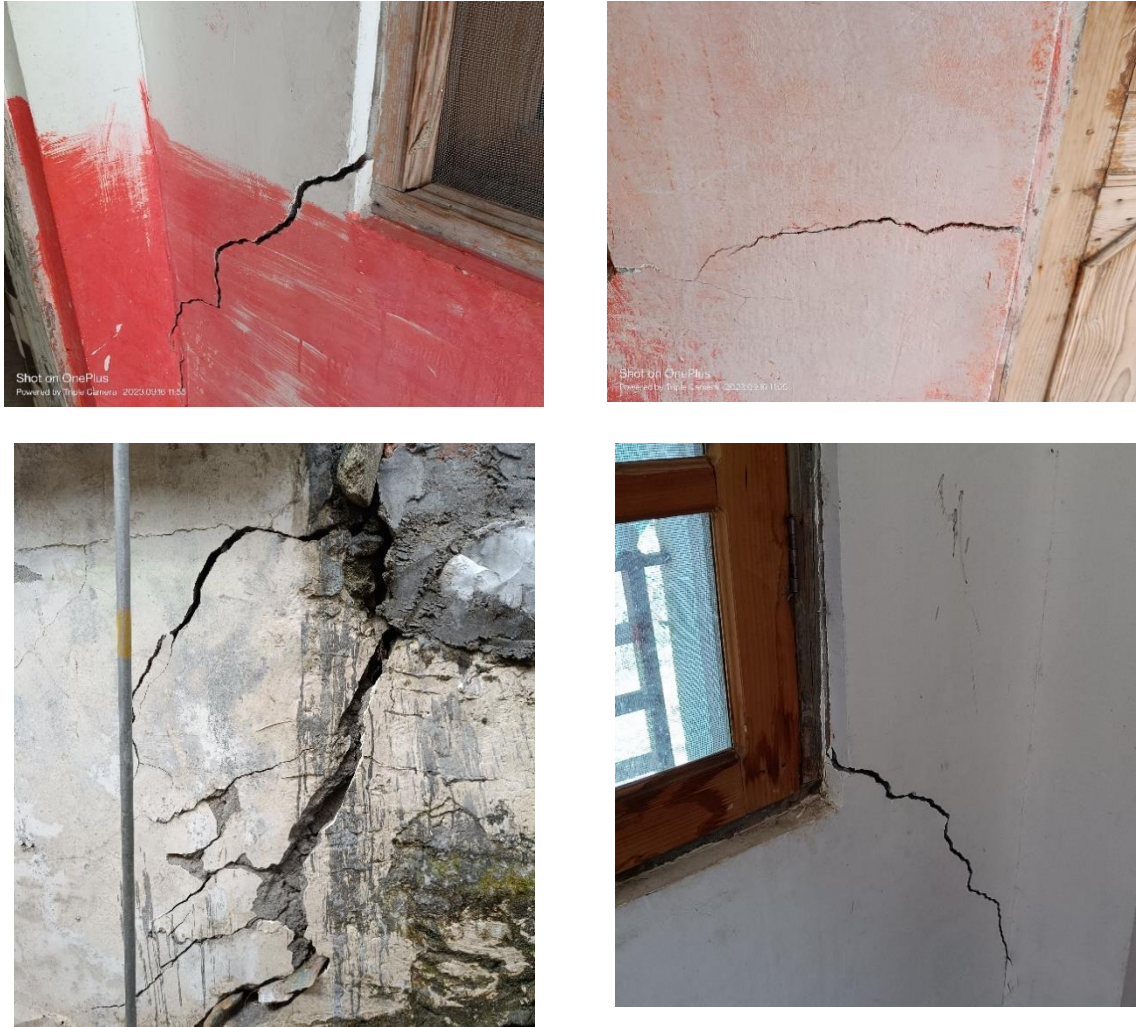
**Fig. 52.** Cracks due to differential settlement at various locations in building.

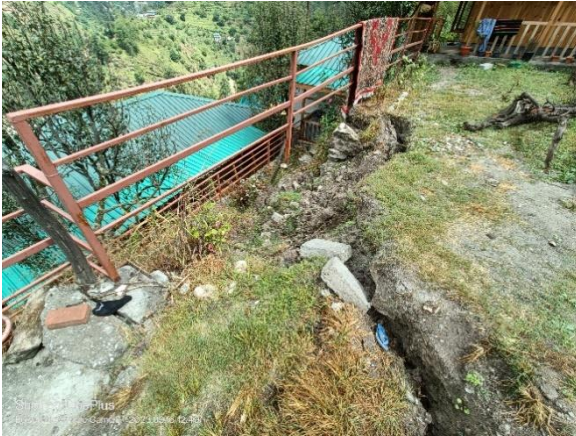
(a)

**Fig. 53.** a) Settlement of slope, b) Differential settlement of the building, c) Cracks on the walls due to differential settlement of the foundation, d) Improper foundation provision.

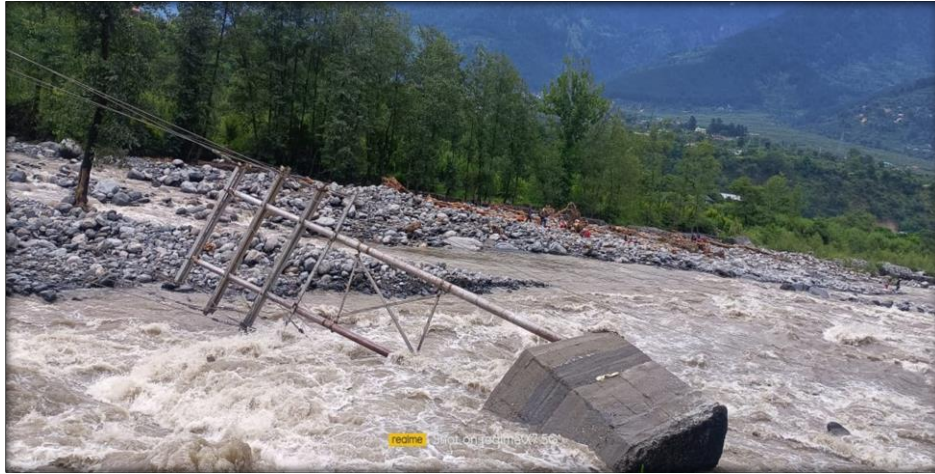
**Fig. 62.** Damaged Bridge located at Jagatsukh
