**REPORT ON THE PRELIMINARY ASSESSMENT OF LANDSLIDE AT  
KULLU, BANJAR, MANALI AND ANNI SUB-DIVISION OF KULU  
DISTRICT HIMACHAL PRADESH**

Item Code No.: M4EGG/C/NR/SU-PHP/2023/46620

By  
Tripti Baba, Senior Geologist  
Weneikhro Krome, Geologist

राज्य इकाईपंजाब :, हरियाणा एवं हिमाचल प्रदेश / State Unit: Punjab, Haryana and Himachal pradesh  
उत्तरी क्षेत्र / Northern Region  
चंडीगढ़ / Chandigarh

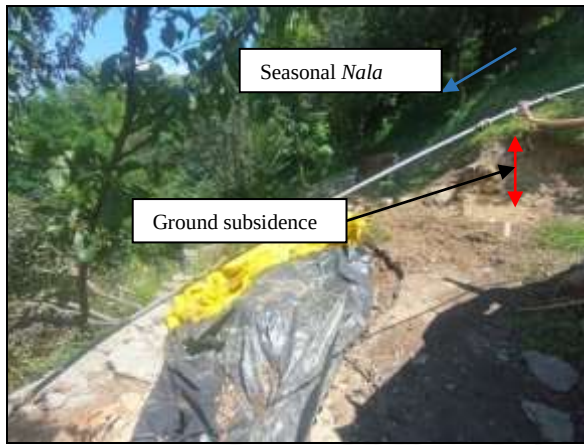
Fig.5; Ground subsidence observed along the left flank/ slope of seasonal *Nala*

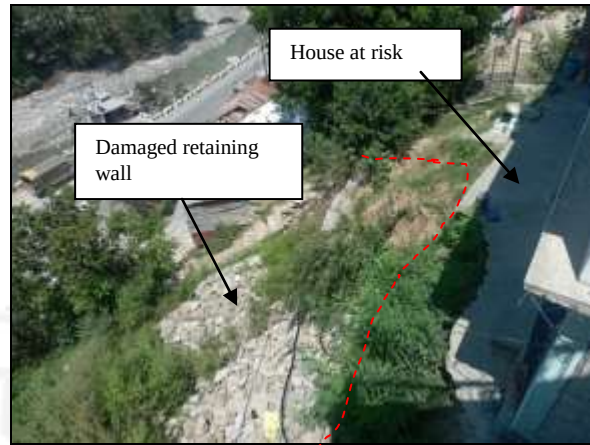
Fig.6; House at risk located upslope of NH-03 at Devdhar village.

- The unchannelized *nalas* and house hold sewage domestic water should be channelized systematically.
- Construct contour parallel drainage system in the upslope of the settlement.
- The damaged retaining wall along the hill side of NH-3 located down slope of the village should be repair/replaced with a provision of weep holes.
- Construction of appropriately designed guide walls is required along both the bank of *nala* located on the right flank of the affected area in consultation with design engineers to prevent further toe erosion and damage to civil structures present vicinity to it.
- Biotechnical stabilisation/ Plantation of suitably identified species that can hold the soil in the failure affected zone in consultation with Botanist/Forest dept.

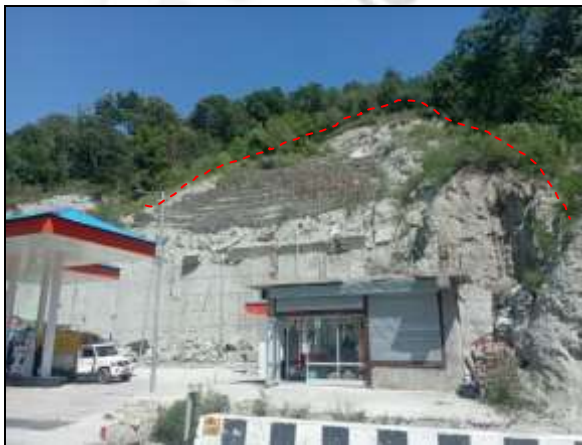
- At the failure affected site, the slope forming material consists mainly of fine to coarse grained loose unconsolidated soil and no *in-situ* rock were exposed.
- The crown of the slide was observed along the local footpath connecting Devdhar to Banontar.(Fig.8). The dimension of the landslide is  $\pm 55\text{m}$  length and  $\pm 50\text{ m}$  width and are retrogressive in nature, dripping to flowing hydrological conditions (Fig.9).
- No drainage system was observed to be present in and around the distressed zone.
- A set of retaining walls constructed on the hill side of petrol pump were observed tilted and displaced due to retrogressive in nature and few ground cracks were also observed near the crown of the slide, which poses more risk to petrol pump/ downslope structures in case of uneven/extreme weather conditions.

Fig.7; Debris slide on upslope of Indian oil petrol pump.

- It is suggested to construct an appropriately designed lined drainage parallel to contour above the crown of the slide to avoid surface water discharge on the distressed slope.
- The source area responsible for dripping water along the distressed slope need to be identified and pipes should be installed at the seepage/source zone for proper drainage management on the slope.
- Biotechnical stabilisation/ Plantation of suitably identified species that can hold the soil in the failure affected zone in consultation with Botanist/Forest dept.
- Immediate filling of ground cracks with appropriate impervious material immediately.
- Appropriately designed retention structures at suitably identified locations at lower levels as support to failing mass in consultation with design Engineers.

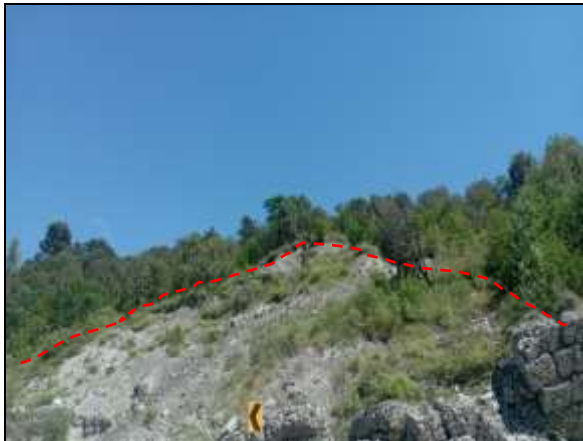
- It was observed that the slope failure has taken place from a moderately inclined hill slope. The slope forming material consist of fined to coarse grained loose unconsolidated soil.

- The affected slide has a dimension of  $\pm 35\text{m}$  length and  $\pm 40\text{m}$  width exhibiting retrogressive and widening in distribution.
- Retaining walls that were placed on the hill side of the NH-3 were observed to be damaged, partly tilted at places and the local foot path was completely wash out.

Fig.10; Debris slide as discernable from the left bank of Beas River.

- The source area responsible for dripping water along the distressed slope need to be identified and pipes should be installed at the seepage/source zone for proper drainage management on the slope.
- Biotechnical stabilisation/ Plantation of suitably identified species that can hold the soil in the failure affected zone in consultation with Botanist/Forest dept.
- Appropriately designed retention structures at suitably identified locations at lower levels as support to failing mass in consultation with design Engineers.

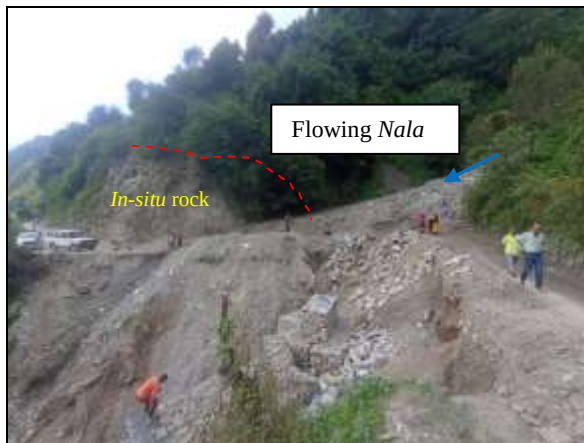
- Garsa village landslide is located (31°49'42.82"N, 77°15'20.12"E) on a slope wash material of unconsolidated loose debris material along steeply inclined hill slope with a general slope direction of ~50°/N250° and presence of flowing *Nala* on the right flank of the affected slope (Fig.17).

- The subsidence is active, retrogressive, widening in distribution with development of multiple crowns and damp to wet hydrological conditions.
- As per field observation, the main affected zone appears to be a part of landslide main body.

Fig.17; Right flank of Garsa village affected slope.

- Appropriately designed retention structures at suitably identified locations at lower levels (in consultation with site Engineers) as support to failing mass.
- Immediate filling of transverse and contour parallel tension cracks with appropriate impervious material immediately.
- Avoid further loading, tampering of slope with heavy civil structures in/adjoining failure affected zone and in immediate vicinity of *nala* courses.
- Appropriately designed guide walls in consultation with design Engineers along the *nala* courses present on the right flank of the slope, to prevent further erosion and damage to civil structures present vicinity to it.

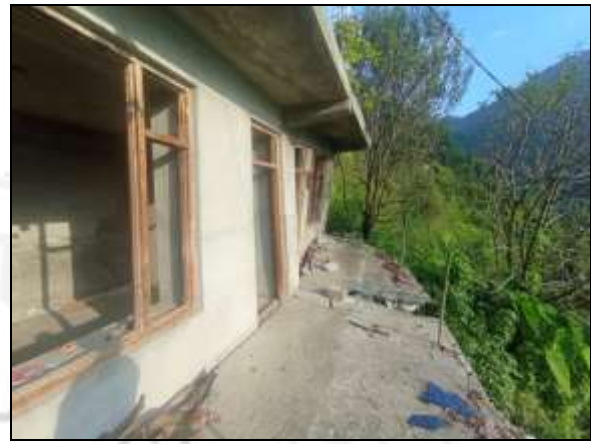
- During field visit/inspection it was observed that several houses were partially to fully damage in the form of cracks on walls and roof, lateral displacement of structures, ground cracks, tilting of houses and tilting of electric pole (Fig.18,19 and 20). A total nos. of 16 houses was damaged (as informed by local residence).

Fig.18; Damaged house at Garsa village.

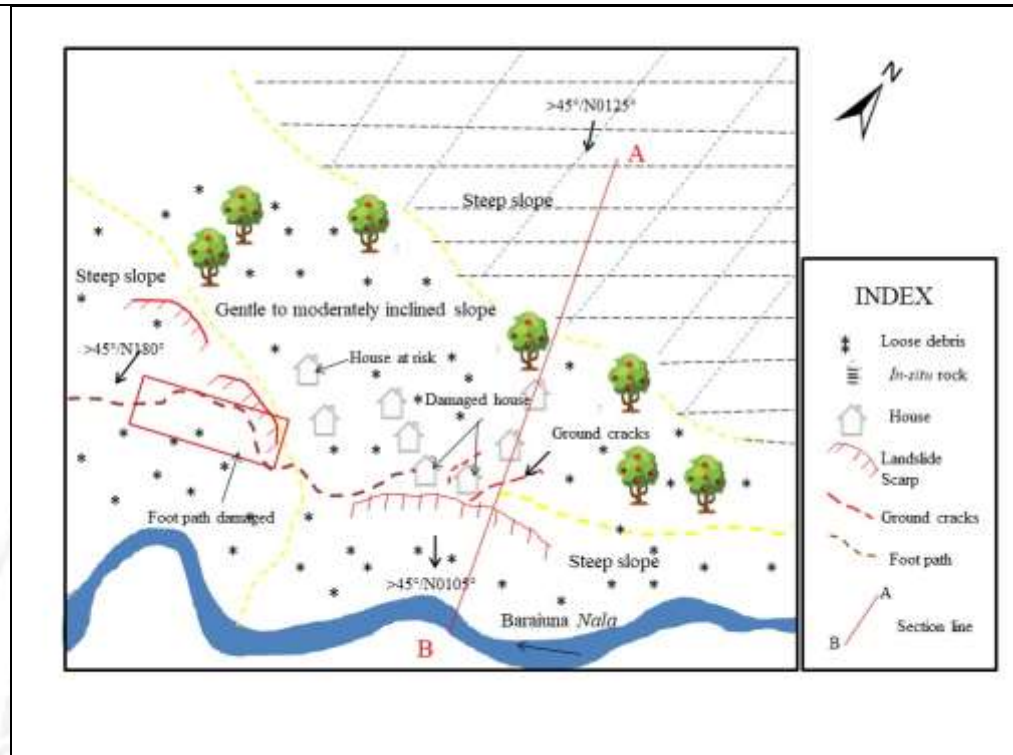
Fig. 27; Schematic diagram of the Baraiuna landslide

- It is suggested to construct an appropriately designed lined drainage upslope to avoid surface water discharge on the distressed slope.
- Appropriately designed retention structures at suitably identified locations at lower levels as support to failing mass.
- The affected house located at the crown of the landslide need to vacate immediately.
- Immediate filling of transverse and contour parallel tension cracks with appropriate impervious material immediately.
- Avoid further loading, tampering of slope with heavy civil structures in adjoining failure affected zone.
- Appropriately designed guide walls along the bank of Baraiuna *nala* to prevent further toe erosion of slope.

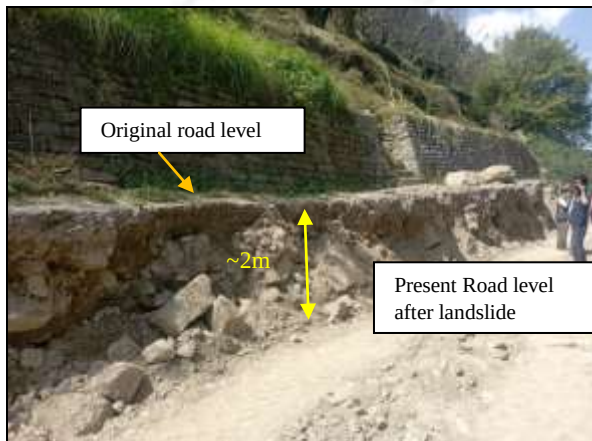
- The Hydrological conditions of the distressed slope are damp, wet and dripping at sporadic locations.
- At least three level of link road were passes along the distressed slope. Several severe instability signatures were observed along all the road level in the main distressed slope such as damages of retention structures (Fig.35), crack on civil structures, lateral ground displacement (Fig.30 and 32), damage houses, ground cracks (Fig.29), tilting of trees (Fig.34), uprooting and road subsidence for about 2-5 m mainly on topmost and middle road level (Fig.31).

Fig.31; Road subsidence observed along the middle road level at Bandal

- It is suggested to construct an appropriately designed channelized lined drainage to avoid surface water discharge on the distressed slope.
- Appropriately designed retention structures in consultation with design Engineers along the hill and valley side of road with a provision of weep holes and hill side drainage.
- Immediate filling of transverse and contour parallel tension cracks with appropriate impervious material immediately.
- Avoid further loading, tampering of slope with heavy civil structures in/adjoining failure affected zone.
- Based on the dimension of the slide, the importance of the affected road and houses located at the slide zone a detailed site specific study is recommended.

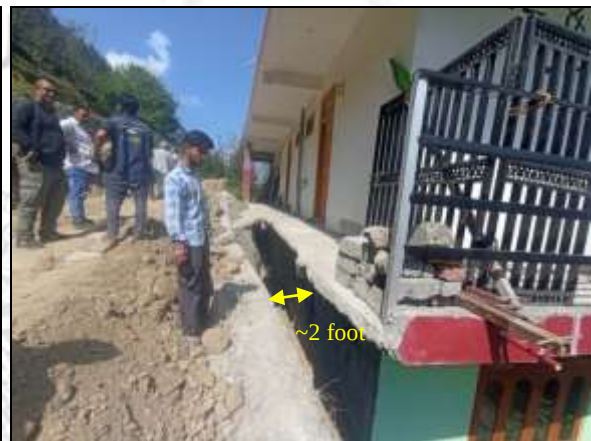
Fig.32; Lateral displacement of civil structure located at the valley side of middle road level at Bandal.

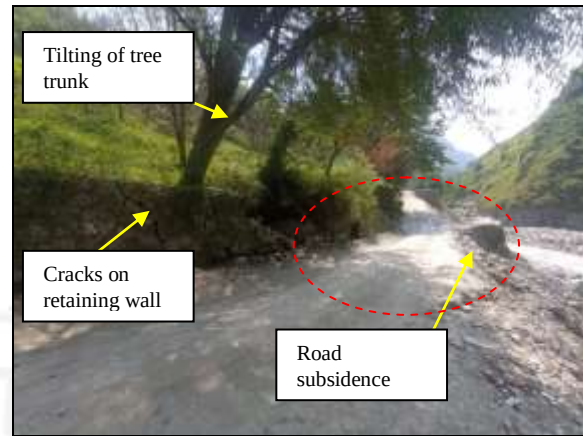
Fig.43; Main subsidence zone at (31°46'18.34"N, 77°18'39.95"E) along Thana Sainj to Taxi stand road stretch.

- At location (31°46'18.34"N, 77°18'39.95"E) a major subsidence zone of about  $\pm 80$  m length and  $\pm 75$  m width was observed on the said affected road stretch (Fig.43). The entire distressed zone at this location is characterised by moderate vegetation cover with a hydrological conditions of damp to dripping.
- The road stretch of about 75m in this zone is observed to be subsiding for about 5-10m. The hill side and valley side retention wall are found to be bulged and damaged along with tilting of trees were observed (Fig.43).
- Few settlements were nestled upslope of the affected zone along moderately inclined hill slope with a general slope direction of  $\sim 40^\circ/\text{N}340^\circ$  poses risk to further damaged to the existing structures if left untreated with suitable remedial measures.

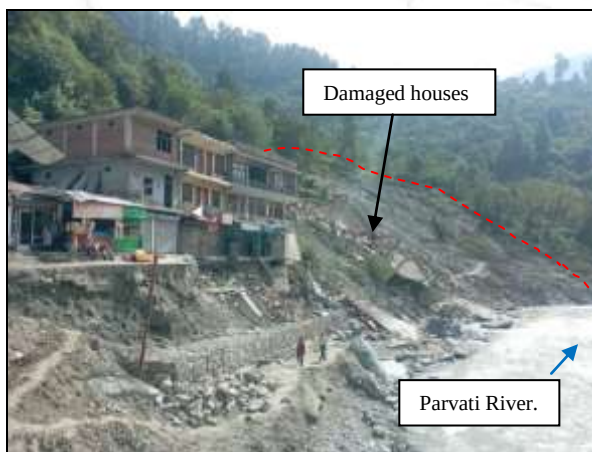
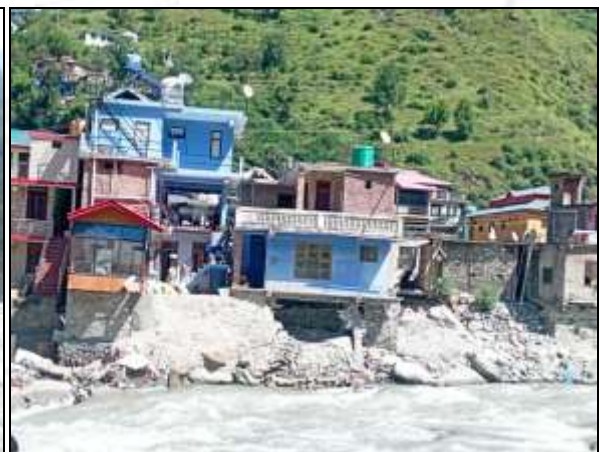
Fig.44; Main landslide affected area at Sainj market,

Fig.45; Houses at risk located at the right bank of the river opposite to Sainj Market

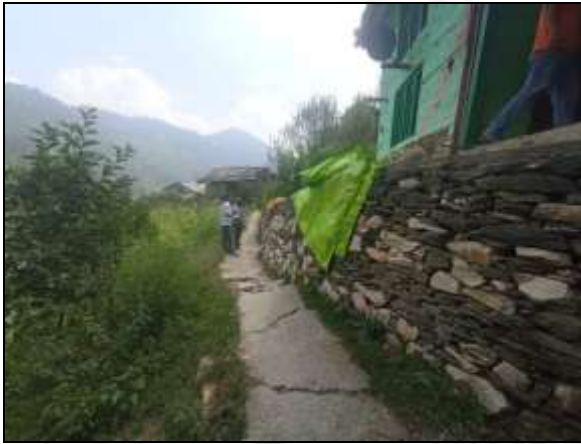
- Instability signatures such as minor ground cracks, partially damaged foot path, partially damaged house, ground subsidence on plantation land were observed (Fig.48,49 and 50).
- The subsidence is active and poses serious threat to some houses (Fig.51) if further activating in the event of external trigger by rainfall/earthquake unless adequate slope protection measure is given.

Fig.48; Ground cracks and partially damaged retaining wall.

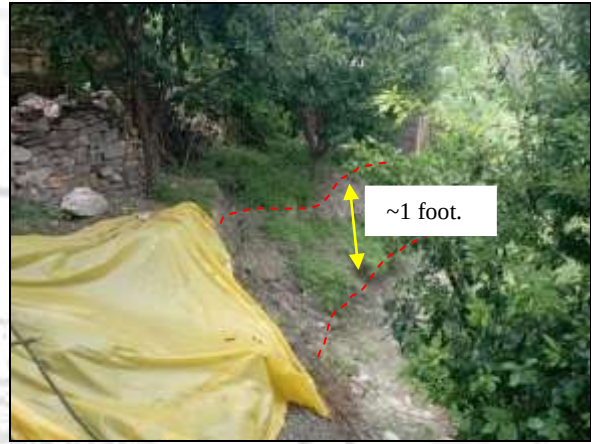
Fig.49; Ground subsidence.

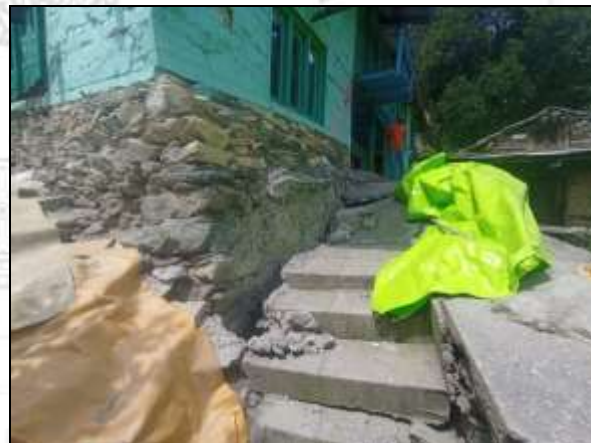
Fig.51; partially damaged houses Mourod

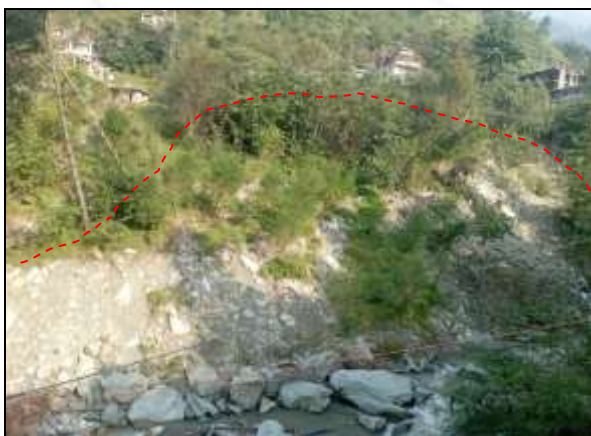
Fig.52; Daduhar slide as discernable from the opposite slope.

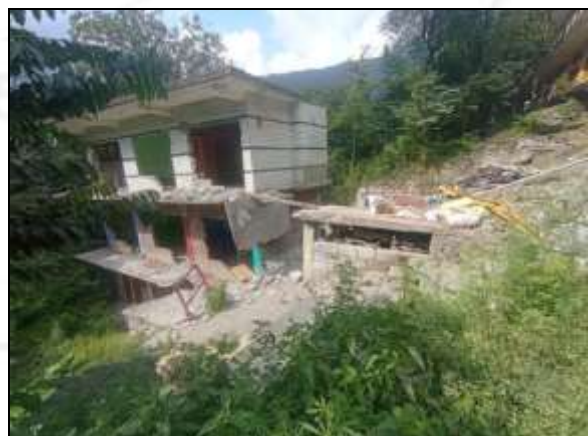
- As per information (received from local residence , SDM Banjar and field observation) a total 5 nos. of houses were damaged including Sarswati Vidya Mandir Sr.Sec, School located on the affected zone/slope. (Fig.53)

Fig.53; Damaged Sarswati Vidya Mandir Sr.Sec, School at Daduhar.

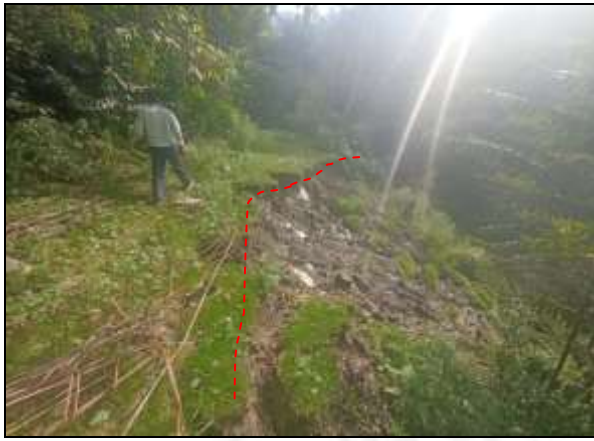
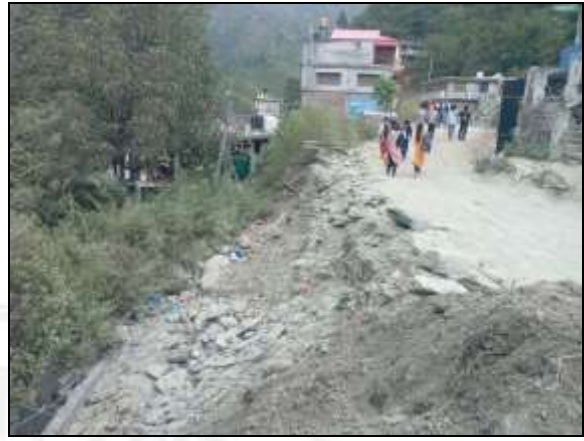
Fig.54; Dripping hydrological conditions on the distressed slope. Fig.55; Damaged road stretch at Daduhar.

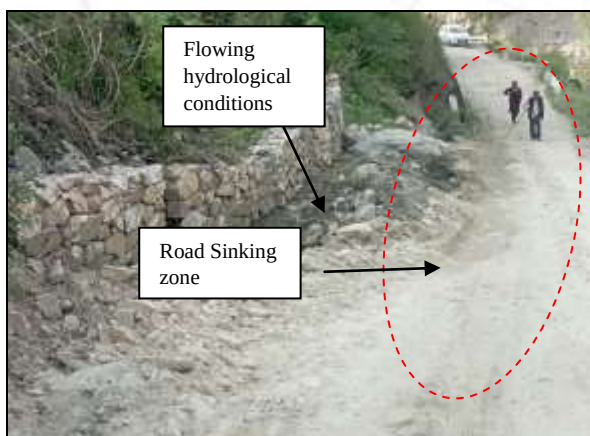
Fig.58; Road subsidence at Kartah

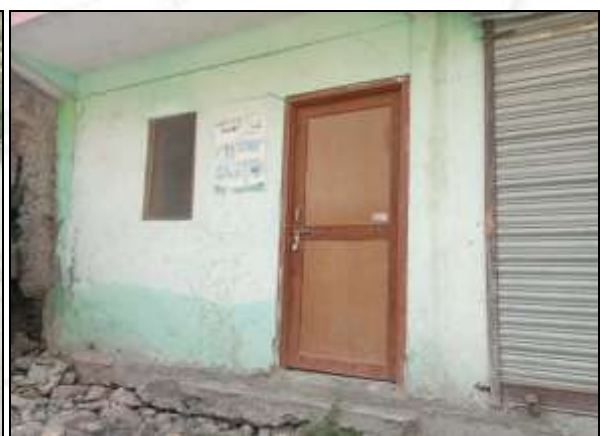
Fig.59; Cracks on walls at Kartah.

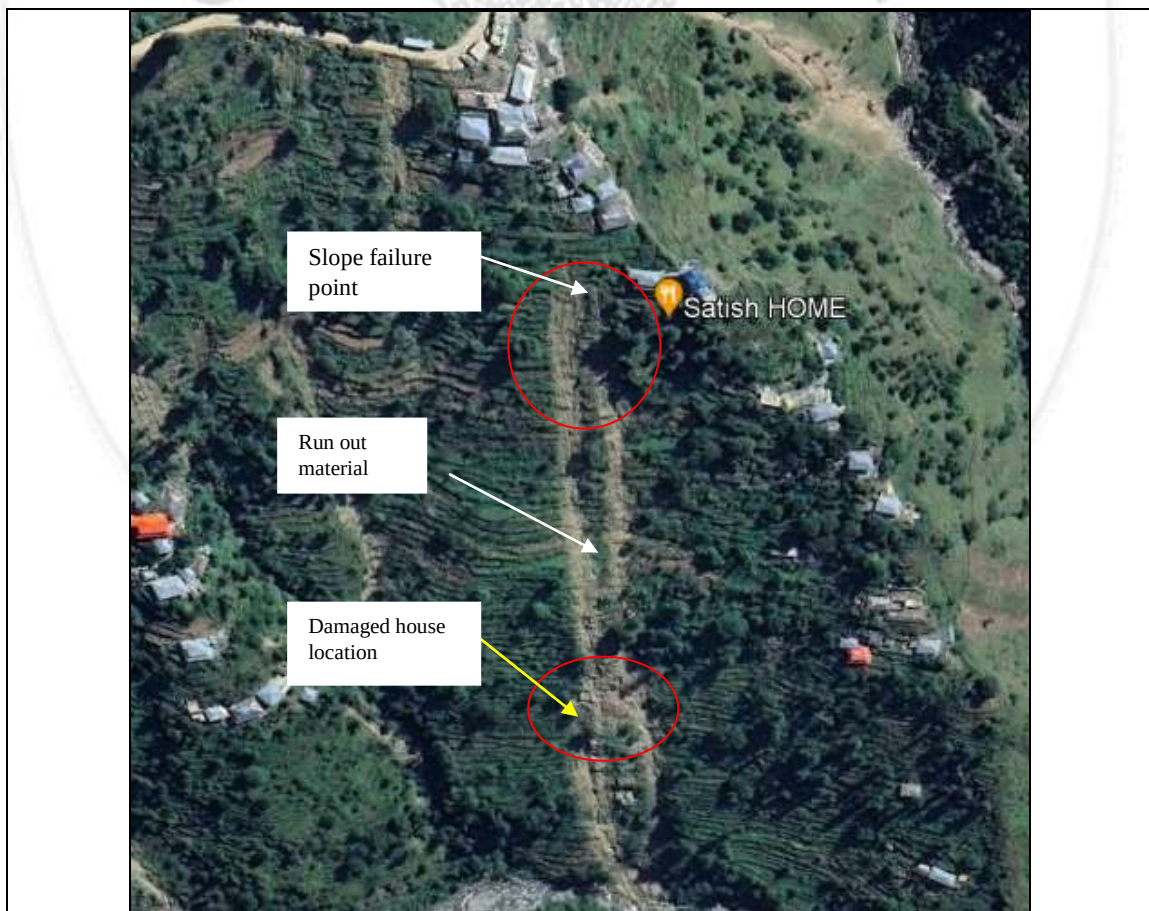
- Nigloodhar Village ( $31^{\circ}28'16.16''\text{N}$ ,  $77^{\circ}22'1.63''\text{E}$ ) is located on semi consolidated debris of slope wash material along steeply inclined hill slope ( $65^{\circ}$ - $70^{\circ}$ /N $270^{\circ}$ ).
- It is observed that 3 houses were completely damaged by run out material from upslope debris slide leading to loss of life to 3 persons. (Fig.64.a)
- The side was triggered by incessant rainfall during the early morning of 14<sup>th</sup> August 2023.
- The hydrological conditions of the affected slope is characterised by damp to dripping.

Fig. 64.a; Google image showing the Nigloodhar slide located along steep slope.

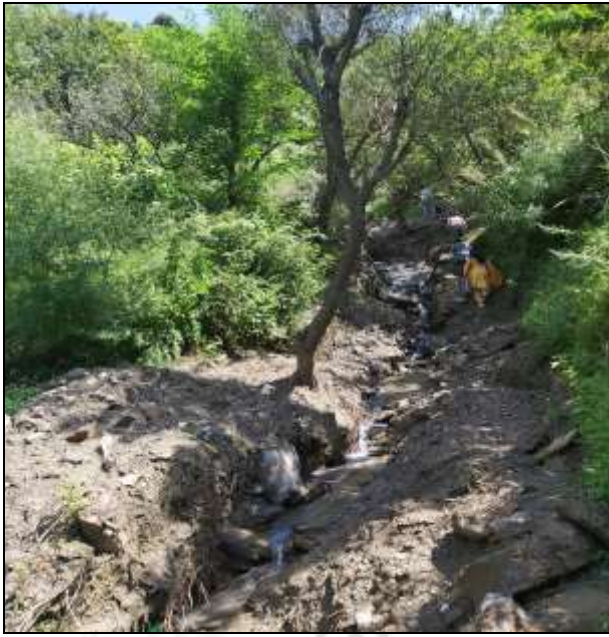
Fig. 64. Flowing nala observed near the Rageli slide

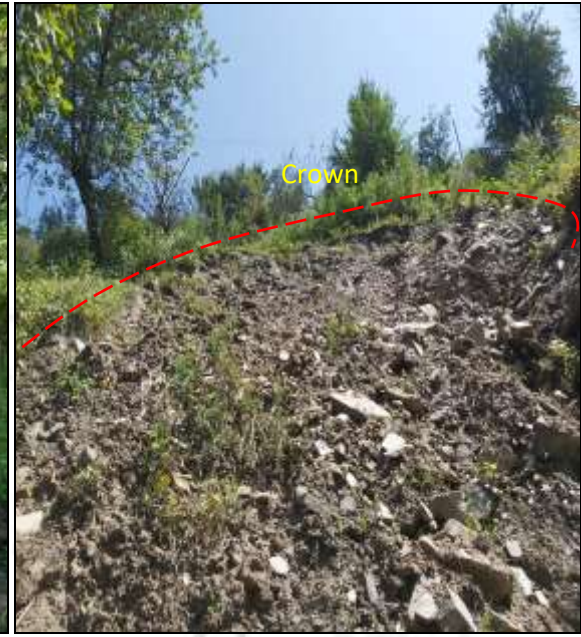
Fig.65. Crown portion observed in the Dharta village slide

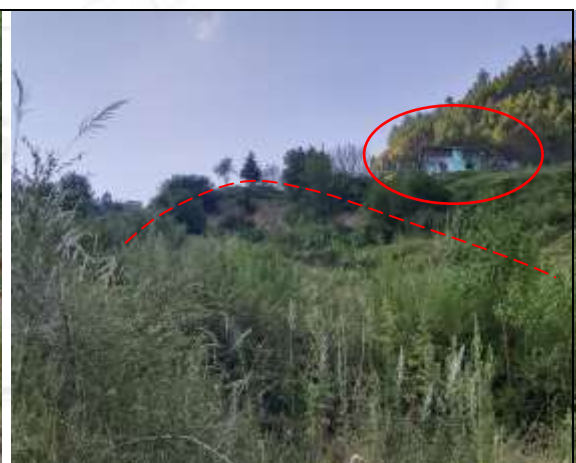
Fig.67. Houses in high risk zone observed on the crown portion.

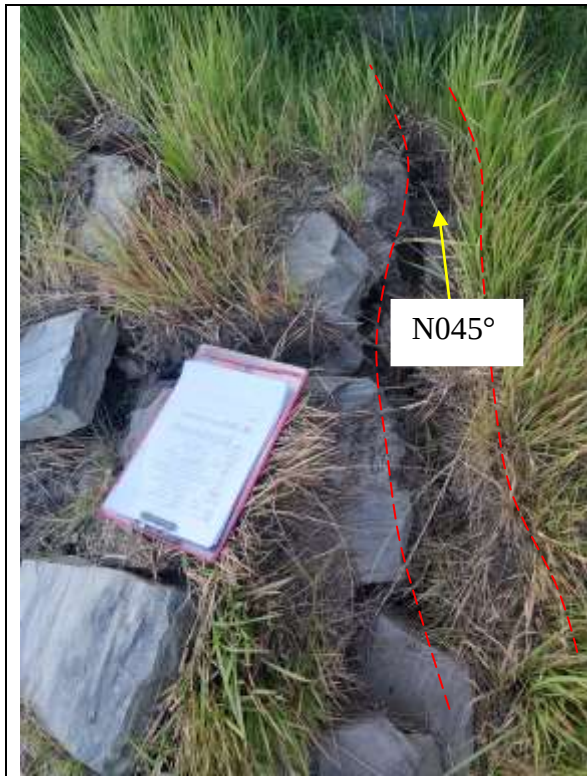
Fig.68. Longitudinal cracks with depth vary from 2-4m observed in the slide area.

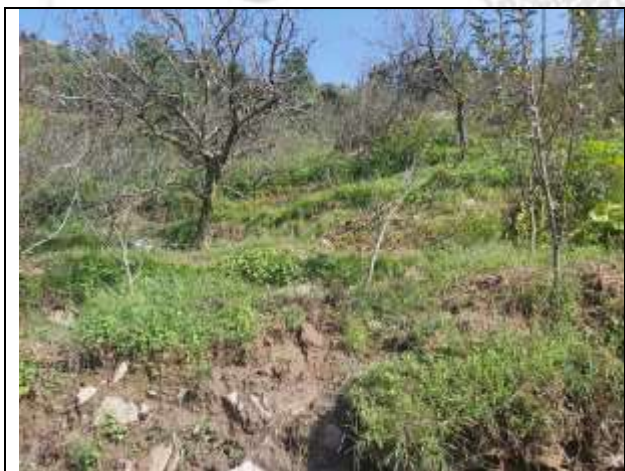
Fig. 70. Debris slide observed in Chehva village on the road side of NH 305

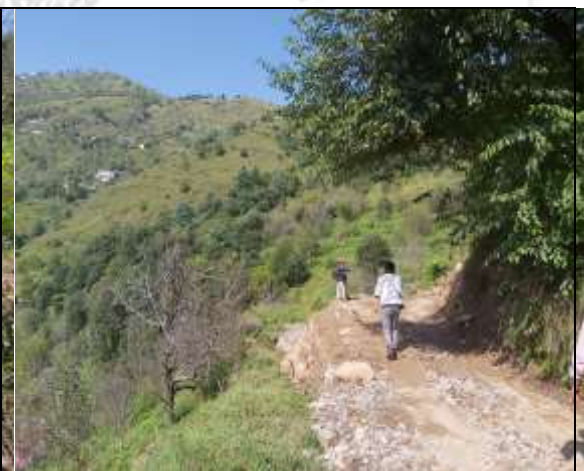
- It is observed that the upslope of the slide-affected zone has few agricultural lands, orchards, and settlements in the downslope.
- The subsidence/sink zone was observed at the road level and adjoining areas of the main slide zone (Fig.71)

Fig.71. Subsidence/ sink zone in road observed on NH-305.

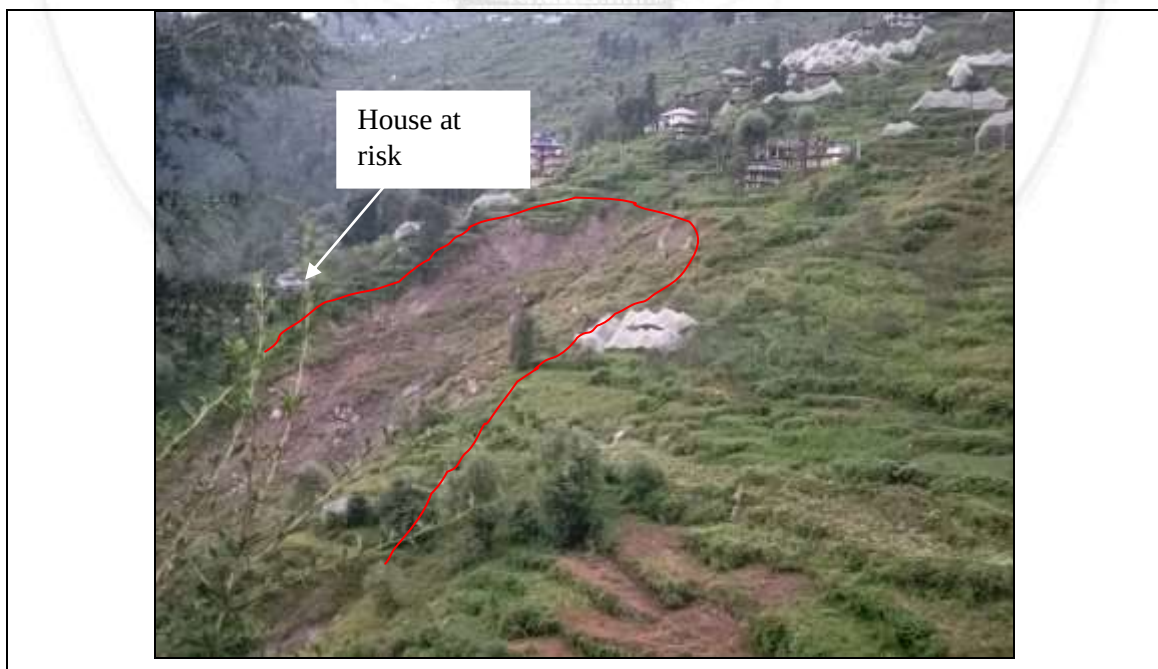
Fig.78.a; Field photograph showing Kot Nala landslide.

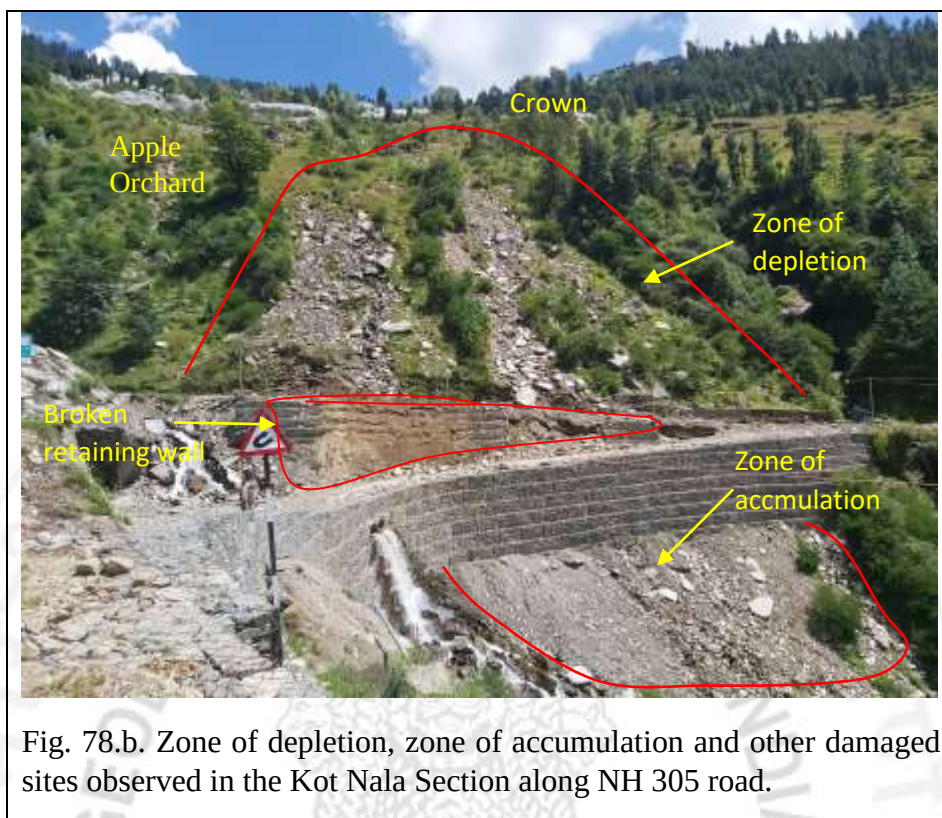
Fig. 78.b. Zone of depletion, zone of accumulation and other damaged sites observed in the Kot Nala Section along NH 305 road.

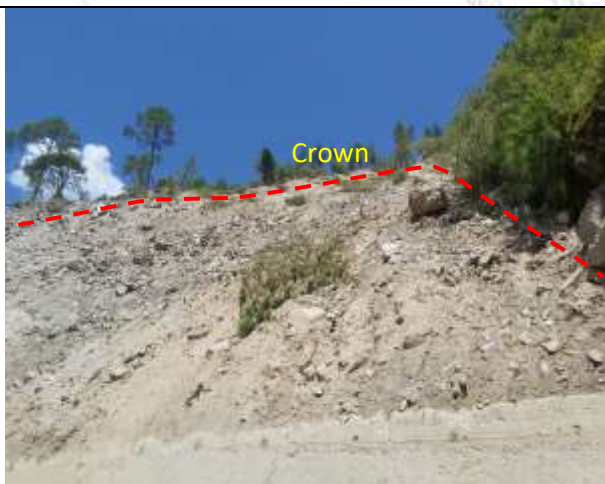
Fig.79. Unstable crown portion of slide

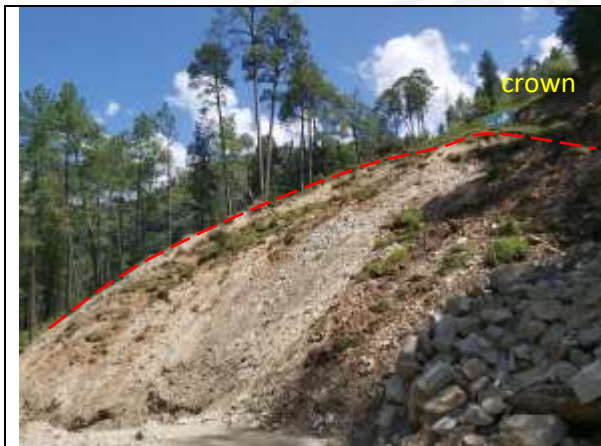
Fig.81. Crown is covered with plastic sheets of the slide

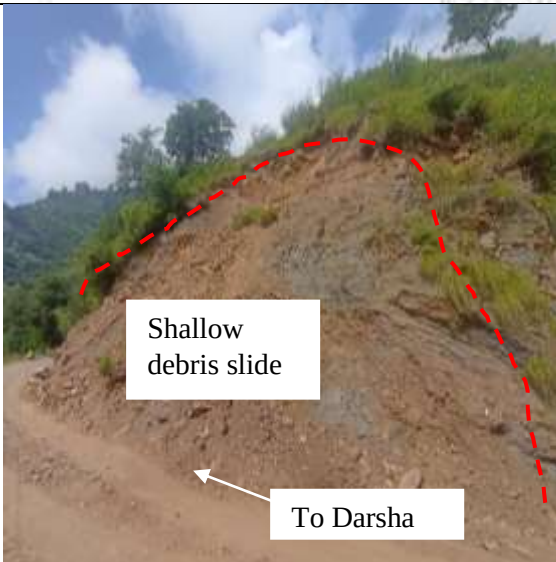
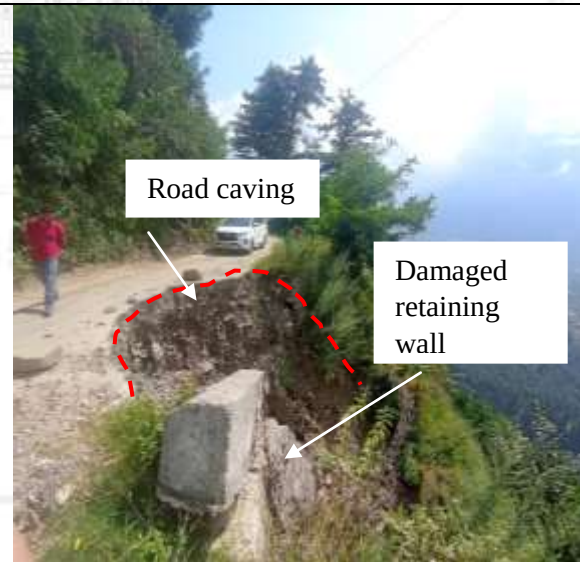
- Saturation of water on the loose debris material during incessant rainfall.
- Lack of drainage management.
- Road cutting along steep slope.

| <p>Fig.88. In Darsha debris slide (<math>32^{\circ} 8'56.51''\text{N}</math> , <math>77^{\circ} 9'8.44''\text{E}</math>) along Manali-Darsha PMGSY Road</p> | <p>Fig.89. Road caving along Manali-Darsha PMGSY Road at location (<math>32^{\circ} 8'58.79''\text{N}</math>, <math>77^{\circ} 9'16.50''\text{E}</math>).</p> |

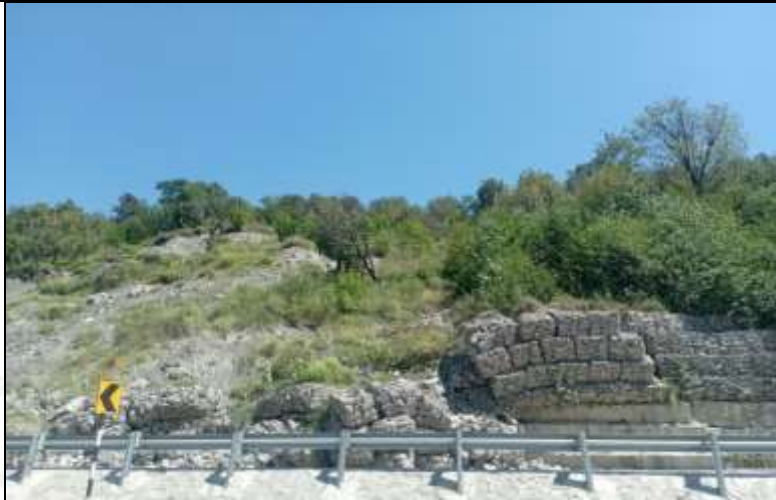
Fig.2. Damaged retention structures along the hill side of NH-3

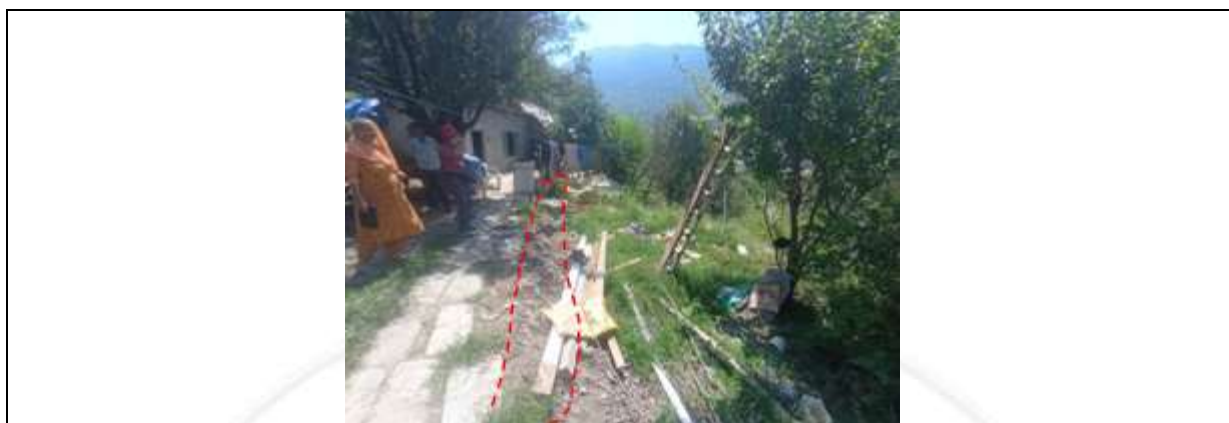
Fig.2. Ground cracks

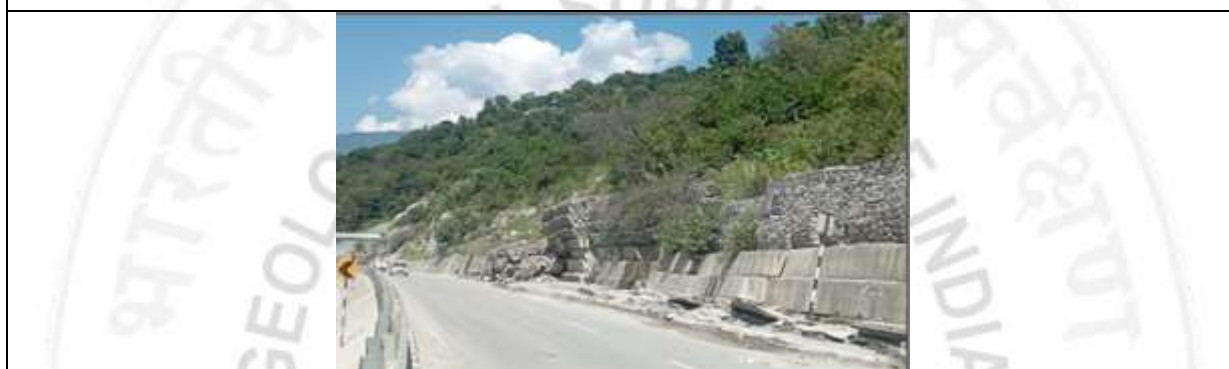
Fig.3 Damage retaining structures along NH-3.

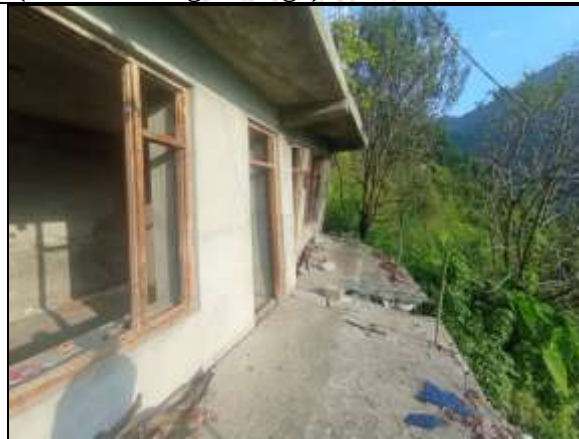
Fig.2. Damaged house

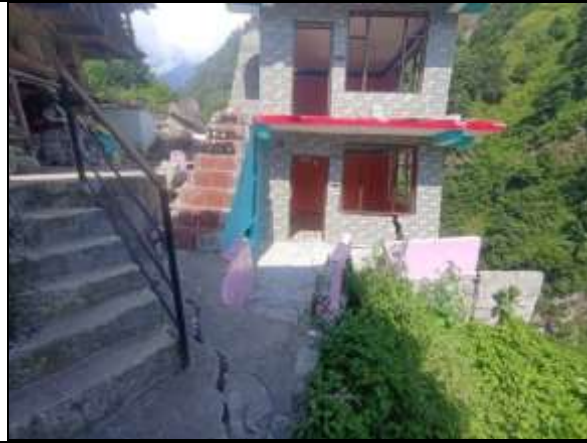
Fig.2. Crack on civil structures

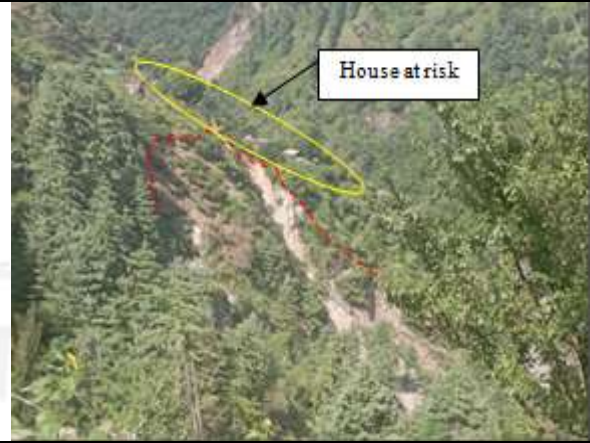
Fig.3. Landslide on right flank of the slope

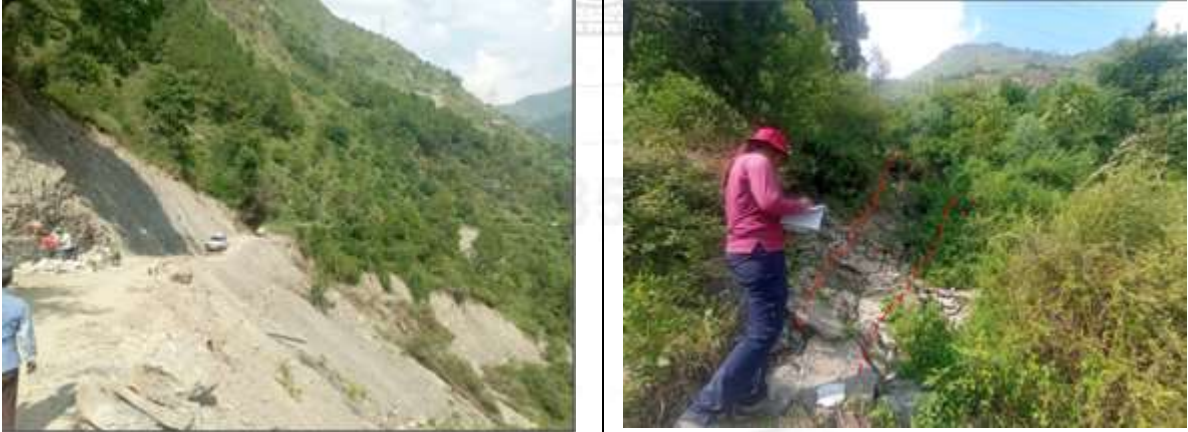
| Fig.2. Road subsidence | | Fig.3. Traverse ground crack on the right flank of landslide. |

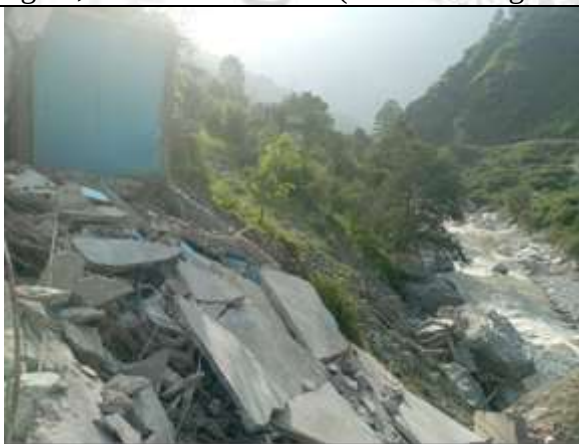
Fig.2. Damaged houses located near the bank of River

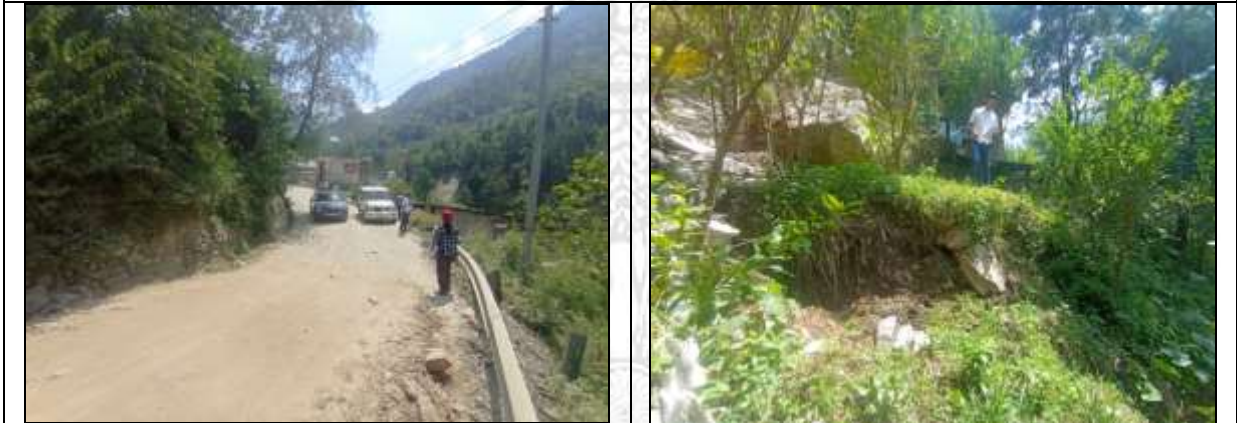
Fig.2. Road subsidence

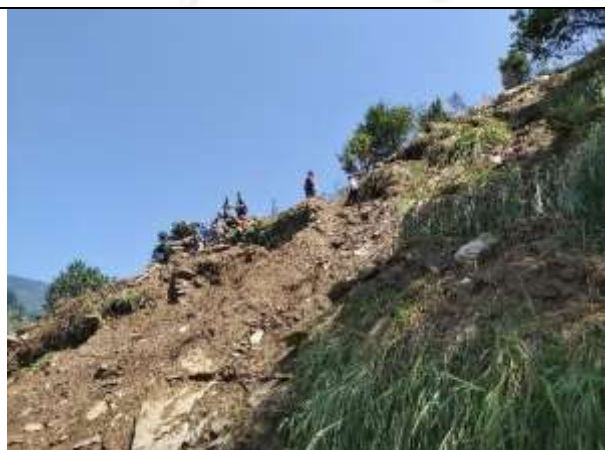
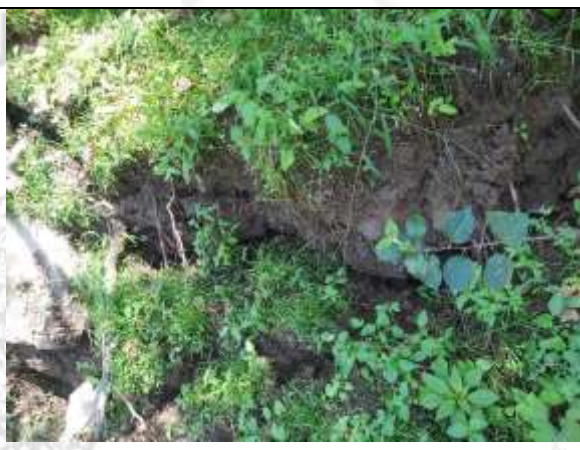
| Fig.1. Rageli landslide in Nigloodhar village | | Fig.2. Open ground cracks in Rageli slide |

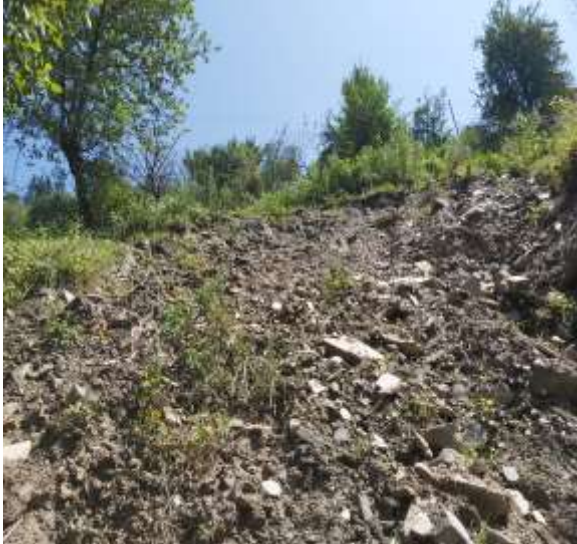
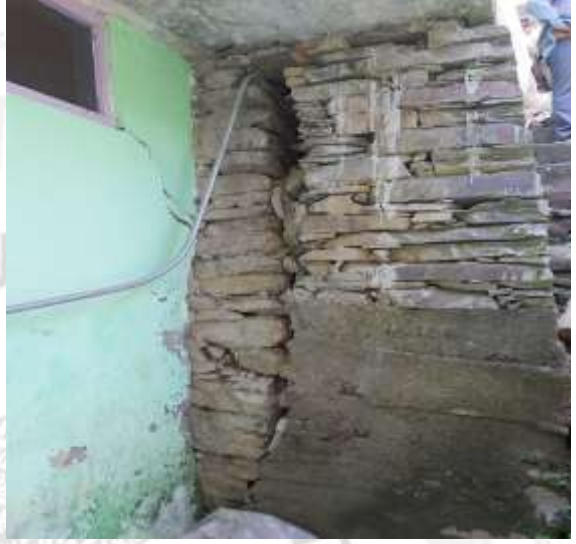
| | Fig.1. Dharta landslide in Nigloodhar village | Fig.2. Cracks in house |

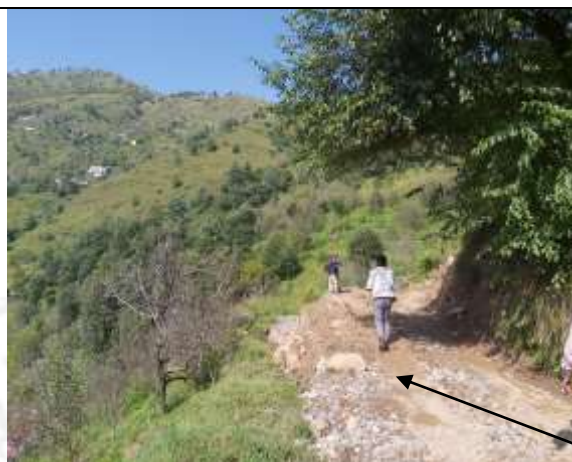
Subsidence  
observed in  
road

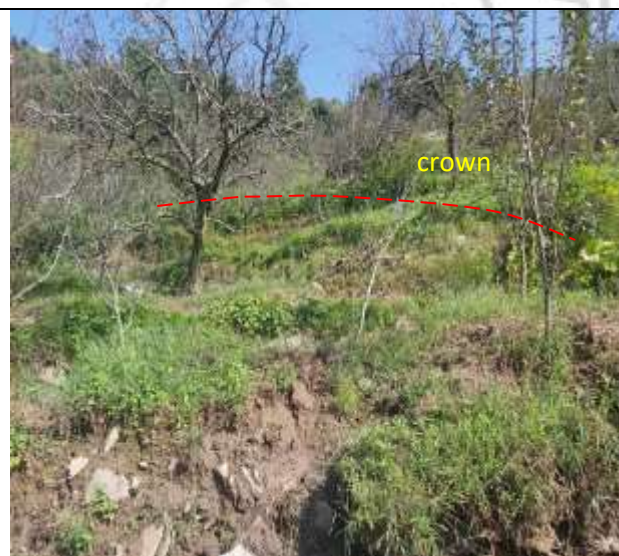
Fig.1. Unstable crown observed in Chehava slide

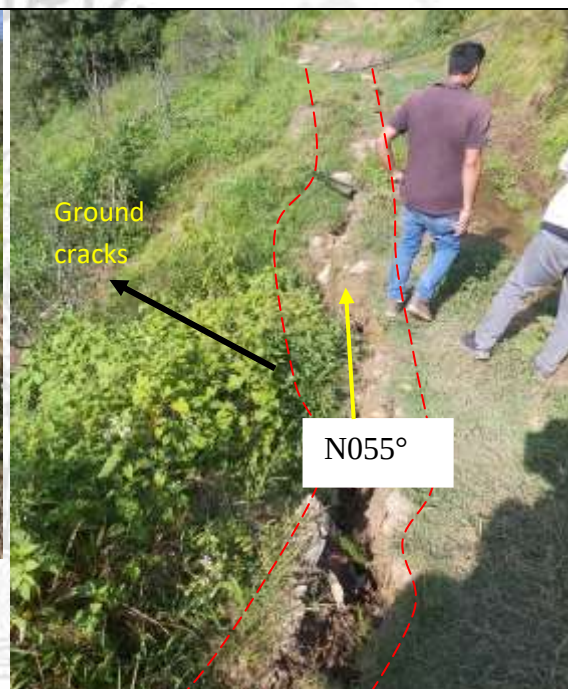
Fig.2. Open ground cracks in Chehava slide

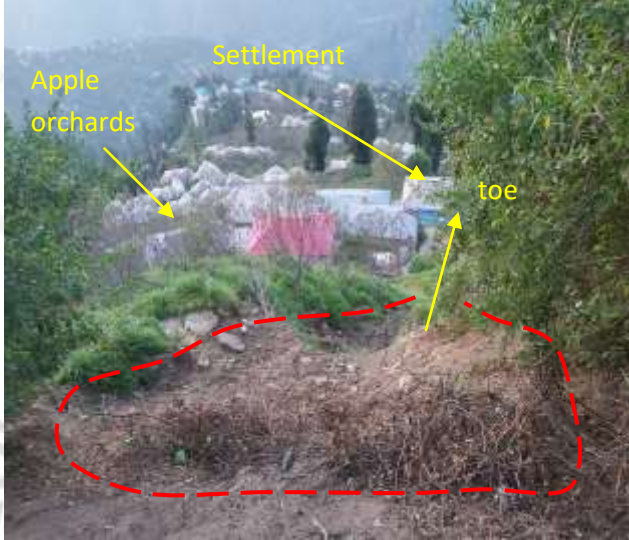
| | Fig.1. Unstable crown with toe side observed in Leharali slide | |

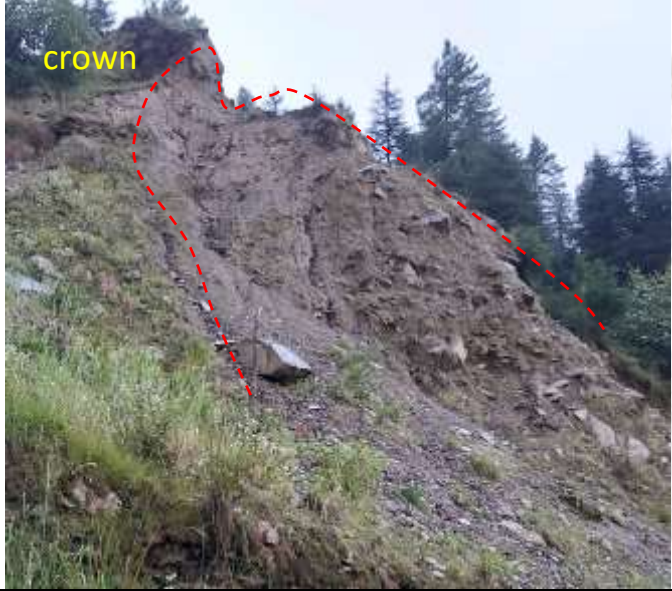
| Fig.1. Unstable crown observed in Mashnoo nala slide | | Fig.2. Toe observed in Mashnoo nala slide |

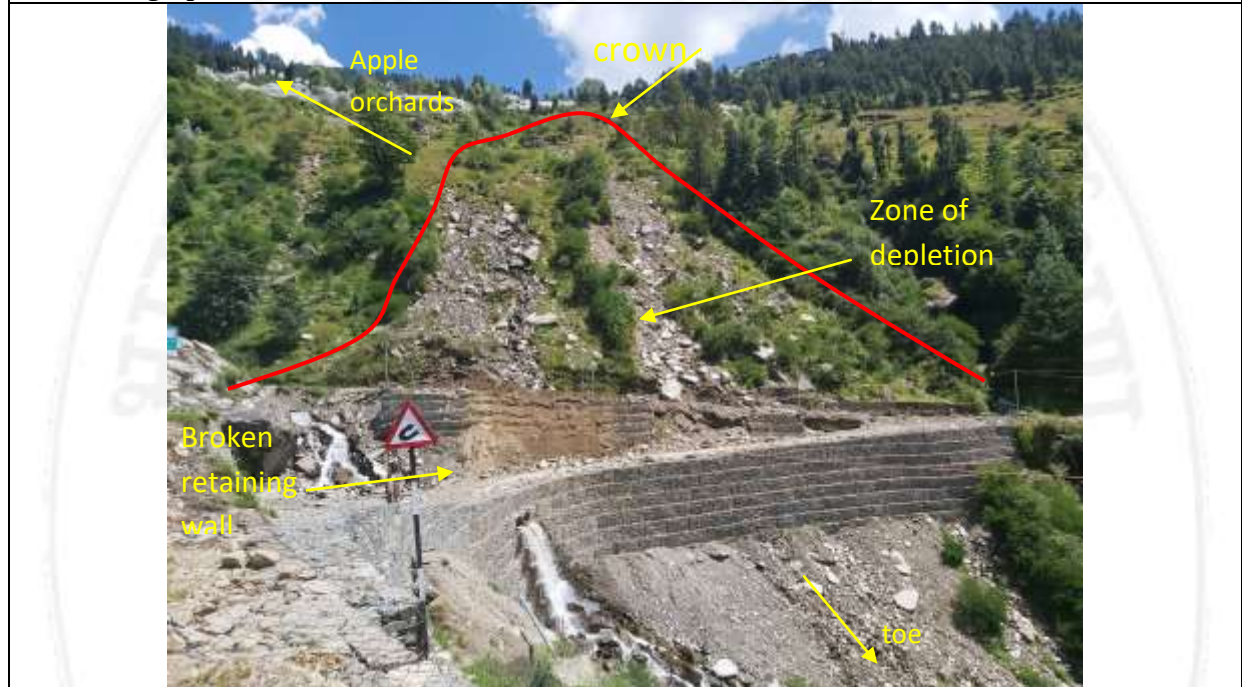
Fig.1. Unstable crown with toe side, and zone of depletion observed in Kot Nala slide
