**REPORT ON THE PRELIMINARY ASSESSMENT OF LANDSLIDE AT  
KULLU, BANJAR, MANALI AND ANNI SUB-DIVISION OF KULU  
DISTRICT HIMACHAL PRADESH**

Item Code No.: M4EGG/C/NR/SU-PHP/2023/46620

By  
Tripti Baba, Senior Geologist  
Weneikhro Krome, Geologist

राज्य इकाईपंजाब :, हरियाणा एवं हिमाचल प्रदेश / State Unit: Punjab, Haryana and Himachal pradesh  
उत्तरी क्षेत्र / Northern Region  
चंडीगढ़ / Chandigarh

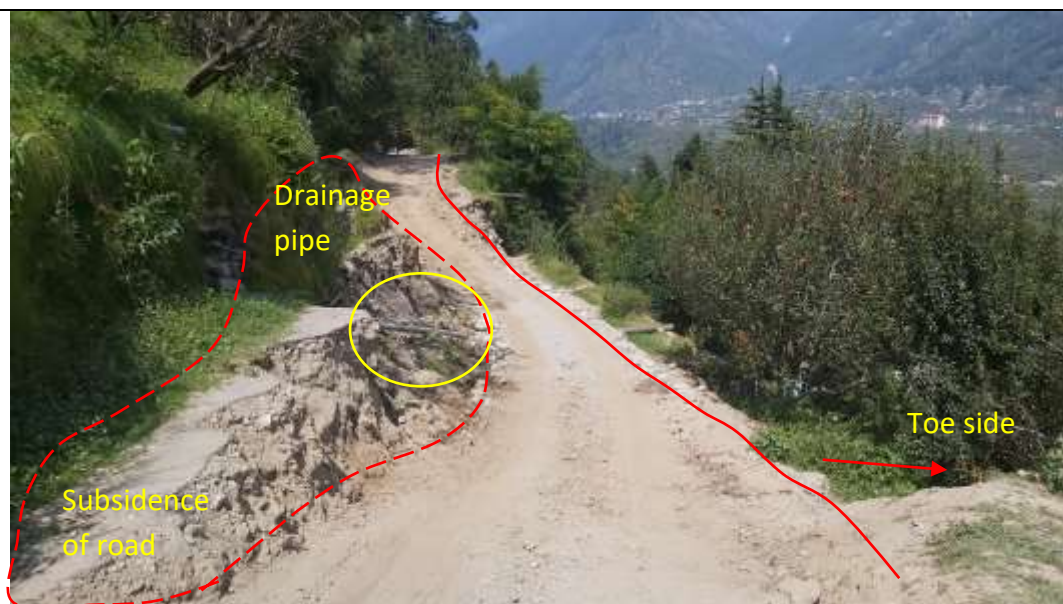
Fig.1. Subsidence of road observed in Shaleen village

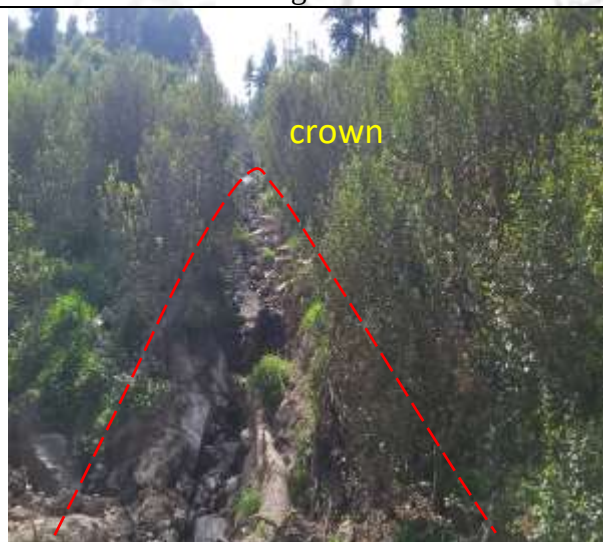
Fig.2. Unstable crown portion of Shaleen slide
