SEISMIC RETROFITTING GUIDELINES OF BUILDINGS IN NEPAL

Government of Nepal
Ministry of Urban Development
Department of Urban Development and Building Construction
Babarmahal, Kathmandu

SEISMIC RETROFITTING GUIDELINES OF BUILDINGS IN NEPAL, 2016
ADOBE AND LOW STRENGTH MASONRY STRUCTURES

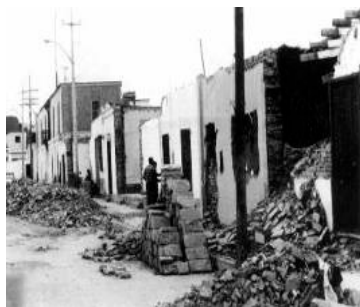
Figure 2.1 Severe damage to adobe buildings in Chorrillos district in Peru earthquake 1974
(Source: www.earthquake.usgs.gov)

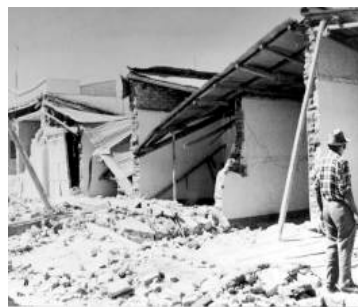
Figure 2.2 Damage of adobe houses in Guatemala City during Guatemala Earthquake 1976
(Source: irapl.altervista.org, figure 69-B, U.S. Geological Survey Professional paper 1002)

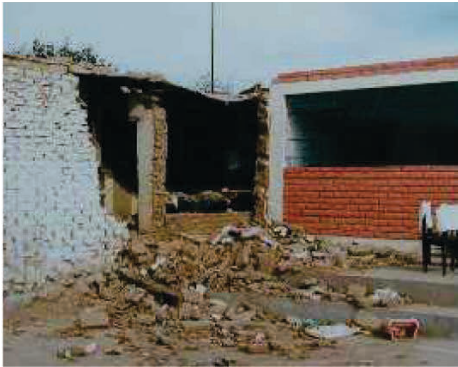
*Figure 2.7 Out-of-plane wall collapse – 1996
Nazca earthquake, Peru*
(Source: Report #52 in EERI/ IAEE World Housing Encyclopedia)

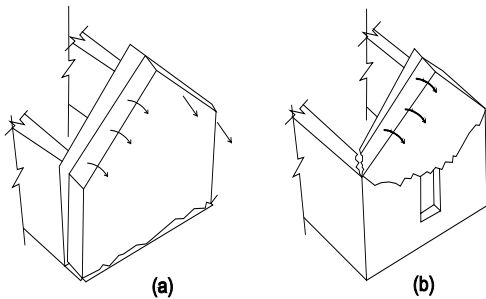
Gable end wall damage is a special case of out-of-plane failure that needs specific discussion as these walls are very susceptible to damage in adobe buildings. Gable-end walls are tall and thin, non-load-bearing, and usually not well connected to the structure at the floor, attic, or roof level. Their overturning is caused by ground motions that are perpendicular (out of plane) to the walls. Instability problems can also result from in-plane ground motions when sections of the wall slip along diagonal cracks and then become unstable out of plane, especially at corners.

*Figure 2.9 Gable-end wall collapse: (a) overturning at
base of wall, and (b) mid-height collapse*
(Source: Manual of The Getty Conservation Institute)

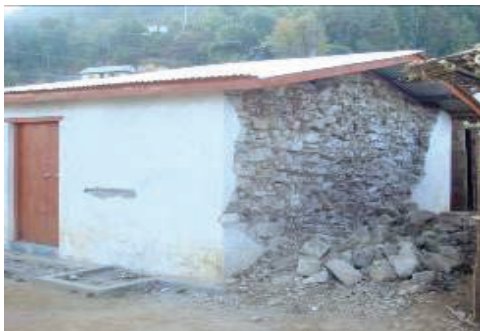
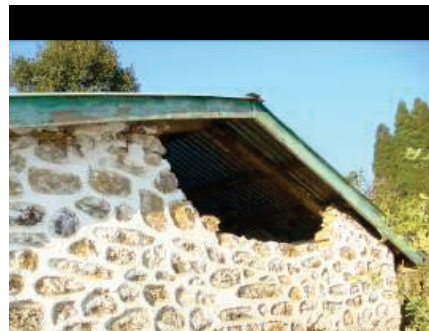
Figure 2.11 some other examples of Gable wall damage during Eastern Nepal Earthquake, 2011
(Photo: CoRD)

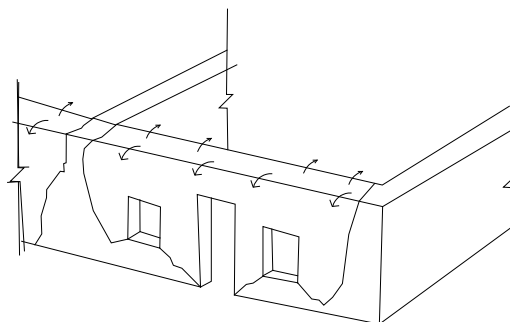
Out-of-plane flexural cracking is one of the first crack types to appear in an adobe building during a seismic event. This damage type and the associated rocking motion are illustrated in Figure 2.12. Freestanding walls, such as garden walls, are most vulnerable to overturning because there is usually no horizontal support along their length, such as that provided by cross walls or roof or floor systems.

Figure 2.12 Out-of-plane flexure of load bearing wall
(Source: Manual of The Getty Conservation Institute)

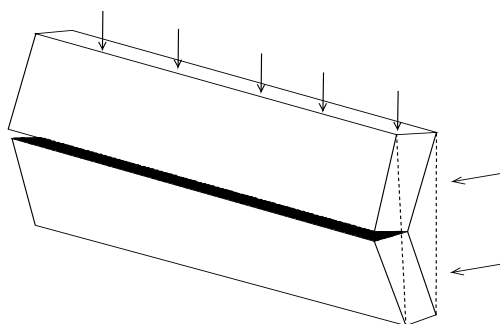
For the most part, historic adobe buildings are not susceptible to mid-height, out-of-plane flexural damage because the walls are usually thick and have small slenderness ratios. However, horizontal cracks may develop when load-bearing walls are long and the top of the wall is restrained by a bond beam or a connection to a roof or ceiling system (Figures 2.13 and 2.14). This type of damage and potential failure mechanism is usually observed only in thin-walled (SL. 8) masonry buildings.

Figure 2.13 Sketch of mid-height out of plane failure
(Source: Manual of The Getty Conservation Institute)

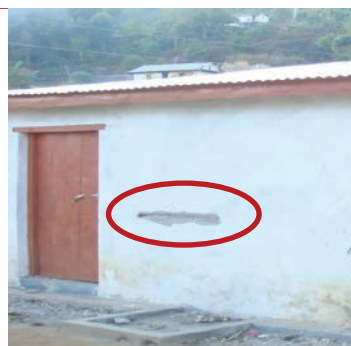
Figure 2.14 Mid-height Crack
(Photo: CoRD)

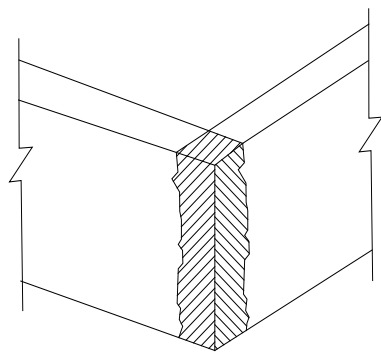
Damage often occurs at the corners of buildings due to the stress concentrations that occur at the intersection of perpendicular walls. Instability of corner sections often occurs because the two walls at the corner are unrestrained and therefore the corner section is free to collapse outward and away from the building.

Figure 2.16 Illustrations showing (a) how vertical cracks at corner can lead to instability of intersection
(Source: Manual of The Getty Conservation Institute)

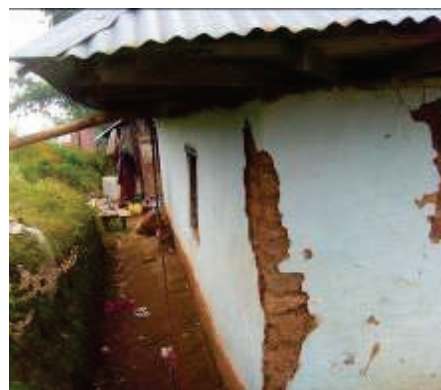
Figure 2.17 Corner damage during Eastern Nepal Earthquake, 2011
(Source: CoRD)

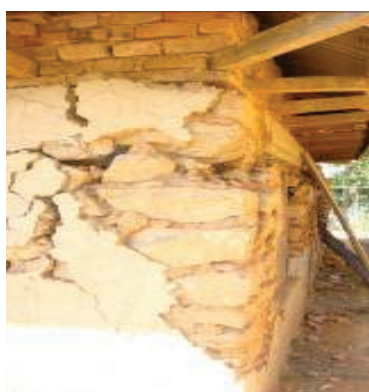
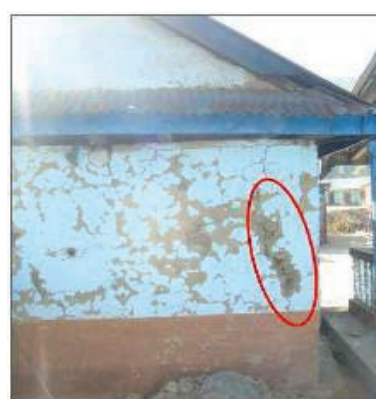
Figure 2.18 Some other examples of corner damages
(Source: CoRD)

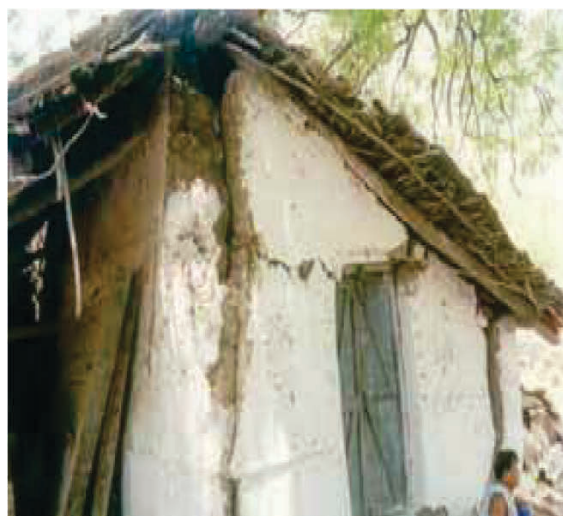
Vertical cracks often develop at corners during the interaction of perpendicular walls and are caused by flexure and tension due to out-of-plane movements. This type of damage can be particularly severe when vertical cracks occur on both faces, allowing collapse of the wall section at the corner (Figure 2.19).

Figure 2.19 Vertical cracking and separation of adobe walls after the 1997 Jabalpur, India earthquake
(Source: Kumar 2002)

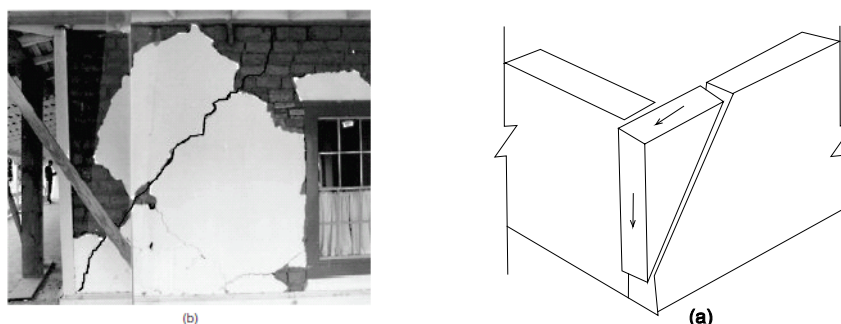
In-plane shear forces cause diagonal cracks that start at the top of a wall and extend downward to the corner. This type of crack results in a wall section that can move laterally and downward during extended ground motions. Damage of this type is difficult to repair and may require reconstruction. Illustrations of this damage type are shown in Figure 2-20.

Figure 2.20 Corner cracks: (a) illustration of vertical downward and horizontal displacement of a corner wall section, and (b) example of displaced wall section (Leonis Adobe)
(Source: Manual of The Getty Conservation Institute)

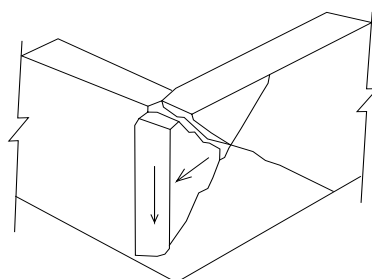
A combination of diagonal and vertical cracks can result in an adobe wall that is severely fractured, and several sections of the wall may be susceptible to large offsets or collapse. An example of a wall section that is highly vulnerable to serious damage is illustrated in Figure 2-21. The diagonal cracking at that location allows the cracked wall sections freedom to move outward. Corners may be more susceptible to collapse if vertical cracks develop and the base of the wall has already been weakened by previous moisture damage.

Figure 2.21 Illustration showing how combination of shear and flexural cracks can result in corner displacement or collapse
(Source: Manual of The Getty Conservation Institute)

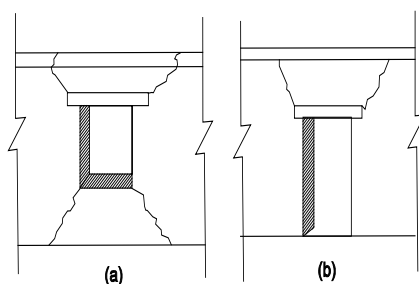
Figure 2.22 Illustration of cracks originating at stress concentration locations: (a) cracks appearing first at upper corners of window opening followed by lower corner cracks; and (b) cracks at upper corners of door opening.

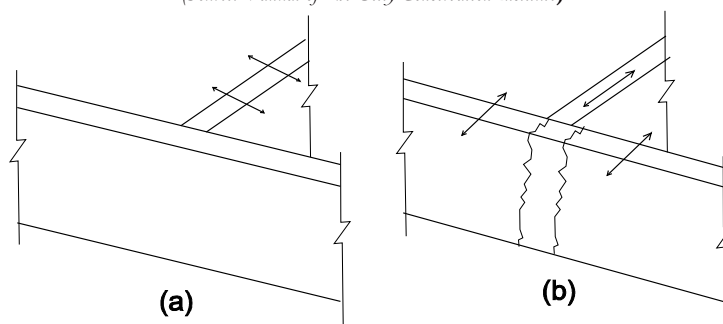
Damage at the intersection of perpendicular walls is normally not serious from a life-safety perspective. However, in the same way that corner damage occurs, adjacent walls can become isolated and behave as freestanding walls. When they reach this state, the possibility of collapse or overturning is greatly increased, and a serious life-safety threat can arise. In addition, if significant permanent offsets occur, repair may be difficult and expensive.

Figure 2.23 Illustrations showing (a) how separation can occur between in-plane and out-of-plane walls, and (b) how vertical cracks develop in out-of-plane walls at the intersection with perpendicular, in-plane walls.

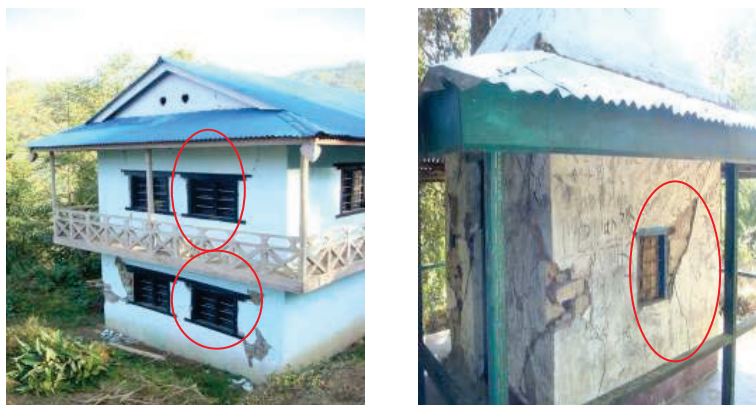
Figure 2.24 Some examples of Cracks at opening

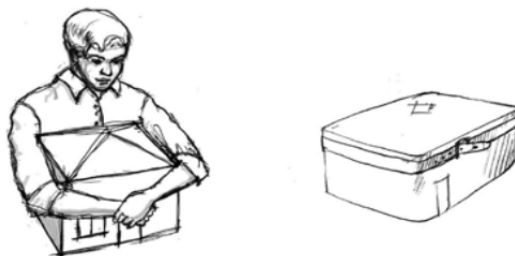
Seismic belts are the most critical earthquake-resistant provision in an adobe building. They act like a ring or belt, as shown in figure below. Seismic belts hold the walls together and ensure integral box action of an entire building. They are to be provided on all walls on both faces (a) just above lintels of door and window openings and (b) just below floor or roof. A lintel band reduces the effective wall height. As a result, bending stresses in the walls due to out-of-plane earthquake effects are reduced and the chances of wall delaminating are reduced.

Figure 4.3 A seismic band acts like a belt
(Adopted from: GOM 1994)

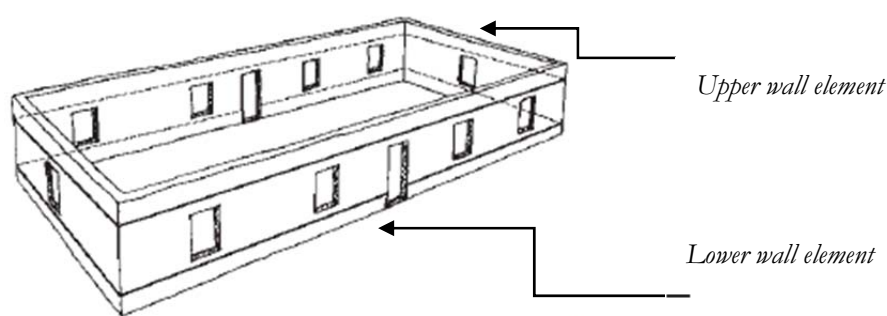
The lower wall elements prevent the kicking out of cracked wall section along the length of the wall. Wall may be displaced into a door and window openings. However more serious problems tend to occur at the ends of the walls where cracked walls are unrestrained leading to the outward movement of the wall at the base. Such basal displacement is prevented from the lower wall elements. Proper placement, continuity of belts and proper use of materials and workmanship are essential for their effectiveness.

Figure 4.4 Seismic belt showing upper and lower wall elements
(Source: Manual of The Getty Conservation Institute)

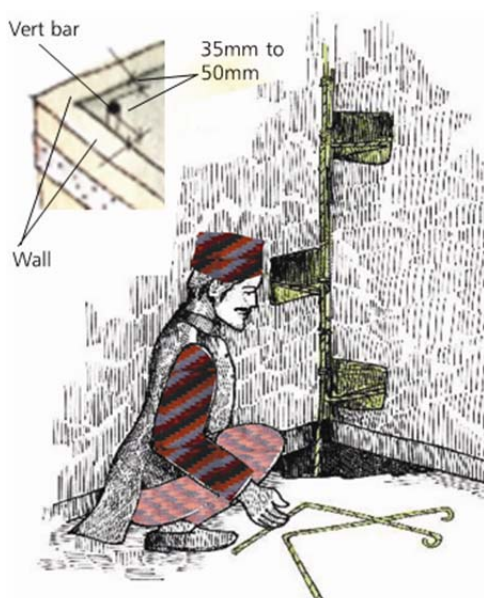
Figure 4.7 Vertical bar in corner
(Adapted from: UNDP, UNESCO & GOI, 2007)

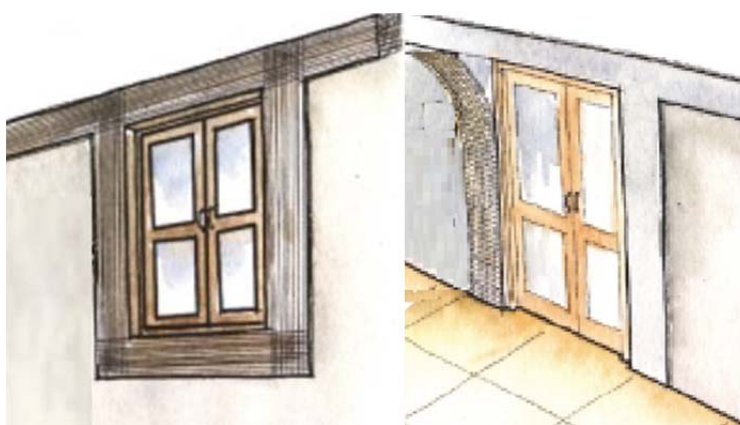
To prevent such damages, it is necessary to strengthen the boundary around the opening, especially at the corners where concentration of tensile stresses occurs. Encasement helps resist the tearing action that occurs at opening corners. Likewise wrapping of the pier which has very weak resistance to shearing and bending is greatly strengthens it against these forces and prevents the cracks and crushing of piers.

Figure 4.13 Encasing around window and door openings
(Source: UNDP, UNESCO & GOI, 2007)

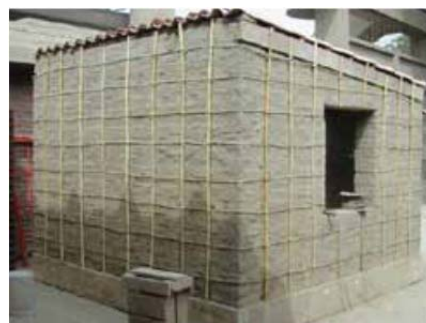
An external reinforcement system consisting of vertical cane tied with horizontal ropes forming an approximately 450 mm square mesh can be used to wrap adobe walls, as shown in Figure 4-20. An adobe building model with this reinforcement system was tested on the PUCP shake table (Torrealva 2005) and even though severe cracking occurred, this reinforcement scheme successfully prevented collapse.

Figure 4.21 Cane reinforcement

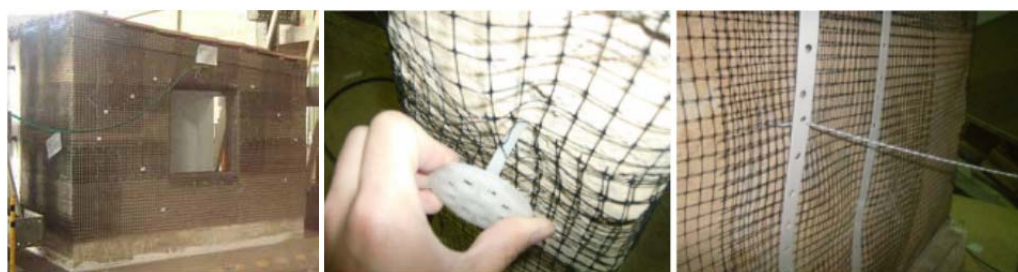
The researchers found that it is possible for the walls to disintegrate into large blocks during severe ground shaking, however the mesh prevents the walls from falling apart, and collapse can be avoided (Blondet et al. 2006).

Figure 4.24 Reinforced house with geomesh

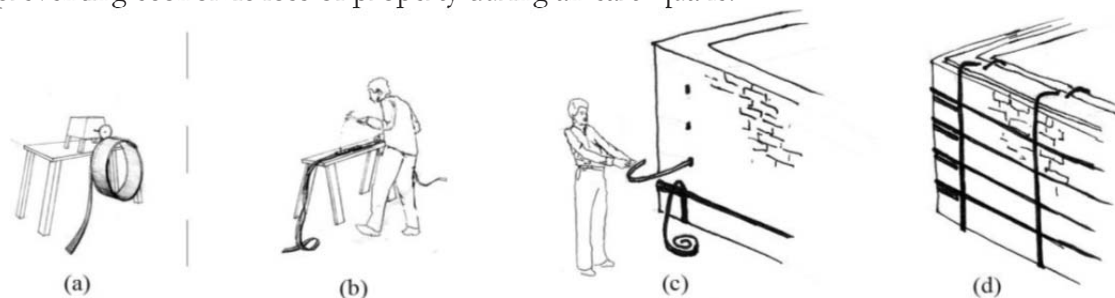
This method uses circumferentially cut straps from the treads of used car tires for tension reinforcement to improve the seismic safety of earthen wall construction. Continuous straps pass through holes drilled in the adobe walls to wrap them horizontally every 600 mm and vertically every 1.2 m approximately. This reinforcement enhances the in-plane and out-of-plane resistance of adobe walls to seismic effects. Vertical straps pass underneath or through the foundations, then rise up the walls, wrap over them and are nailed to the timber wall top plate. The main purpose of this strengthening method is to improve life safety rather than preventing economic loss of property during an earthquake.

Figure 4.25 Steps in the process of reinforcing an earthen (adobe) house with tire straps.

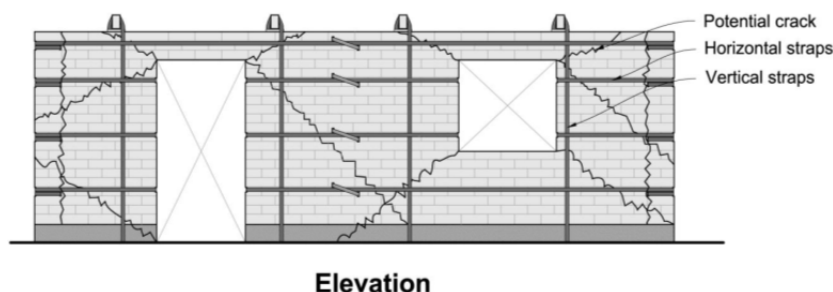
Figure 4.26 An elevation of a typical wall showing positions of expected cracks and strap

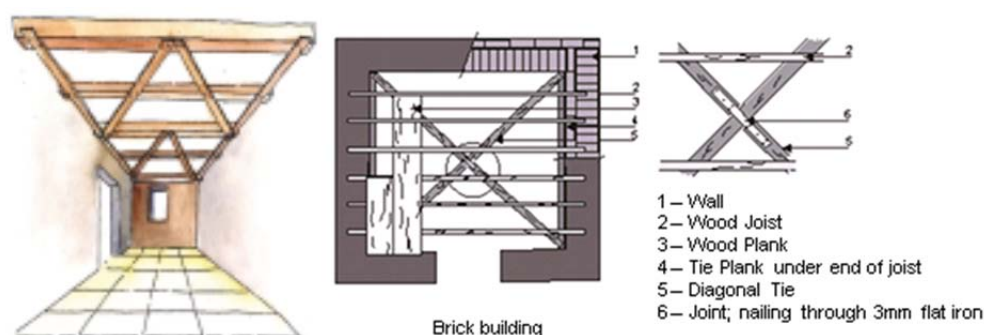
Figure 4.30 Stiffening flat wooden roof

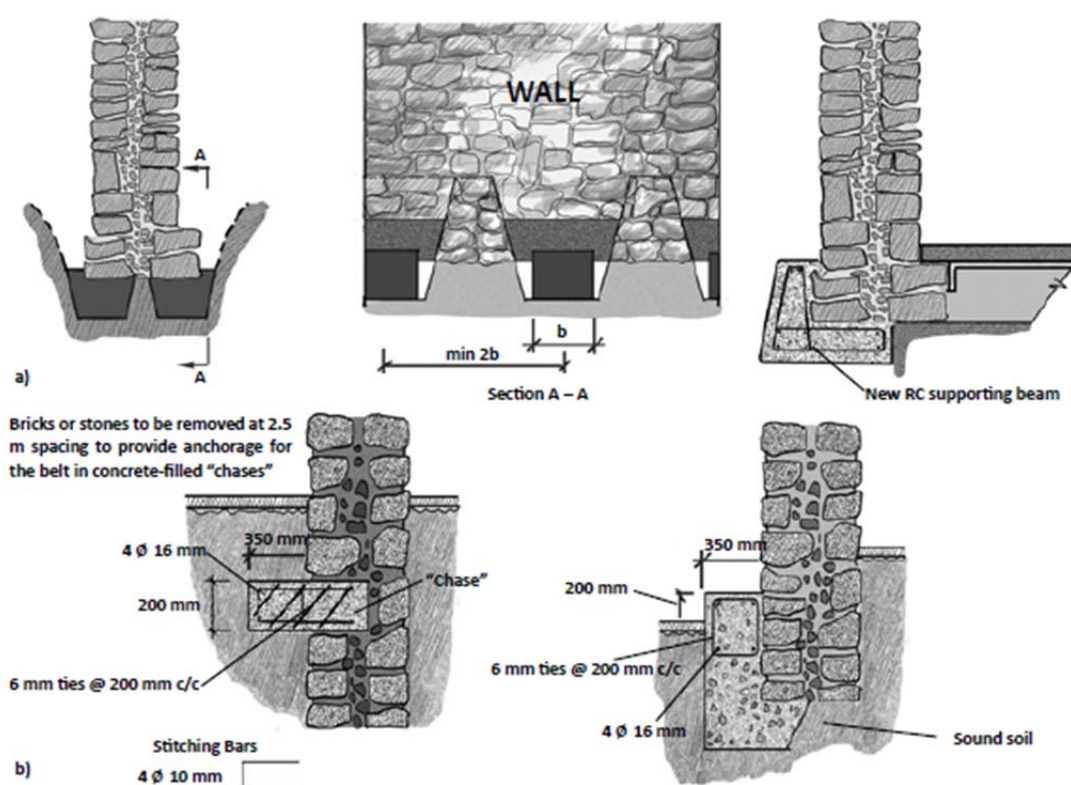
Figure 4.35 Strengthening existing foundations: a) underpinning the foundation, and b) external RC belt
(Adapted from: GOM 1998 and UNIDO 1983)

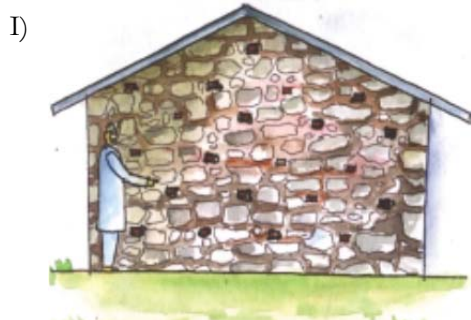
Figure 4.38 Marking points for bond elements

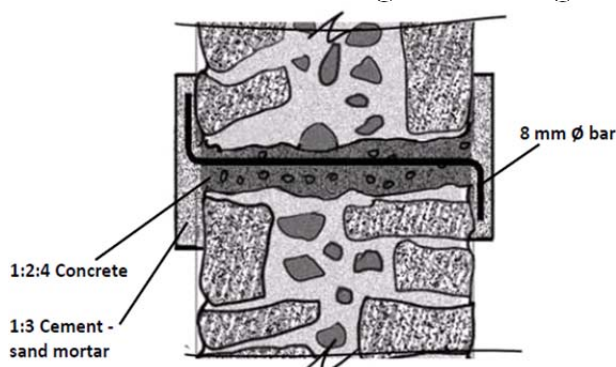
Figure 4.42 Cross section of through-stone
(Source: UNDP, UNESCO, GOI, 2007)

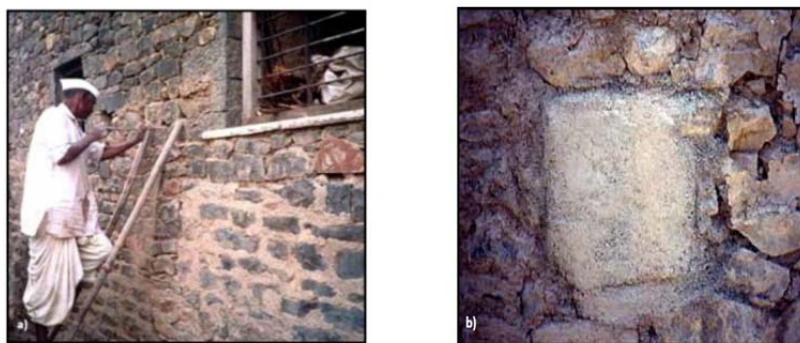
Figure 4.43 Examples of through-stone installation in Maharashtra, India: a) removing stone from the existing wall, and b) surface of a through-stone covered with a plaster
(Source: UNDP, UNESCO & GOI, 2007)

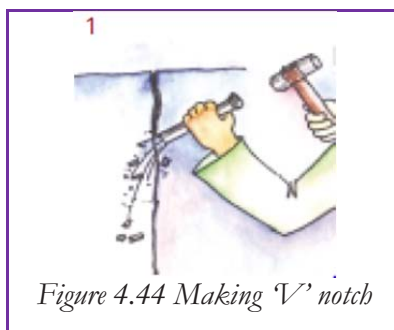
Figure 4.44 Making 'V' notch

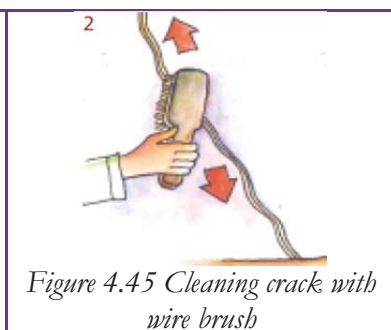
Figure 4.45 Cleaning crack with wire brush

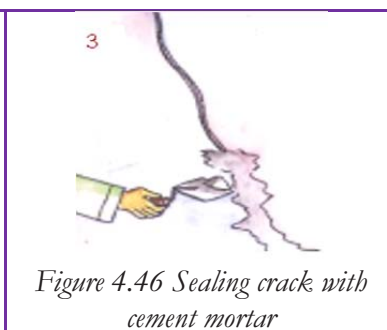
Figure 4.46 Sealing crack with cement mortar

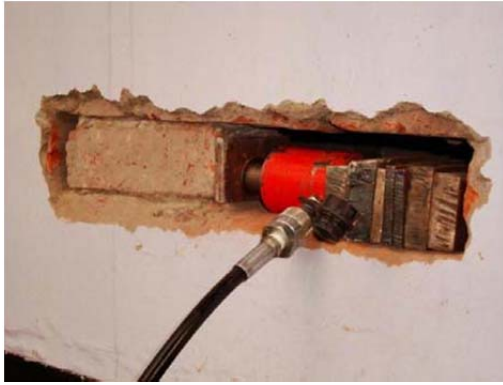
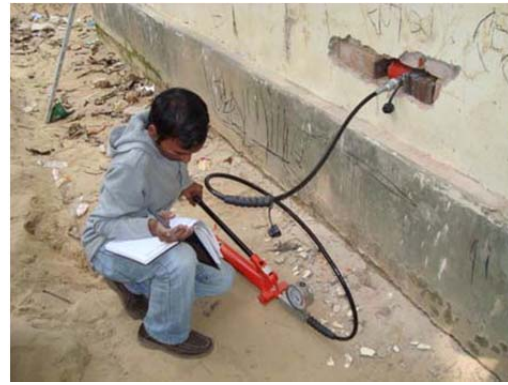
Fig A. I.3. Test Setup for In-Situ Shear Test

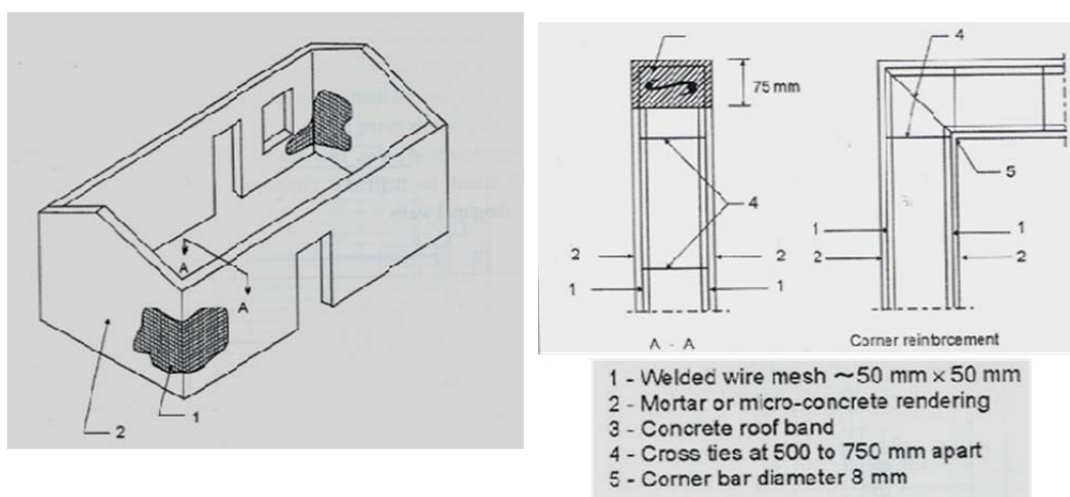
Fig A.I.4.(a) General Scheme of Jacketing

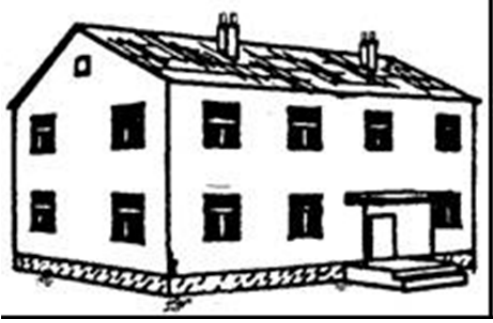
<p>Grade 1: Negligible to slight damage (no structural damage, slight non-structural damage)</p> <p>Hair-line cracks in very few walls. Fall of small pieces of plaster only. Fall of loose stones from upper parts of buildings in very few cases.</p>

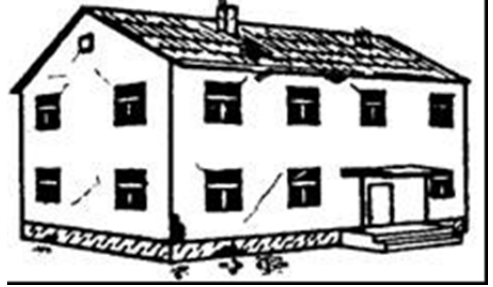
<p>Grade 2: Moderate damage (slight structural damage, moderate non-structural damage)</p> <p>Cracks in many walls. Fall of fairly large pieces of plaster. Partial collapse of chimneys.</p>

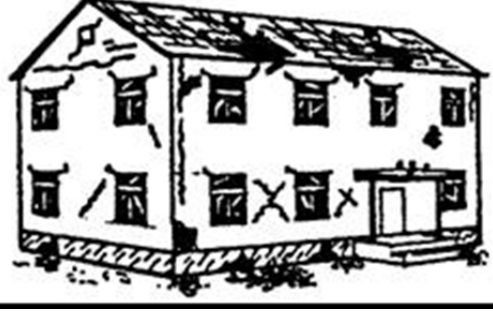
<p>Grade 3: Substantial to heavy damage (moderate structural damage, heavy non-structural damage)</p> <p>Large and extensive cracks in most walls. Roof tiles detach. Chimneys fracture at the roof line; failure of individual non-structural elements (partitions, gable walls).</p>

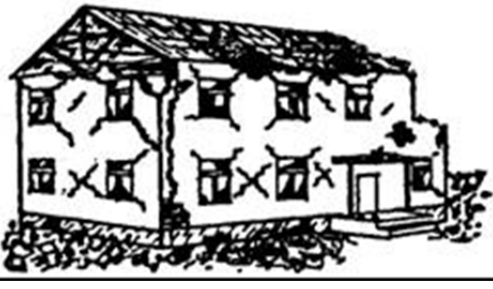
<p>Grade 4: Very heavy damage (heavy structural damage, very heavy non-structural damage)</p> <p>Serious failure of walls; partial structural failure of roofs and floors.</p>

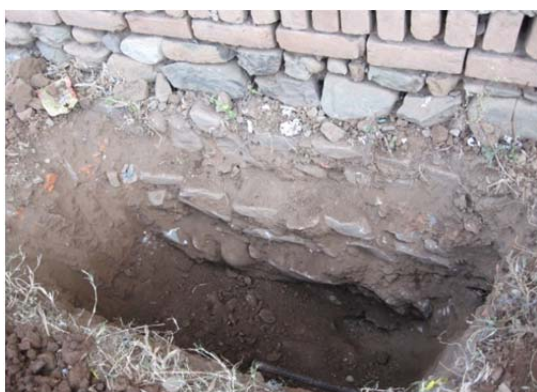
Exploration of foundation

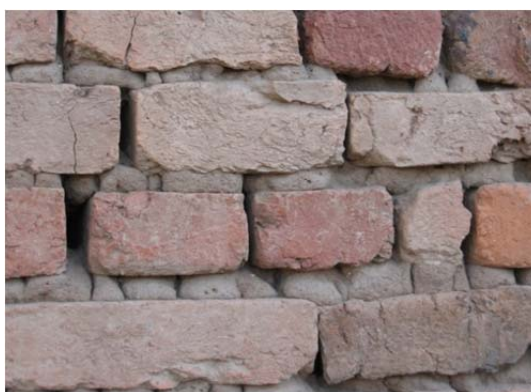
Void between masonry units

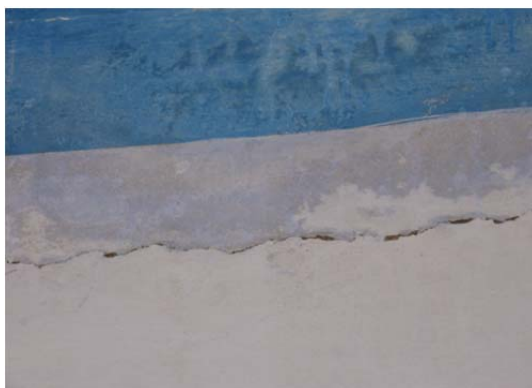
Cracks at slab & wall connection

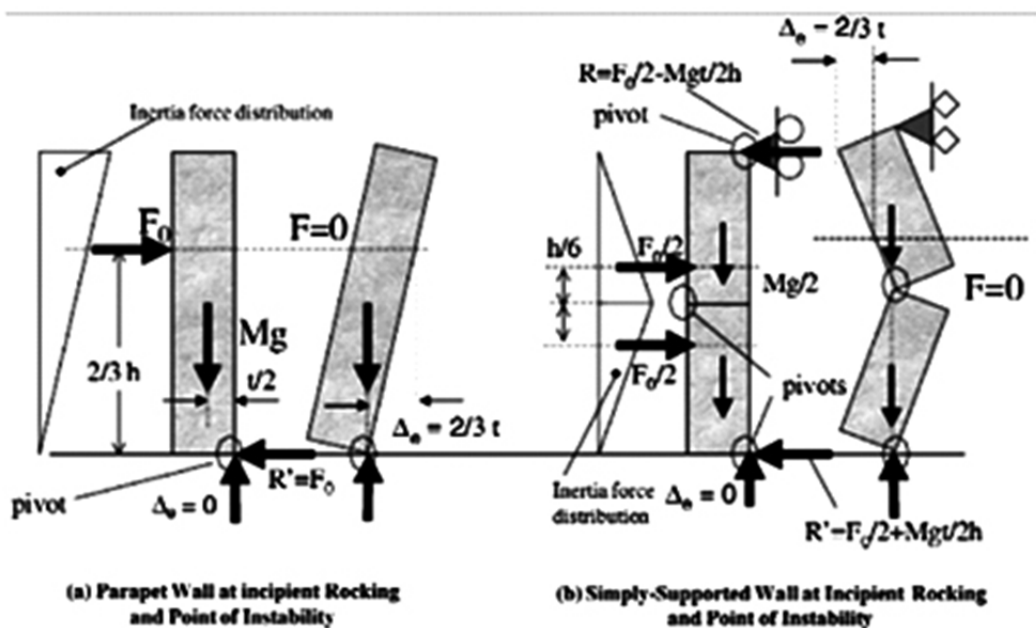
Figure A- 4: inertia forces and reactions on rigid URM walls (Doherty et.al 2002)

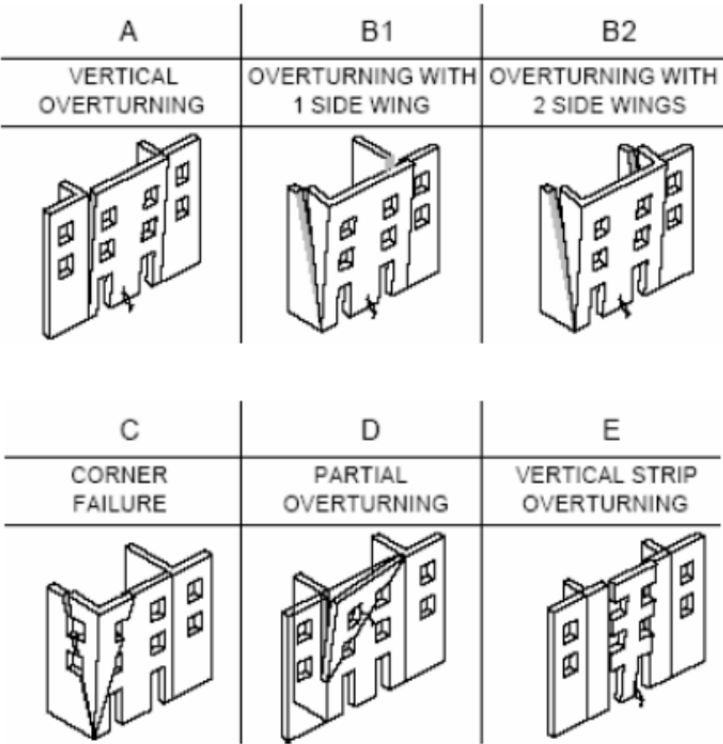
Figure A- 5: Collapse mechanism (D' analysis and Speranza 2003)

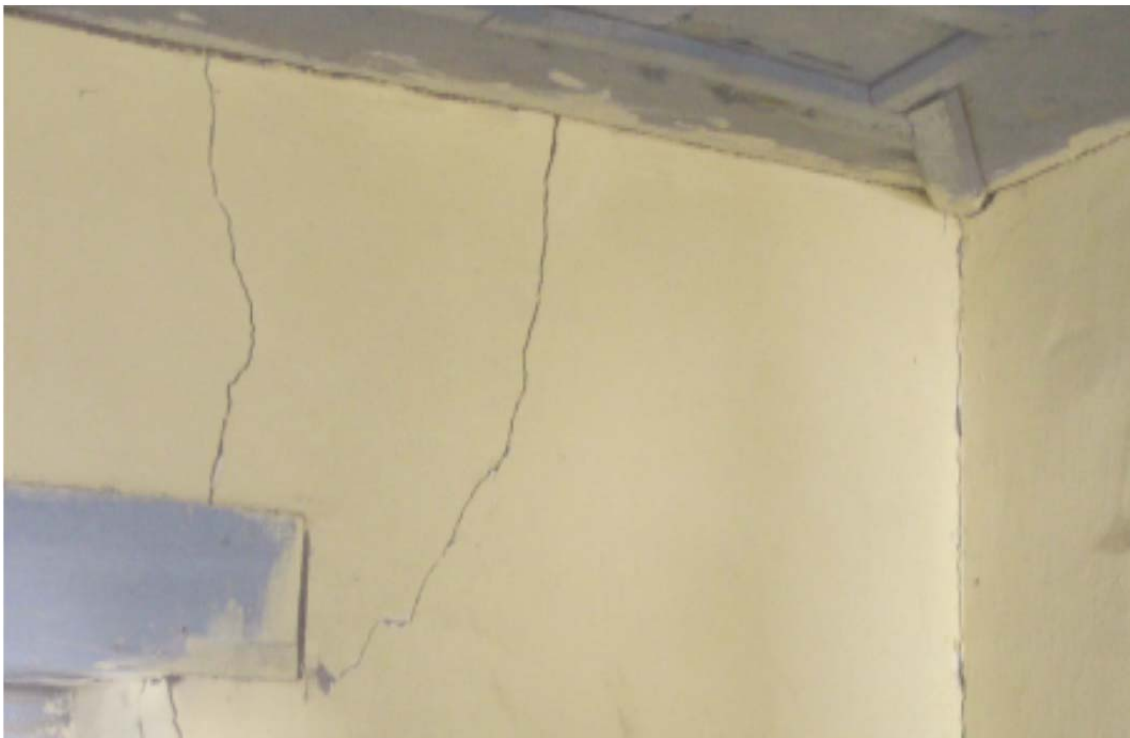
Figure A- 3: Typical cracking in corners and at corners of opening such as windows

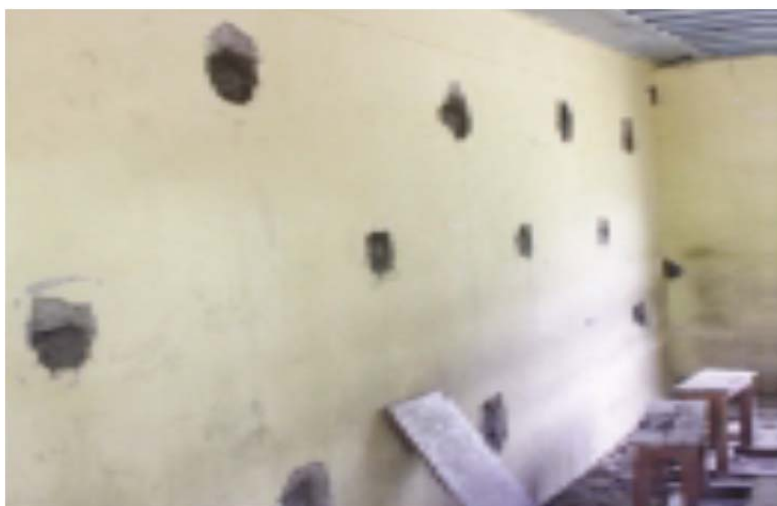
Figure A- 4: Bond elements yet to be completed in RR wall

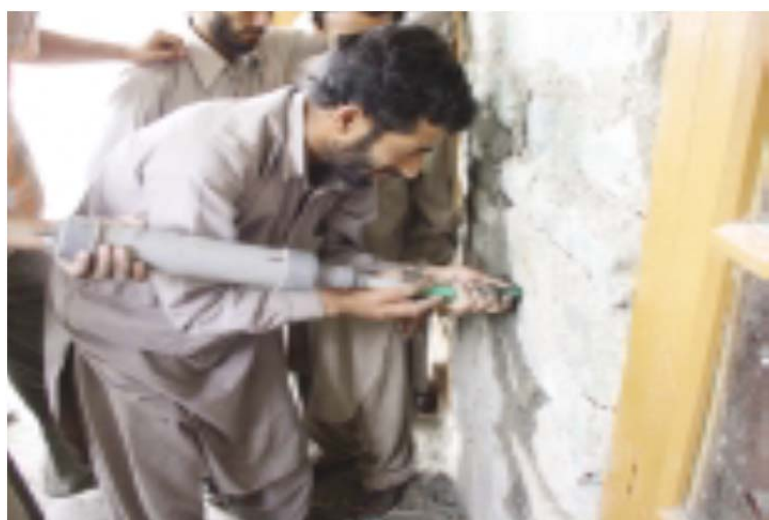
Figure A- 5: Grouting no-shrink grout in crack with hand pump

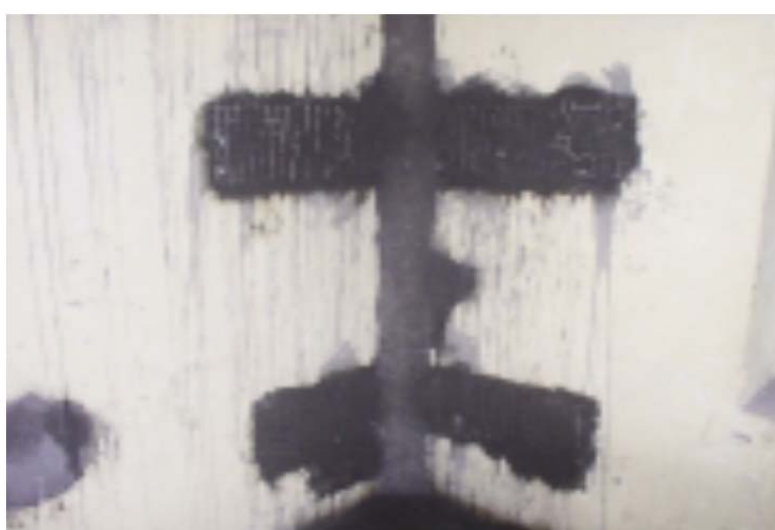
Figure A- 6: Corner crack splicing with WWM

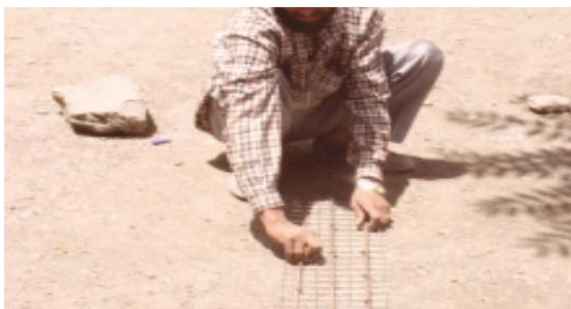
Figure A- 7: Preparing WWM with 6 mm rebars
