# Report on Geological and Bathymetry survey of glacial lake at Baspa Upstream of Sangla [Lake ID - NDMAo81]

07.09.2024 TO 10.07.2024

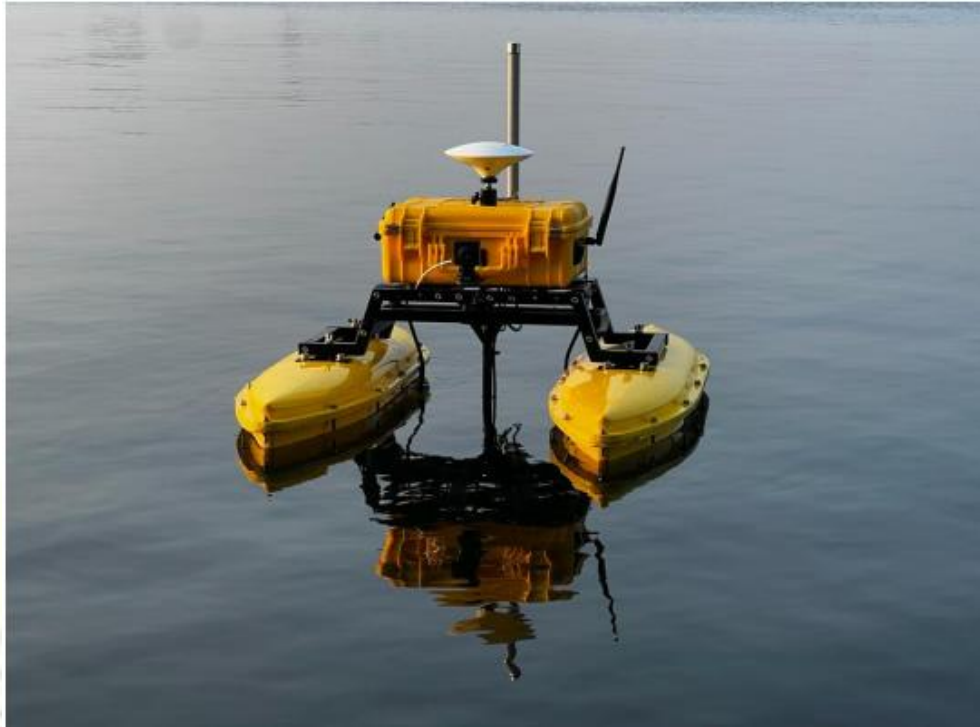
ASVs are battery operated, compact & stable, portable, crew-less surface vessels, having autonomous control and way point navigation with obstacle detection & collision avoidance feature. The vessel can be configured with multiple sensors/equipment as payloads depending on use case, as per customer requirements. This indigenous autonomous surface vessel has subsystems like the vessel hull and auxiliary structural elements, propulsion and power systems, GNC system, control & communication systems and bathymetry sensor suites including single beam echosounder and DGPS.

**Features:**

- Autonomous control & way point navigation using GPS/IRNSS
- Echosounder with depth measurement up to 200m
- Collision avoidance & obstacle detection suite
- Battery operated– powered by high density battery pack
- Long endurance operation
- Remote Operation Mode
- High degree of Maneuverability
- Modular design, portable
- Autonomous Navigation, and Mission planning suite

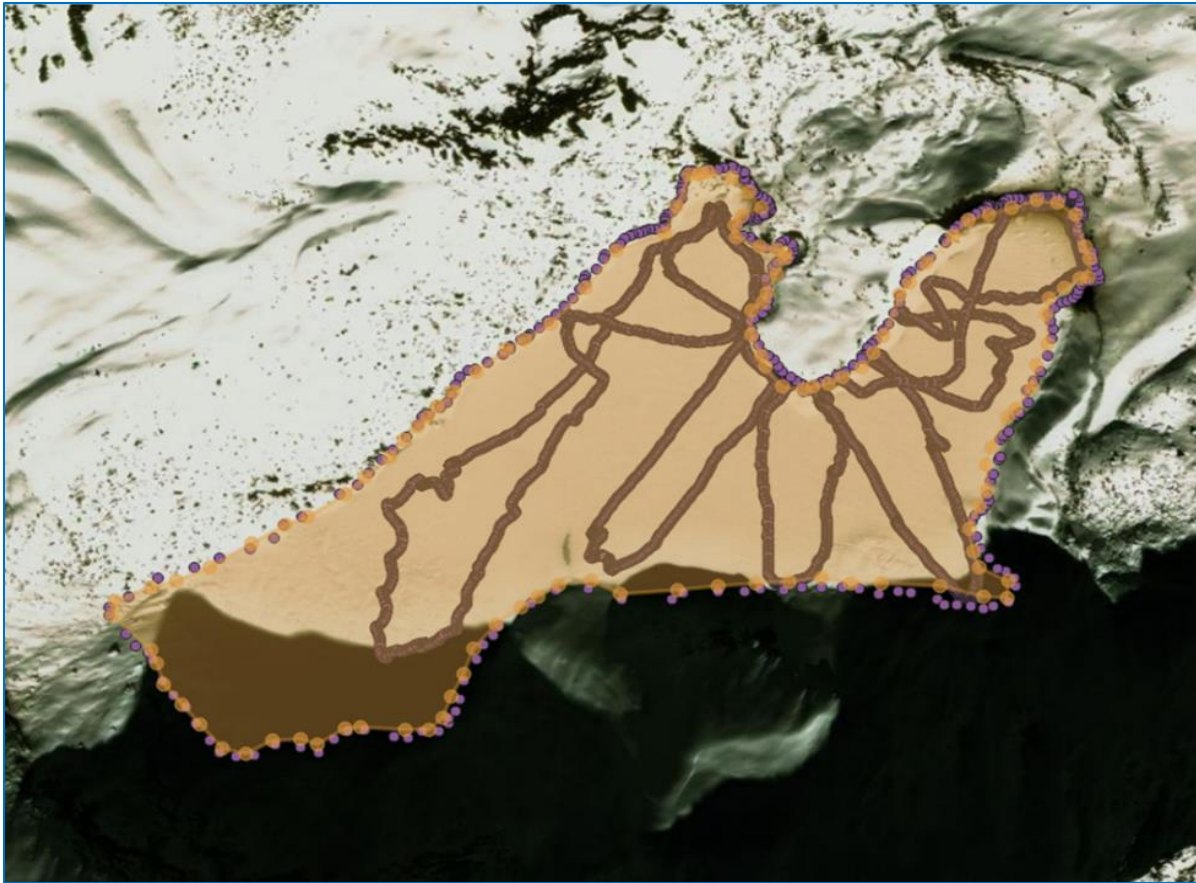
**Fig 2. Manually marked lake boundary**

Due to the short window period and adverse weather conditions that prevailed at Lake Face, the survey was conducted haphazardly, covering almost the entire lake area. Using the survey data, depth values were interpolated to fill out the non-surveyed regions of the lake. Therefore, the lake's boundary had to be manually marked using the base map as given in Fig 2, and the data thus created has been utilized to automatically generate the envelope of the lake body. Drone images were captured of the entire lake to assist with this activity.

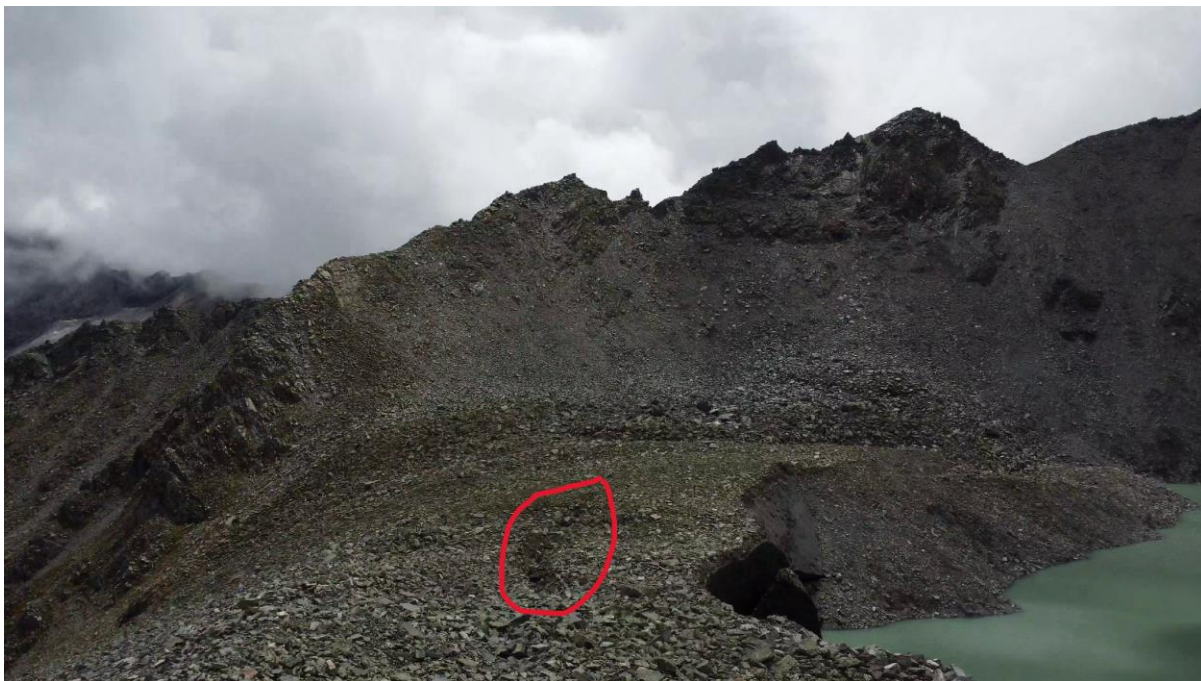
1. The lake is not connected to an active glacier. The glacier has retreated and only a remnant glacier is left behind.
2. During winter or snow fall seasons, some snow deposition is possible on the higher part. Shortly after the snowfall, the entire snow appears to get melted and drained in the lake.
3. There is piping and water is flowing down the moraine.
4. Southern and western slopes are steep with loose rock fragments.
5. New cracks are getting developed in the moraine dam wall (Fig. 1)
6. Moraine dam wall collapsing in shorter span (Fig. 2, Fig. 3, Fig. 4)
7. Dead ice core upto 2 m is seen on the southern side.
8. The moraine dam is vulnerable and in due course of time may fully collapse leading to release of water downstream

Fig 1: Crack seen on the moraine wall (Photo captured using drone)

- Suggestions for further studies.
  - ✓ Frequent field surveys are required to ascertain the moraine dam stability.
  - ✓ Time series analysis of lake using high satellite imageries is required
  - ✓ Installation of EWS
  - ✓ Water flow in the downstream of the lake needs to be monitored
  - ✓ The Moraine dam width is decreased drastically over the last 10 Years
  - ✓ The Fischer formation above the Moraine Dam is to be closely observed

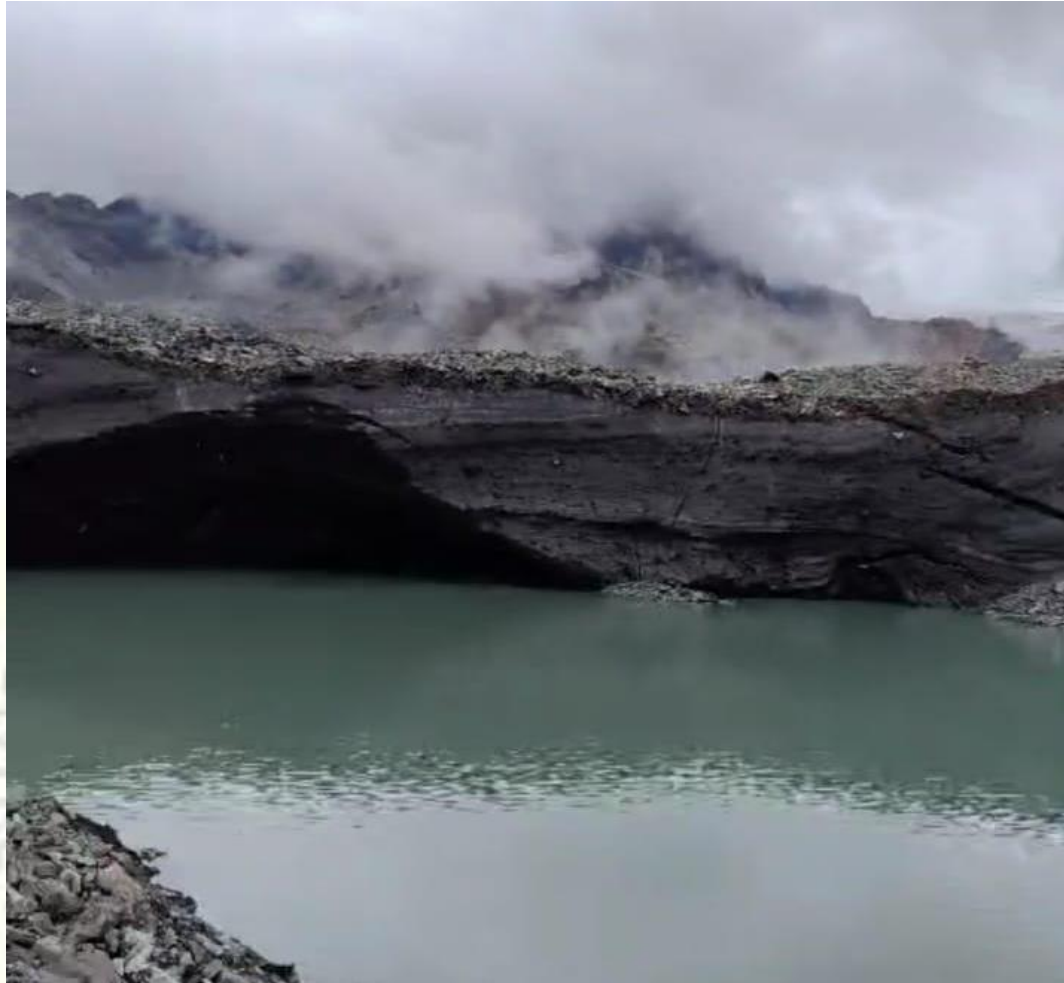
Fig 3: The moraine dam wall in August 2024

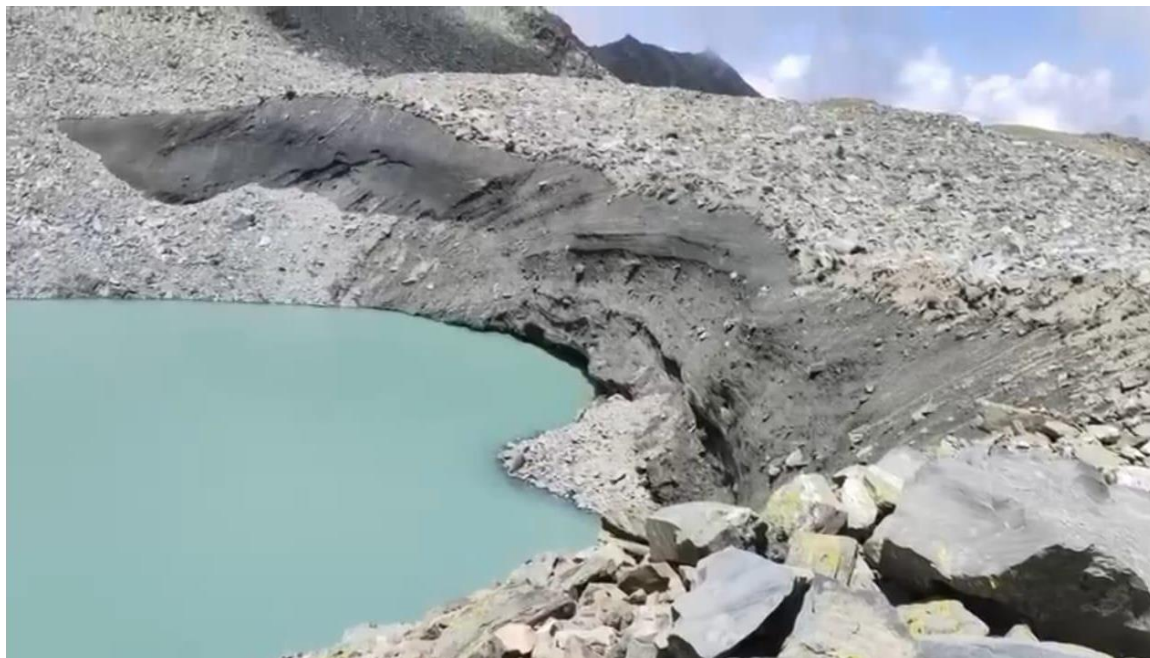
Fig

4: The moraine dam wall in July 2024
