# Report on Geological and Bathymetry Survey of Vasuki Glacial Lake [Lake ID – NDMAo77]

07.10.2024 TO 16.10.2024

REPORT ON SURVEY CONDUCTED AT VASUKI LAKE, HP

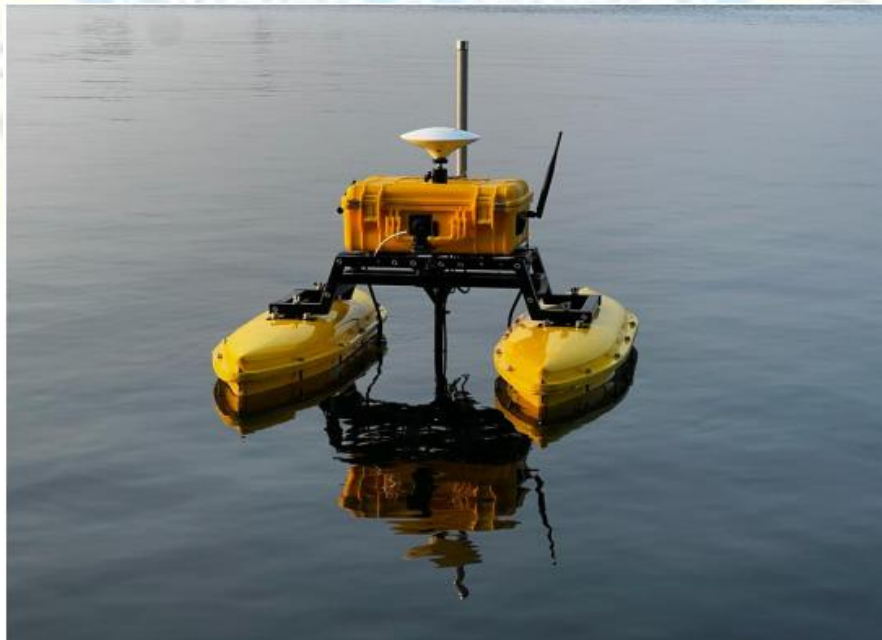
**Fig 1: Autonomous bathymetric Survey Vessel for Glacial Lake Survey**

- Autonomous control & way point navigation using GPS/IRNSS
- Echosounder with depth measurement up to 200m
- Collision avoidance & obstacle detection suite
- Battery operated– powered by high density battery pack
- Long endurance operation
- Remote Operation Mode
- High degree of Maneuverability
- Modular design, portable
- Autonomous Navigation, and Mission planning suite

ASVs are battery operated, compact & stable, portable, crew-less surface vessels, having autonomous control and way point navigation with obstacle detection & collision avoidance feature. The vessel can be configured with multiple sensors/equipment as payloads depending on use case, as per customer requirements. This indigenous autonomous surface vessel has subsystems like the vessel hull and auxiliary structural elements, propulsion and power systems, GNC system, control & communication systems and bathymetry sensor suites including single beam echosounder and DGPS.

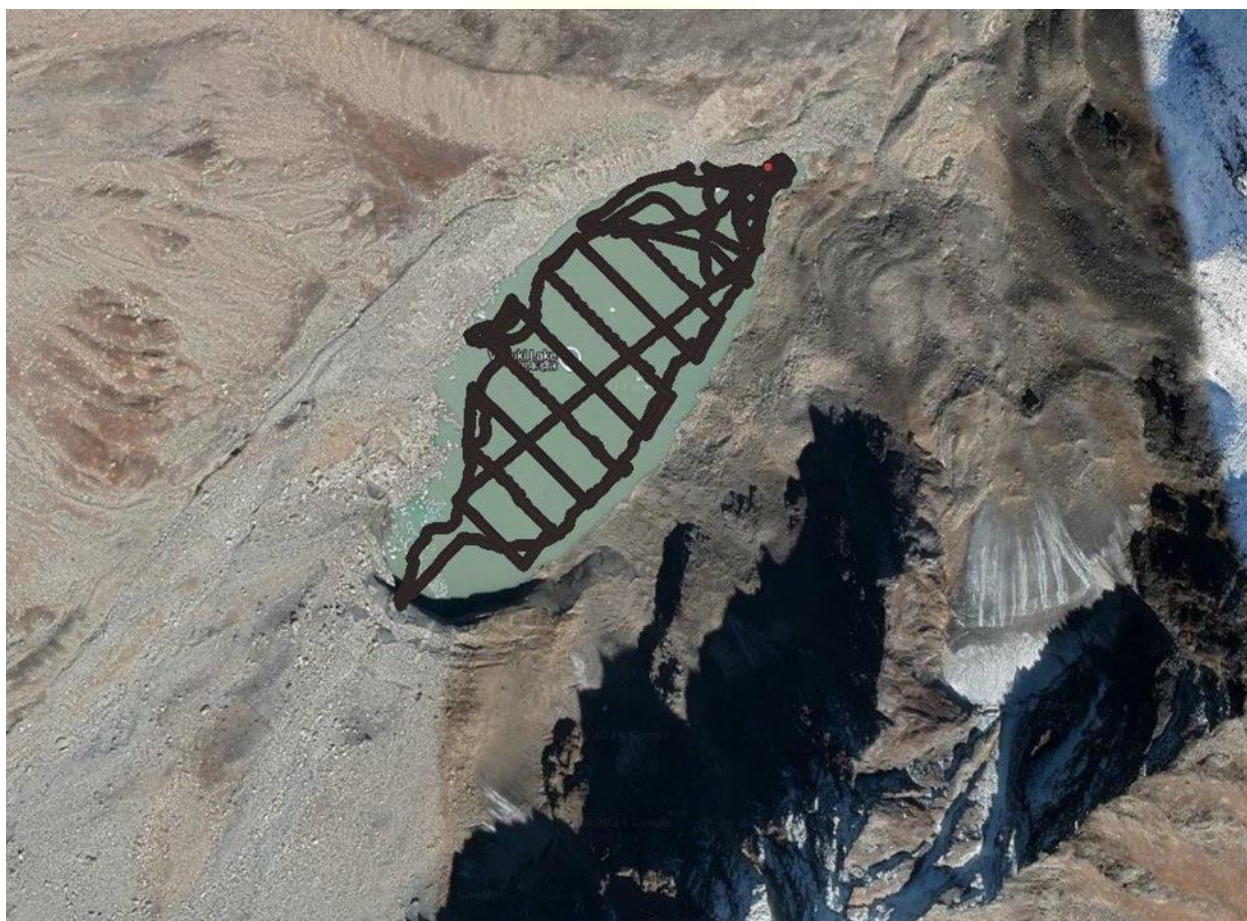
**Fig 3. Survey data plotted in the background of Vasuki lake**

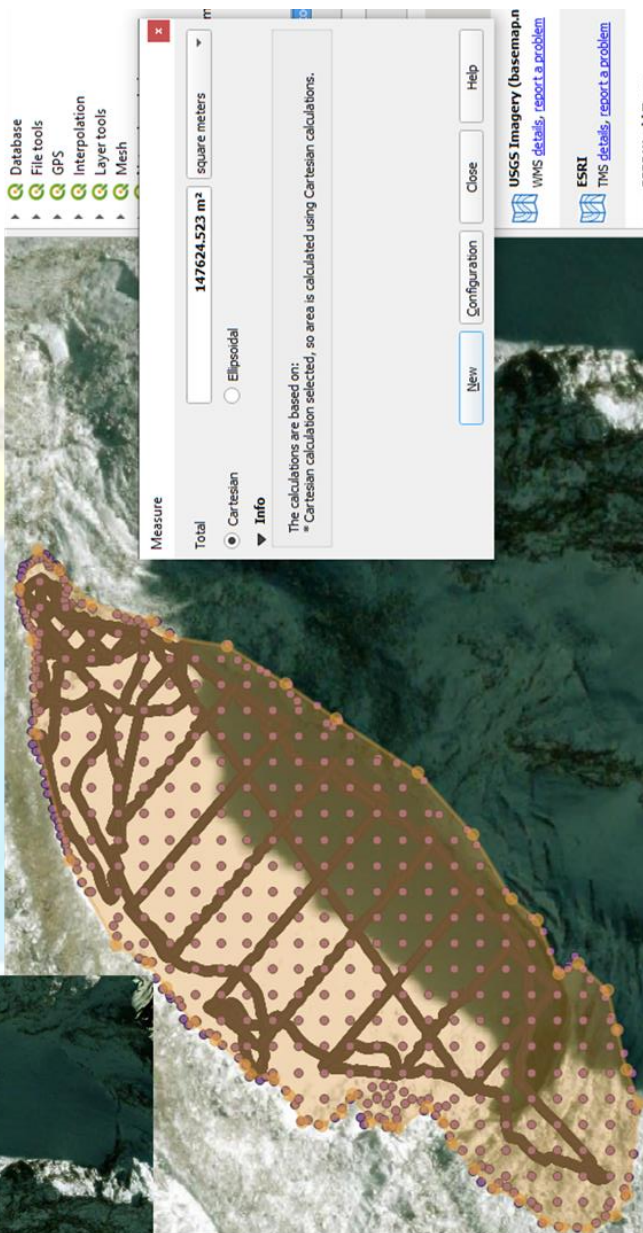
Fig 5(a). Calculated Area and volume of Vasuki lake

Thereafter, the interpolated data, along with bathymetric data, was used to calculate the total area of the lake through the Delaunay triangulation method. For validating the calculated area, a manually calculated area using QGIS software was also used. Fig 5(a) shows the comparison between the areas calculated by AGLPS and through QGIS. The volume of water in the lake was also calculated based on the depth data surveyed for the lake.

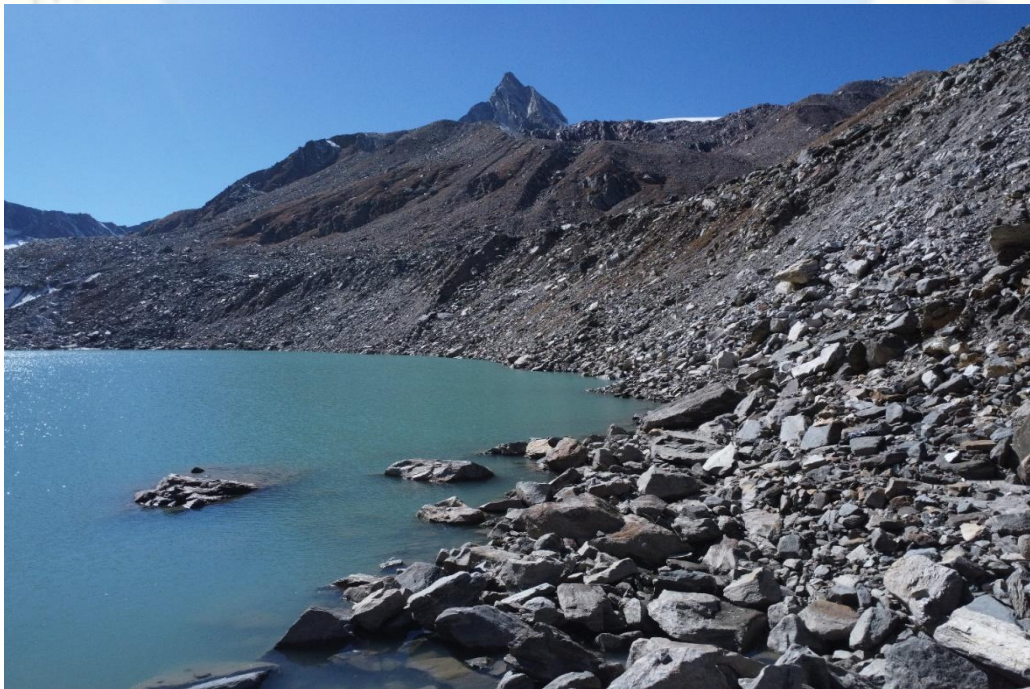
Figure 10: Moraine
