**REPORT ON GEOLOGICAL ASSESSMENT OF KOTRUPI LANDSLIDE, MANDI -  
JOGINDERNAGAR - PATHANKOT NATIONAL HIGHWAY (N.H.-154),  
TEHSIL PADHAR, DISTRICT MANDI, HIMACHAL PRADESH**

(Field Season: 2017-18)  
(Item No.: M4/EGG/C/NR/SU: PHP/2017/11904)

By  
Prashant T. Ilamkar, Sr. Geologist and Atul Kohli, Sr. Geologist  
Geological Survey of India  
(Northern Region)

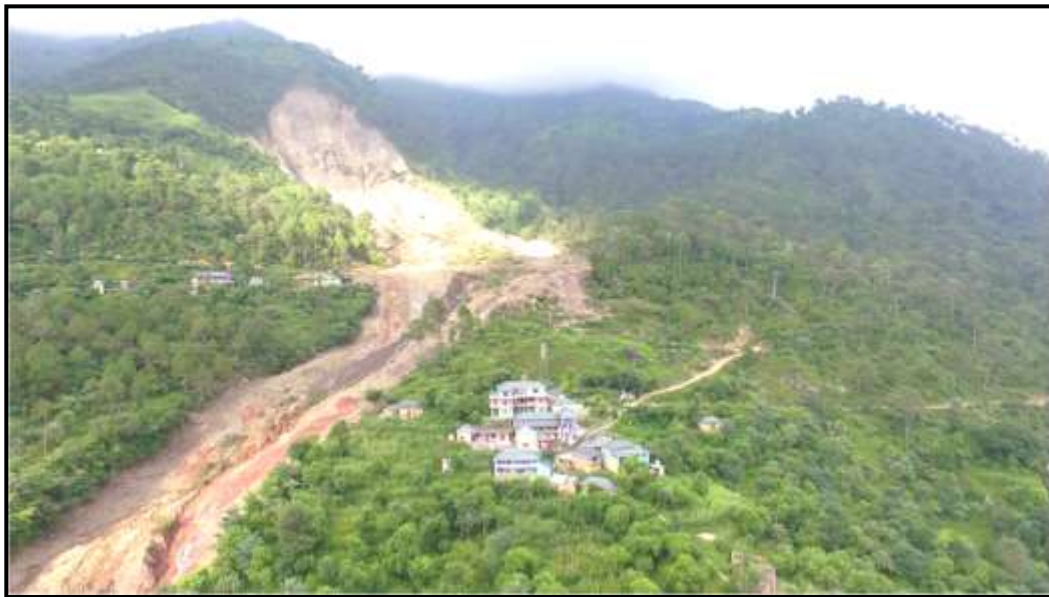
**Fig.-2:** Distal view of Kotrupi Landslide, Kotrupi, NH-154, (Date of Landslide Incidence: 13/08/2017).

Of the civil structures present in the landslide area, mention may be made of section of Mandi - Joginder Nagar - Pathankot National Highway - 154, and part of Kotrupi - Chukku village road, in addition to houses of the villages viz. Kotrupi (Right fringe: next to road on valley side), Badond (Left fringe: on valley side), Jaged (mid-slope on right fringe natural slope) and Saraj Bagda (On natural slope above Kotrupi landslide crown). All these features, including a few other feature(s) viz. water tank, one of the destroyed HRTC bus etc. were mapped and plotted appropriately. The length of the highway passing through slide zone is  $\pm 175\text{m}$  (Fig.-2).

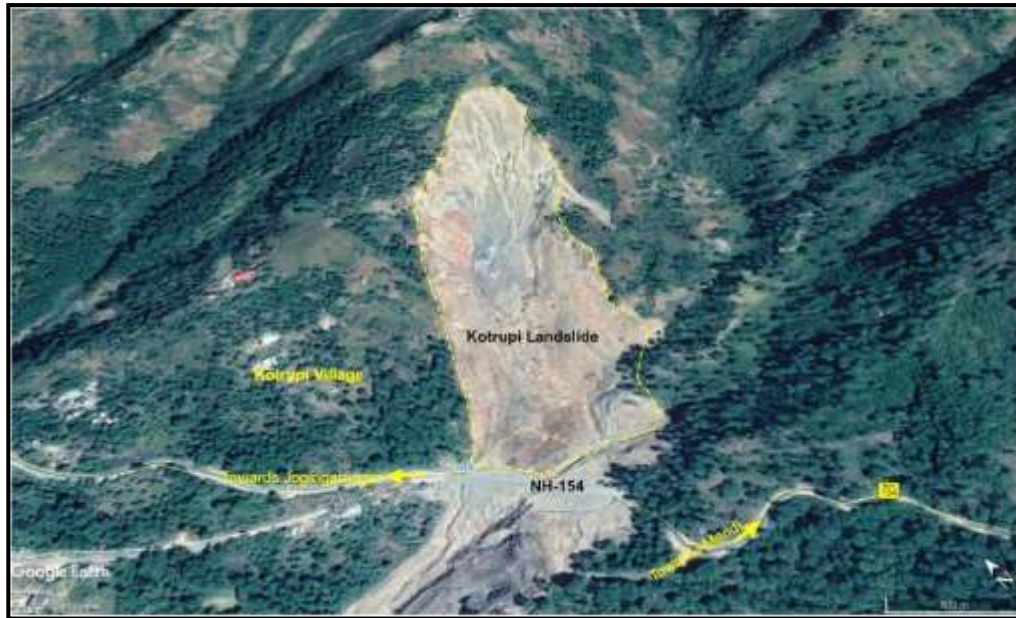
**Fig.-3:** Updated/ Post-2017 incidence satellite view of Kotrupi Landslide [Part of NH-154 can be seen repaired] [Source: Google Earth].

failure affected zone. On either side of the failure affected slope, natural seasonal *nala* depressions are there (Fig.-3).

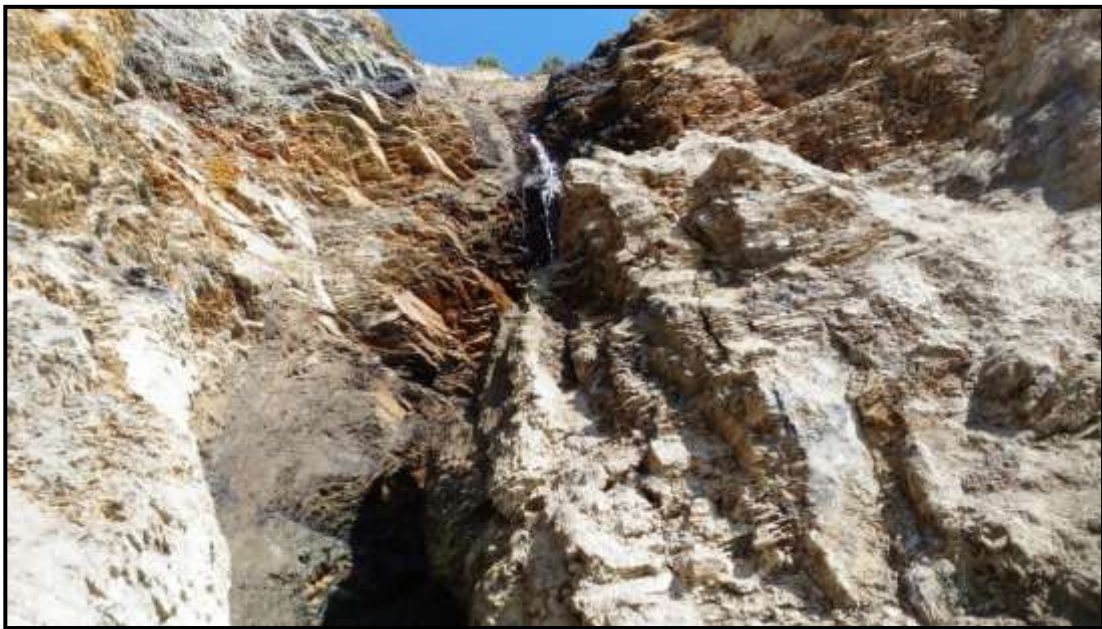
gentler slope and flattish land (Saraj Bagda village area) in Kotrupi landslide hill slope. The orientation of slope is broadly  $50^{\circ}$  /N224°. Below the crown portion, moderately to highly weathered and highly jointed rock-mass, particularly slates, is exposed (Fig.-4).

Broadly four sets of joints are seen here in weathered slates as:  $J_1$  ( $S_0$ ):  $34^{\circ}$  /N060°,  $J_2$ :  $74^{\circ}$  /N186°,  $J_3$ :  $52^{\circ}$  /N246°,  $J_4$ :  $86^{\circ}$  /N320°(Fig.- 4).The joints are relatively closed spaced with clay infillings occasionally seen in the joint apertures/ openings. The joints are having minor openings (closed to  $\sim 2$  to 3mm), as seen in the middle portion of sub-vertical scar.

**Fig.-4:** Closer view of weathered and jointed slates exposed in sub-vertical scar.

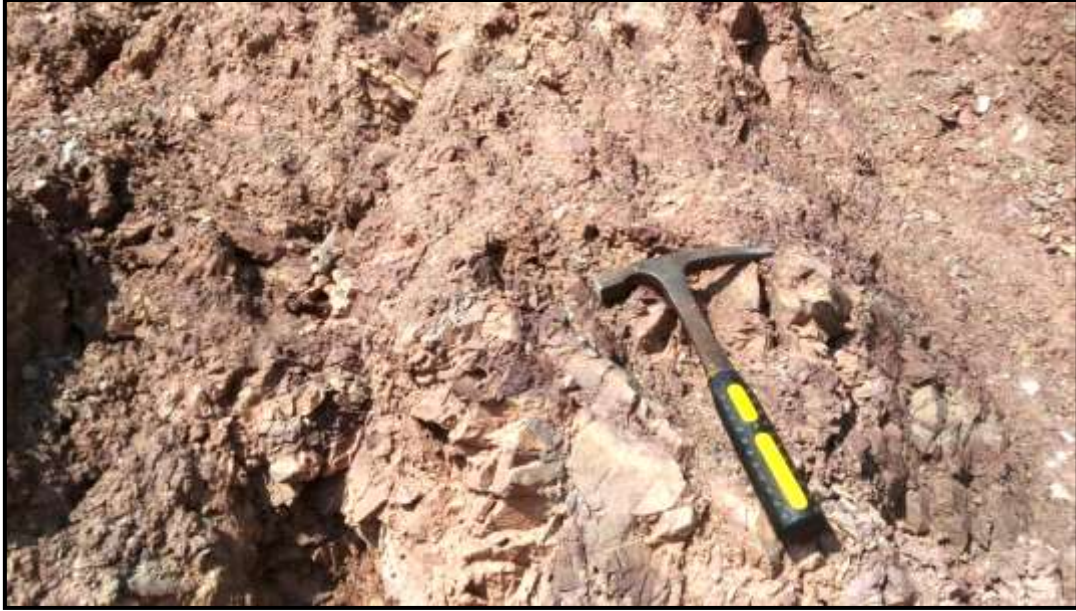
Similarly, rock exposures of red Shale with siltstone were seen on the right fringe of the slide. The rock is splintery in nature with  $\sim 1$  to 4mm opening at places. The rock is highly jointed with broadly four sets of joints as:  $J_1$  ( $S_0$ ):  $46^{\circ}$  /N048°,  $J_2$ :  $42^{\circ}$  /N220°,  $J_3$ :  $82^{\circ}$  /N314°,  $J_4$ :  $72^{\circ}$  /Northerly (Random)(Fig.-5).At the lower/ bottom part of the sub-vertical scar, piles of slide debris (particularly fine grained scree with rock chips/ chunks) are seen accumulated and, therefore, full view of sub-vertical scar is not visible (Fig.-6).

**Fig.-5:** Closer view of weathered red shale with siltstone exposed on right bank of Kotrupi landslide.

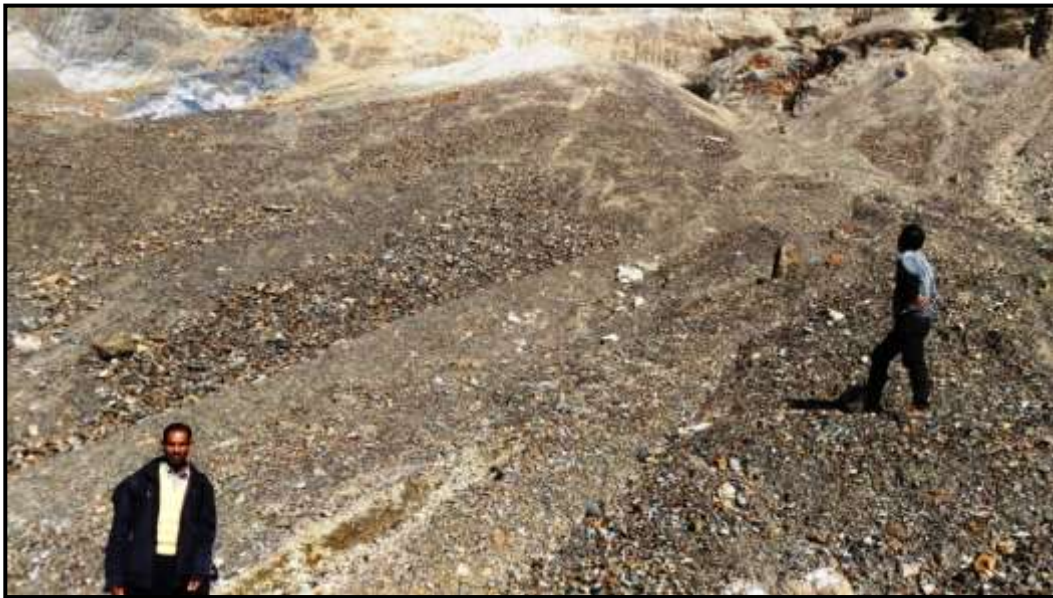
**Fig.-6:** Piles of slide debris (particularly fine grained scree with rock chips/ chunks), accumulated below the sub-vertical scar.

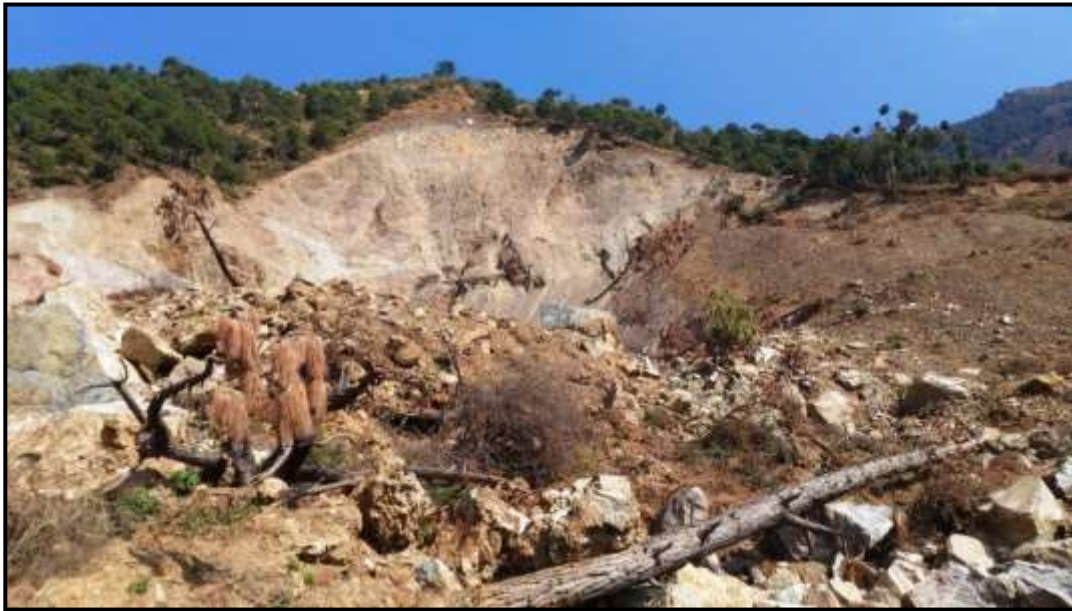
Concentration of rock blocks/ fragments are seen from El  $\pm 1370\text{m}$  to El  $\pm 1405\text{m}$  characterized by the presence of relatively larger size blocks ( $\pm 1\text{m}$  to  $\pm 3\text{m}$  or so). The rock blocks within debris include those of phyllite, phyllitic quartzite, limestone and slate. In the valley side flow path, however, mostly slide debris are present and include fine to coarse

grained slide debris, rock chips and chunks of about few centimeters to a few relatively bigger rock blocks as stated above (Fig.-7).

**Fig.-7:** Part of the main debris of slide zone with assorted rock blocks/ fragments.

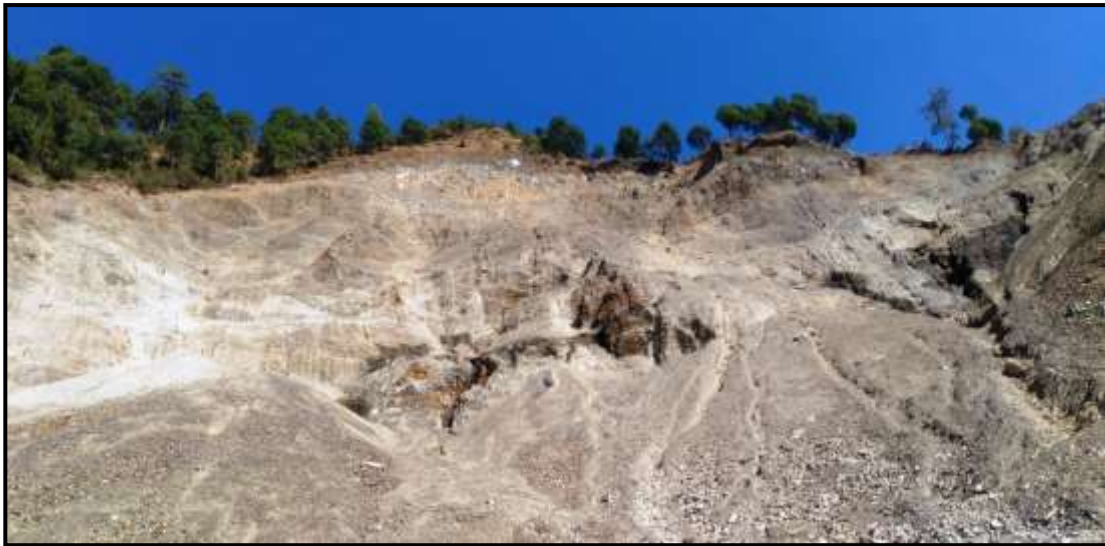
A number of water springs have been observed in the slide zone mainly in carbonaceous slate (in thrust zone) (Fig.-8). Oozing of water has been observed in the in the red shale exposed on the right flank of the slide. The discharge of water in the springs in the slide

zone has decreased considerably since 13/08/17 (the date on which the disastrous landslide took place).

**Fig.-8:** Springs and water oozing out in parts of sub-vertical scar area (the wet portions visible in the photograph).

Considering the site conditions, field traverses, topographic and geological mapping, slide morphology and configuration, field based geological and geotechnical evaluation of slide area, slope forming material indicated that, the slide ( $\pm 300\text{m} \times \pm 210\text{m}$ ) is a complex slope failure, involving both rock as well as overburden material. Water seepage played a critical role in triggering the landslide as it has lubricated the old slide debris as well as highly sheared/ crumpled rock mass. Water seepage was observed at least at half a dozen spots

within slide area (mainly in parts of sub-vertical scar and right fringe portions) (Fig.-8). The rock mass exposed is crushed and of low competency due to the effect of thrust.

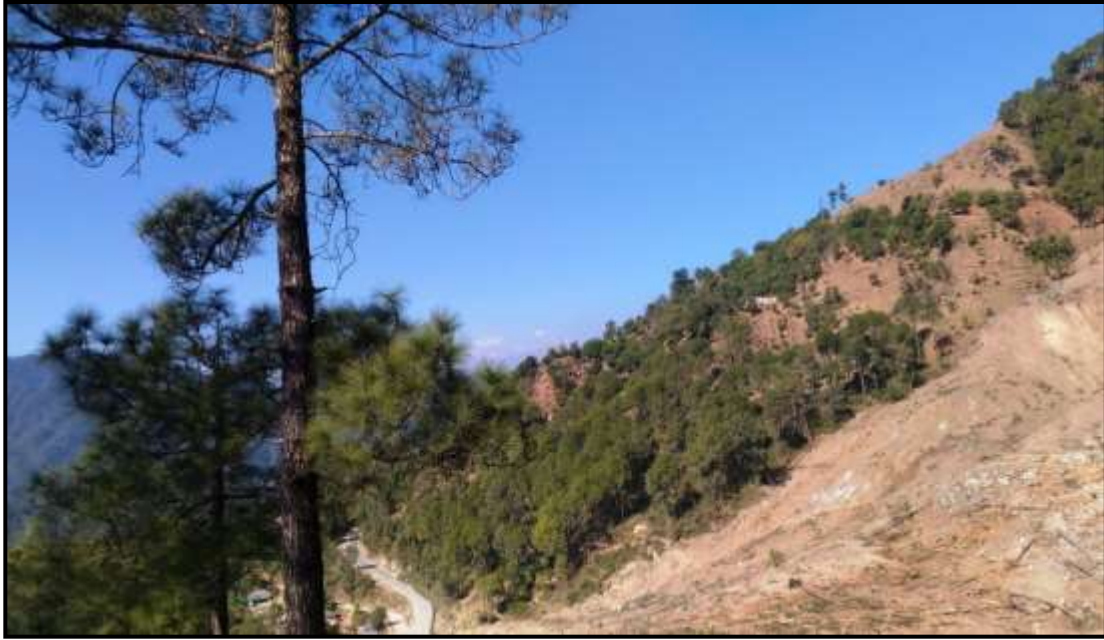
Pockets of trees depicting the density of vegetation observed in adjoining areas of the slide/ slide fringes were plotted appropriately on the map (Fig.-9). Similarly, agriculture terraces, wherever present in the adjacent areas of the slide/ slide fringes were plotted. This was done to have an idea of land cover and land use practices within slide area and to analyse their possible affect, if any, on slope failure/ slope instability.

**Fig.-9:** Pocket of trees in part of right fringe of the slide

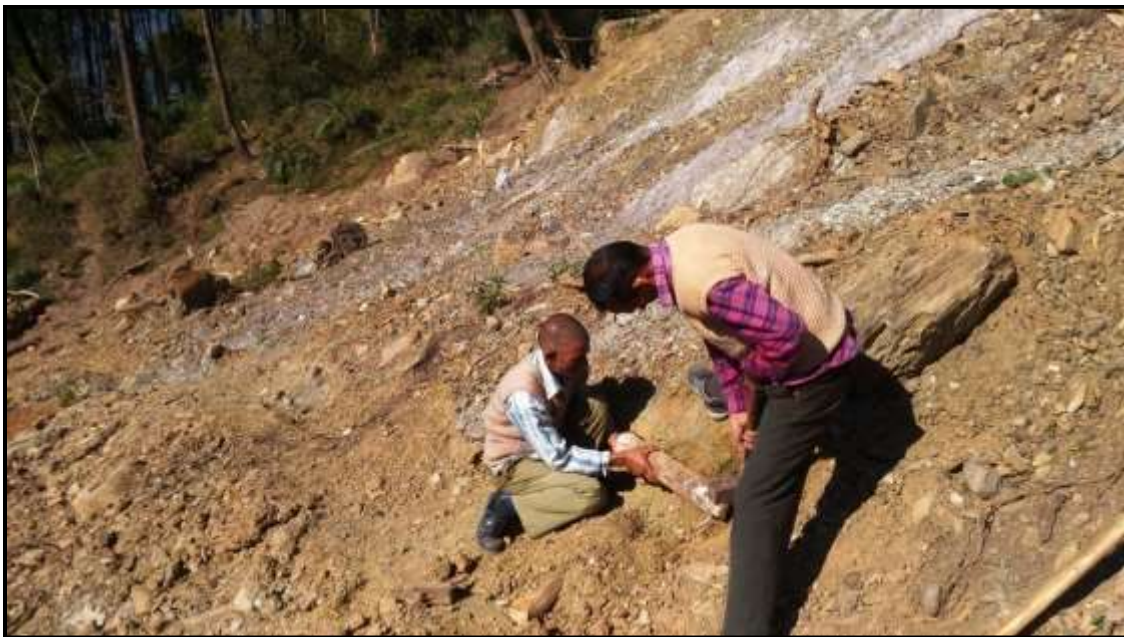
With a view to understand the behavior of slope forming material and its role in Kotrupi landslide, it was decided to collect samples of slope forming material. Soil samples were collected (Fig.-10) from selected locations within Kotrupi landslide area (Plate-1). It was attempted to collect representative samples from failed and natural slope. The coordinates (latitude and longitude) were collected using GPS, and later converted to UTM system (Northing-Easting) to plot the sample location on the Geological map of the slide.

**Fig.-10:** Sample collection in steel pipes from parts of slide and adjoining area

As there are no standard guidelines/ methodology/ code is available for sample collection, the samples were collected by following procedure:

**Step-1:** Identification of suitable/ required spot for sample collection.

**Step-2:** Clearing the surface suitably.

**Step-3:** Inserting metal pipe tube to get undisturbed sample within it.

**Step-4:** Proper packing of sample with mild hammering.

**Step-5:** Sealing both ends of metal pipes properly with molten wax.

**Step-6:** After drying up molten wax, covering both ends of pipe with news paper and tightening with thread.

**Step-7:** Sealing both ends with packing tape perfectly.

**Step-8:** Naming the sample pipe with required code name/ number.

The authors opined that by following the procedure, the Natural Moisture of the sample does not get lost for a certain time span and also there remain no gap within sample tube as well. The samples were collected for determination of geotechnical parameters enumerated in Table-1.
