NOTE ON PRELIMINARY STUDIES OF BOH VILLAGE LANDSLIDE, TEHSIL SHAHPUR, DISTRICT KANGRA, HIMACHAL PRADESH

Manoj Kumar, Director and Pradap Jagan R, Geologist
Geological Survey of India, Chandigarh

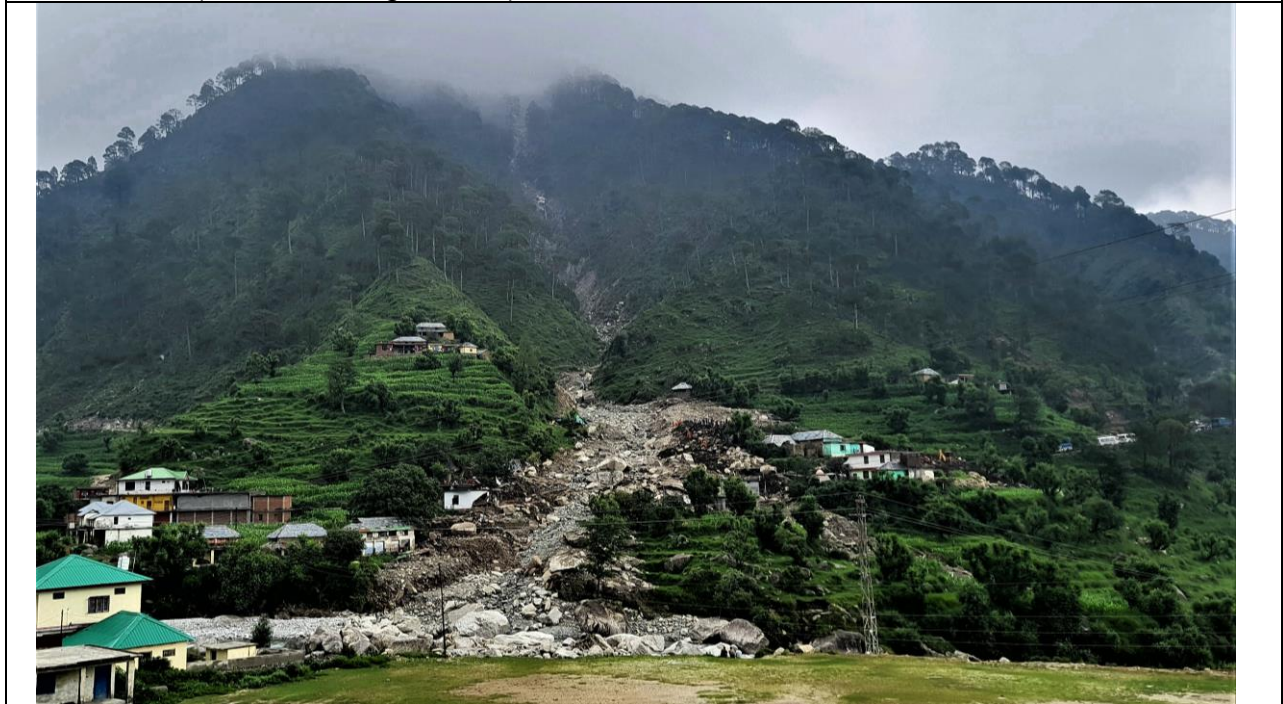
Photo-2: The perspective view of landslide, runoff and debris flow hit Boh village area

The catastrophic landslide occurred at 10.30 hrs (approx.) on 12.07.2021 at Boh village resulting in loss of ten lives and washing away of seven major houses, other constructions, road and agricultural land. The incidence also made the adjoining areas unstable. The damage was caused by a flash flood charged with debris flow in the upslope incised gully triggered by head ward landslide due to incessant heavy rainfall during previous night. Therefore, the incidence at the Boh village can precisely be describe as a debris flow hit. A short curve in nala course at the downstream end, possibly facilitated the spread of debris flow over the entire Boh village establishment. As on date of visit, the Boh village landmass was totally destabilised and can be reclaimed only after proper ground stabilisation applications. The adjoining landmasses on right bank have also been disturbed due the incidence, as evidenced by the presence of tilted trees, ground cracks and excessive ground seepage. It has been observed that the adjoining hill masses also suffered moderate landslides disrupting the communication at places.

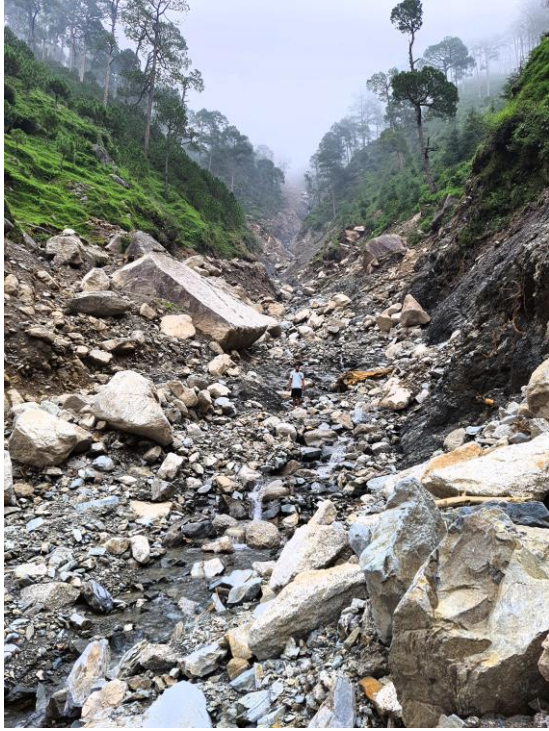
Photo-3: Downstream view of part of runoff

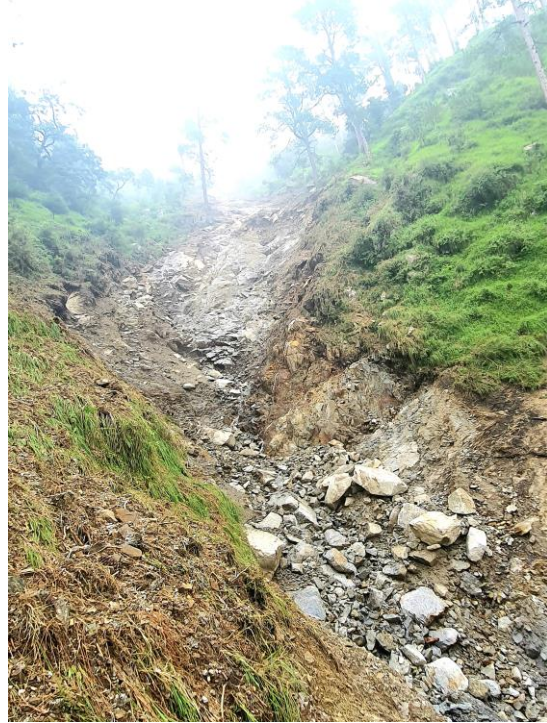
Photo-4: Rock slide in the upstream part of runoff.

The observations along the nala revealed presence of lot of bed load material comprising rock chips of Morang Formation as well as precariously disposed large boulders of Dalhousie Granite. In view of the steep gradient of the upstream nala/gully, unstable side slope material and landslide prone upstream most part of the nala, the recurrence of debris flow/ flash flood incidence cannot be ruled out. In this effect and in view of rainy season still remaining ahead, it is suggested that the dwellers at Boh and surrounding area may be shifted to a safer place. The above pursuit of safety may also be followed in other villages/ habitats, in particular for those living along nala banks and dormant nala courses. Similar mode of catastrophes appears common in the area and also reported from Basolda village located nearly 18km on Boh-Dharala link road.

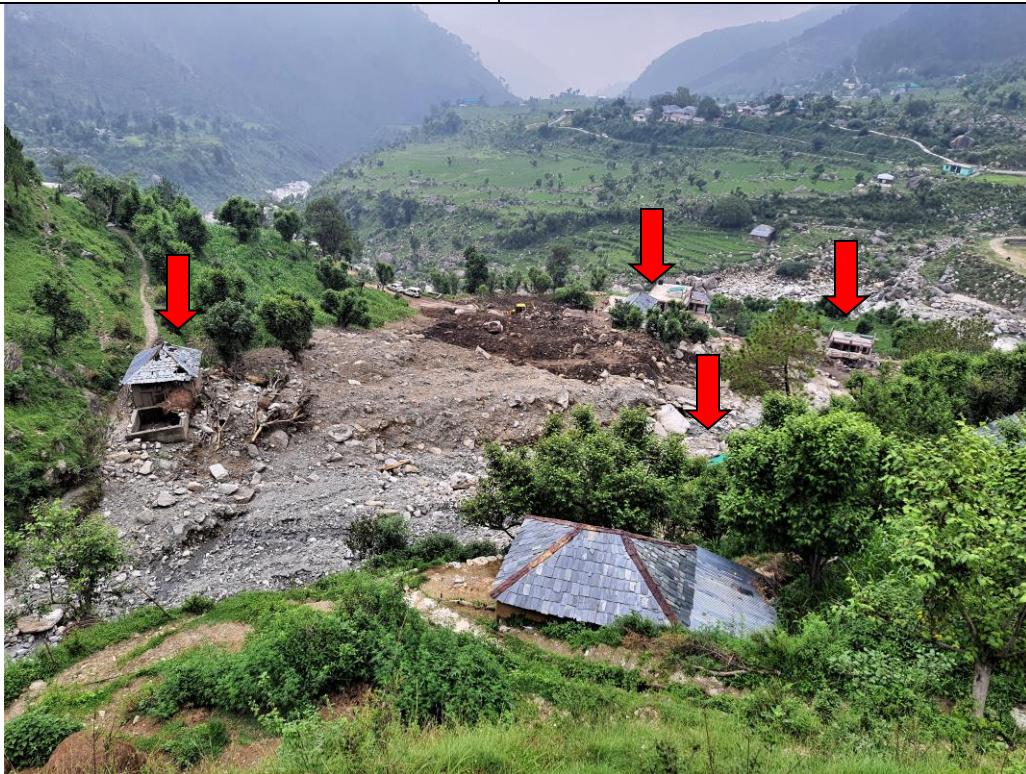
Photo-5: The downhill view of debris flow hit Boh village with remains of damaged houses (shown with red arrows)

1. Rehabilitation of affected inhabitants of Boh and adjoining area to a safer place in view of destabilize ground condition and possible recurrence of incidence at Boh village.

2. The reclamation of the land mass at Boh after proper applications of ground stabilisation measures like compaction, channelizing out the seepage, provisions of drainage outlet, provisions to check ground settling and retaining structure to confine the ground mass, protection wall from nala side etc.

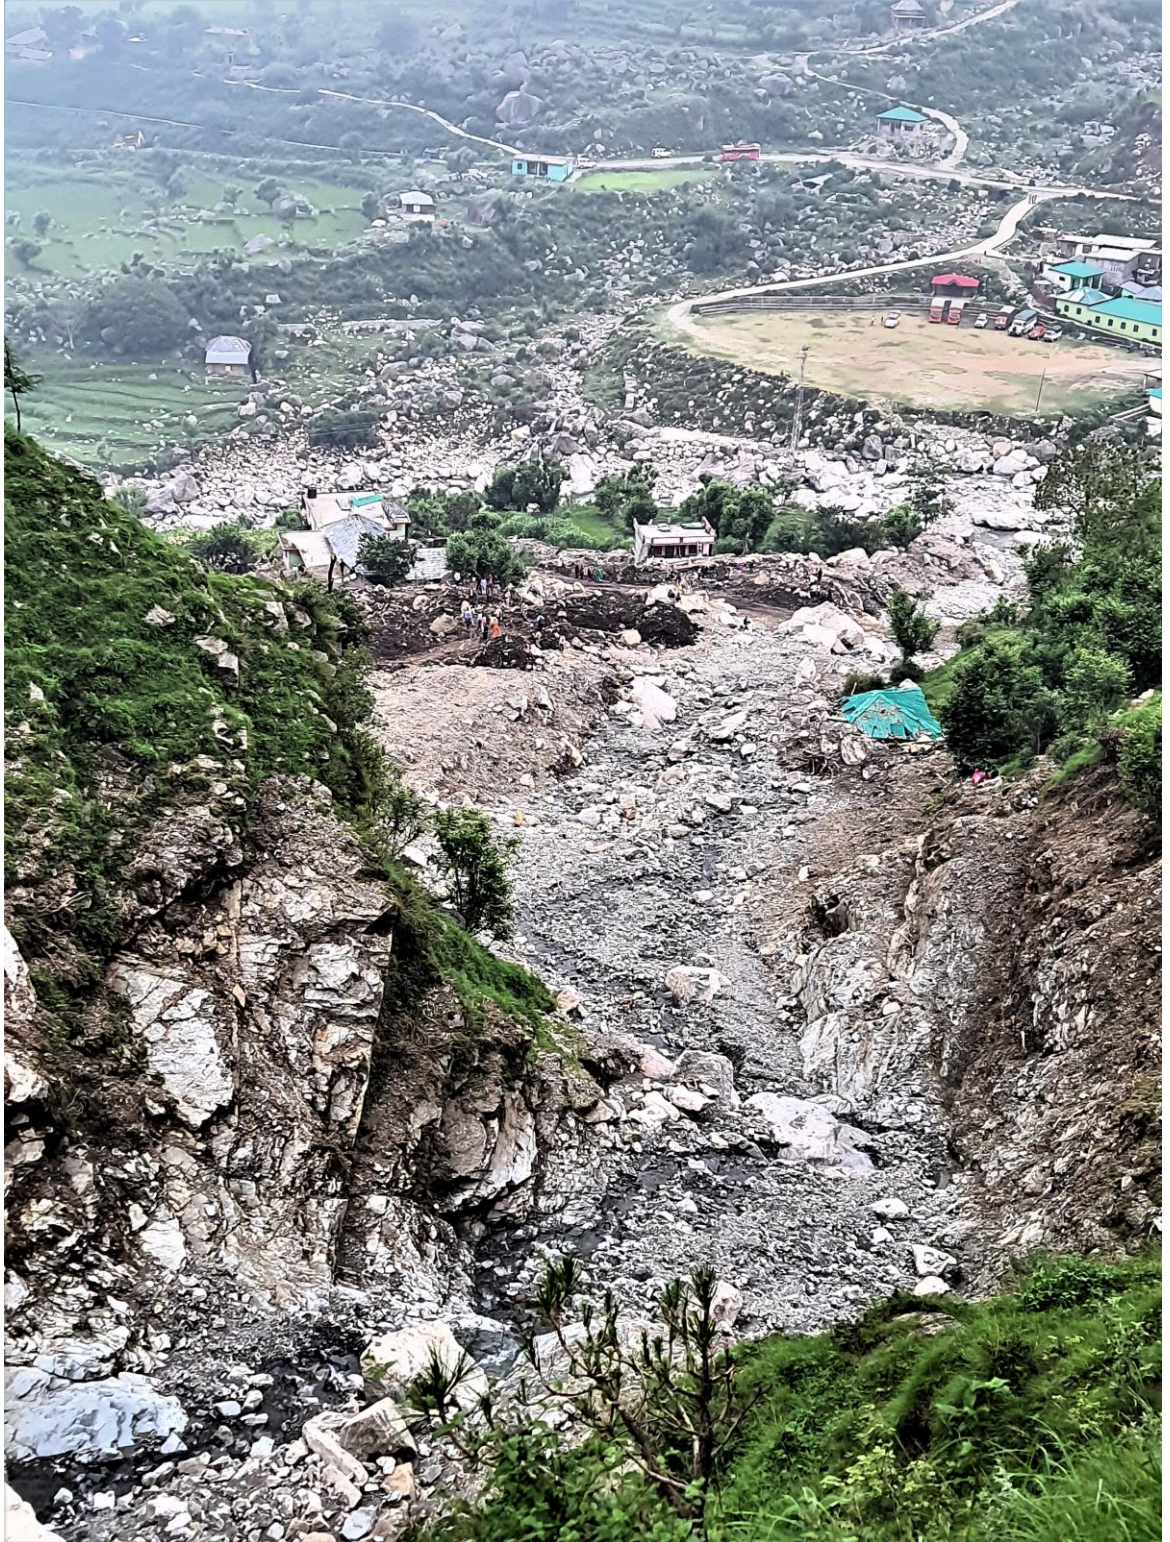
Photo-6: The curve at the downstream end of nala course possibly lead to spread of debris flow in the Boh village.

3. Prohibition of flow barriers all along upstream nala course at suitable distances
4. Provision of concrete lined spacious nala course with a provision of culvert on the road ensuring the easy passage of debris flow.
