**Himachal Pradesh State Disaster Management Authority**

**District Disaster Management Authority Kullu**

**KULLU DISTRICT DAMAGE REPORT:  
TECHNICAL ASSESSMENT AND SUGGESTIONS**

**October 2023**

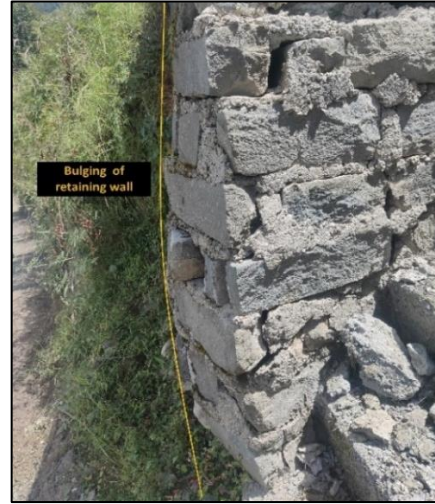
4. A large settlement of around 150 cm was observed in a 135 m stretch of road (Fig. 30). From the exposed part of the road, it was clear that the road was poorly constructed and did not comply with guidelines provided by IRC: SP:48-1998. The inspection of a recently constructed retaining wall revealed that it is bulging in some places and is at risk of collapse (Fig.31). Further, the old retaining wall has already been damaged due to earth pressure (Fig. 32).

**Fig. 31.** Bulging of retaining wall.

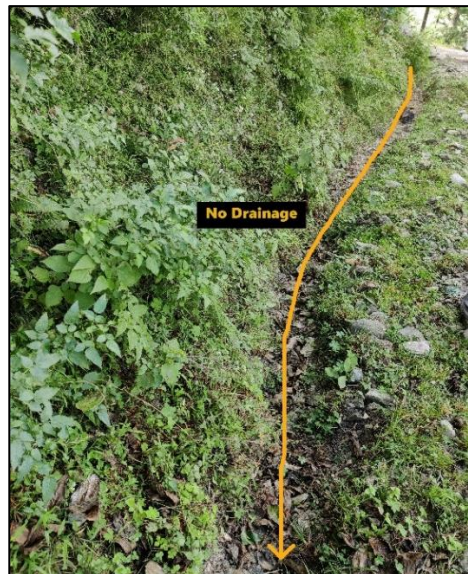
**Fig. 34** Clogging of the drain.

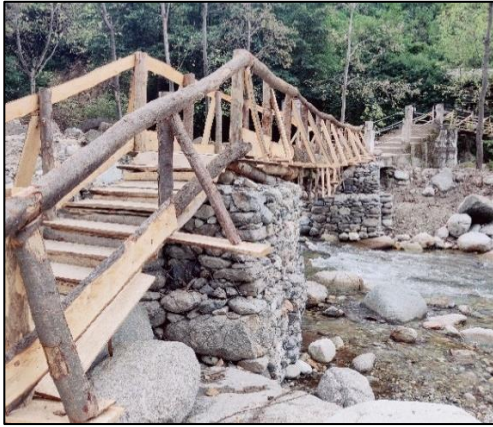
**Fig. 35.** Temporarily constructed bridge.

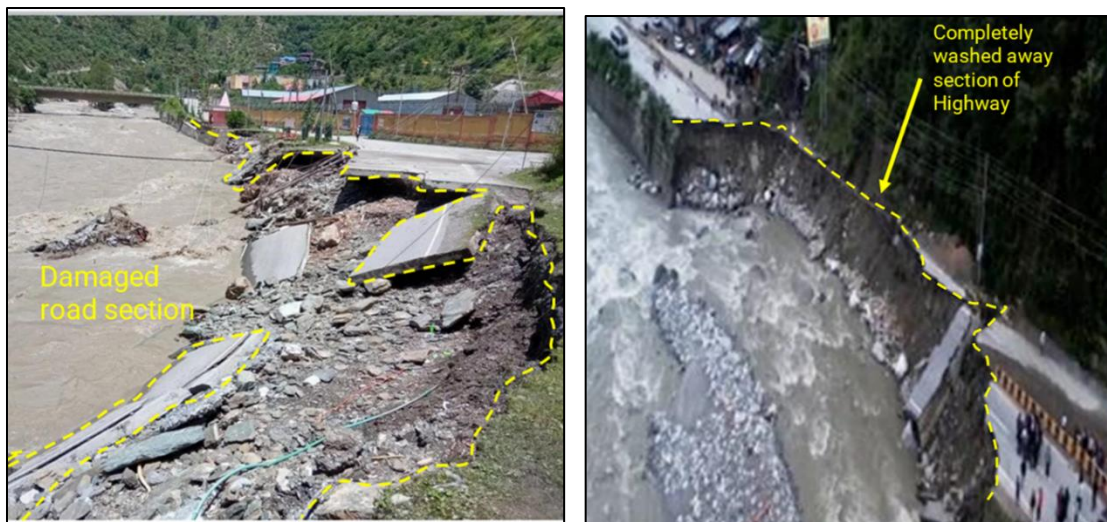
1. The Kullu-Manali national highway was obstructed due to the collapse of a significant portion of the road at multiple locations. The collapse resulted in the formation of large gaps in the road, rendering it impassable.

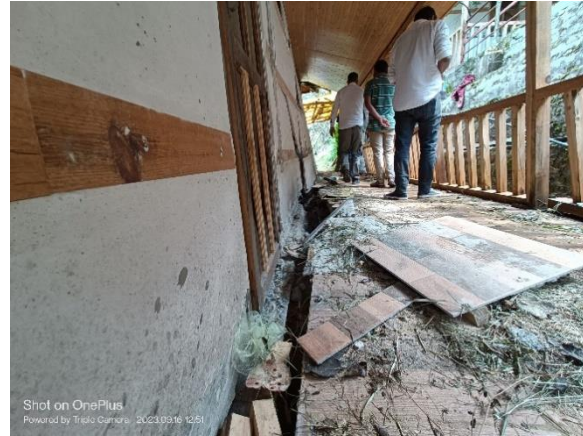
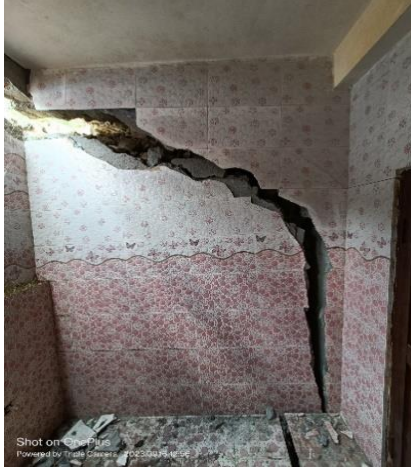
2. In Bandal village, more than 28 houses are affected due to subsidence, and people have been moved into the relief camps. Most of the houses were inaccessible, but the team visited one of the houses. The area has suffered a continuous settlement for over a month. Between the duration of 8 to 10 July 2023, a significant settlement took place, leading to big cracks in the building, indicating again a case of differential settlement (Fig.53). In this location, a similar pattern was followed when it came to load transfer from superstructure to substructure as in previous case. No proper provision of footing was present, and the column was raised over a stone retaining wall (Fig. 53d).

**Fig. 53.** a) Settlement of slope, b) Differential settlement of the building, c) Cracks on the walls due to differential settlement of the foundation, d) Improper foundation provision.

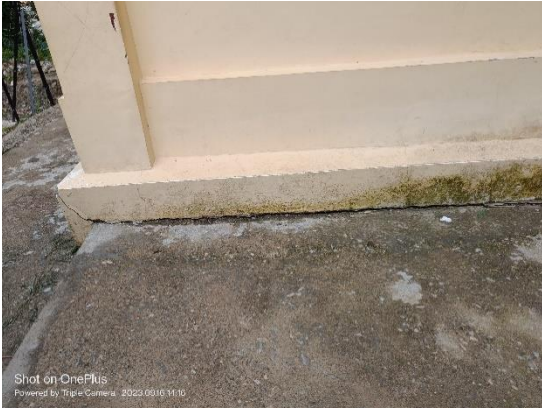
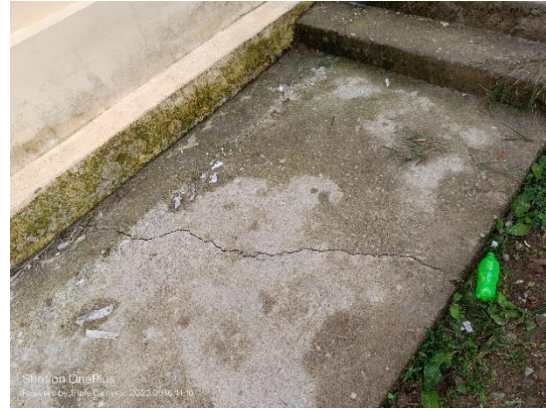
3. The school in Gishaini town is located at the toe end of the slope where the subsidence occurred. Differential settlement is observed on the school grounds. The newly constructed school building, located next to the subsidence zone, has started developing cracks at the ground level, as shown in Figure 54. Even though the cracks are not severe at present, close monitoring of the same, particularly during the rainy season, is advised.

**Fig. 54.** Cracks due to differential settlement

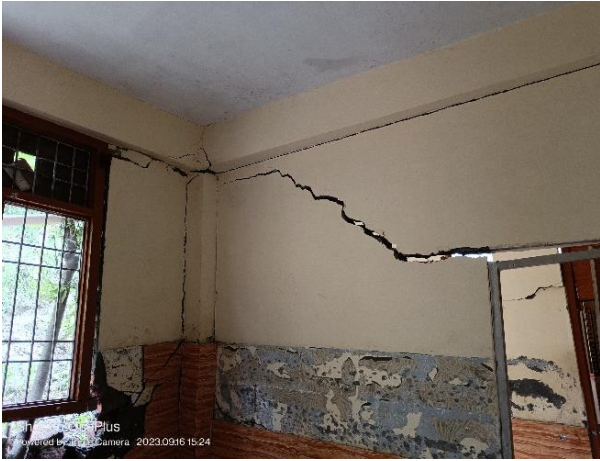
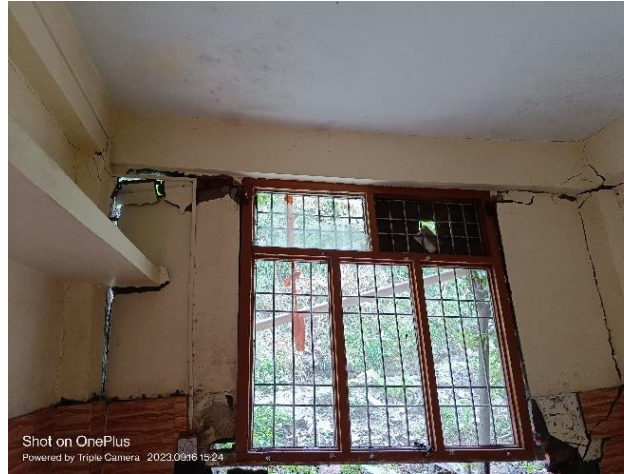
4. Another subsidence zone is located in Banjar town. Four buildings above the road have suffered damage, with one completely collapsed and 3 having large cracks, as shown in Fig. 55. The surprising thing to observe was that some buildings were still occupied, and shops were running on the ground floor. It is advised to vacate these buildings at the earliest. Below the road level, a school named Saraswati Vidya Mandir lost one of its blocks due to differential settlement, as shown in Fig 56. Again, the foundation construction practices (Fig. 56(b)) are observed to be the same as earlier ones. Some parts of the existing building foundations are exposed, and the load-carrying mechanism is not fully operational. So, close and continuous monitoring of the existing building is advised. The ongoing classes may be shifted to another building until appropriate strengthening measures are implemented.

**Fig. 55.** Cracks on building due to deferential settlement at Banjaar

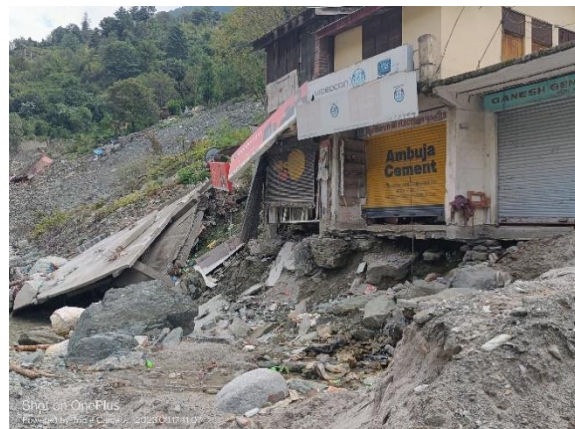
5. On 17th September, the team visited the Sainj town in Kullu district, Himachal Pradesh. The Larji-Sainj road was damaged at multiple locations on the way to Sainj town. The Sainj town is situated downstream of Parbati -III hydropower plant dam Fig. 57. On 8th July, the extreme rainfall and cloud burst event led to flash floods. The flash floods caused the collapse of 28 houses in the town (Fig. 58), and many houses are highly damaged or on the verge of collapse. The foundation of most of the houses in the town rested upon the gabion walls formed with the river boulders. Due to the huge amount of water released on the day of the extreme event,

**Fig. 58.** Various building collapsed due to erosion in Sainj market.

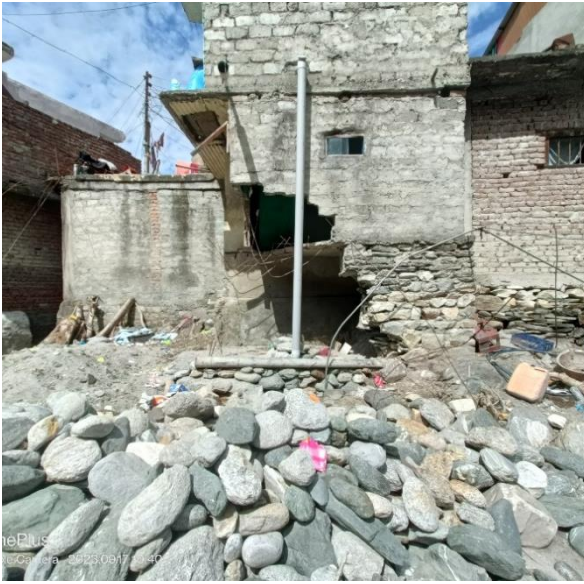
these boulders got displaced, leading to an improper load transfer mechanism from superstructure to substructure and eventually resulting in the collapse of the buildings (Fig. 59). Like Tirthan Valley, in this case also there was no provision of proper footing arrangement and columns were raised from the stone retaining walls (Fig. 60). In addition to this there were many bad construction practises noticed in the area like floating columns, offset projections without support and brick columns observed at the site. Additionally, it is to be noticed that the houses were still occupied, and the same construction practices were continuing in under-construction buildings as well (Fig. 60).

**Fig. 59.** Various bad construction practices in Sainj buildings: a) Brick columns is provided in structure, b) Floating column and column provided over cantilever projection, c) Improper load transfer mechanism due to missing footing, d) Insufficient tie spacing leading buckling of column.

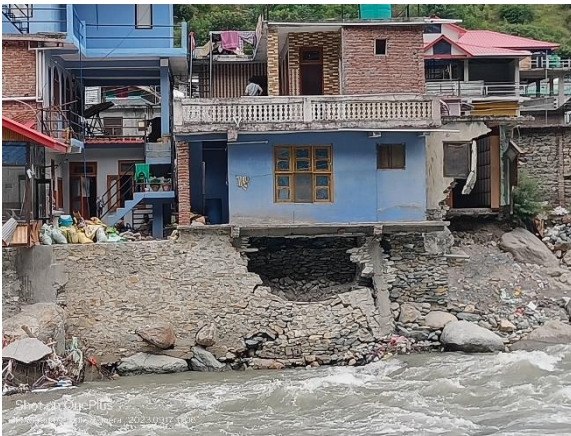
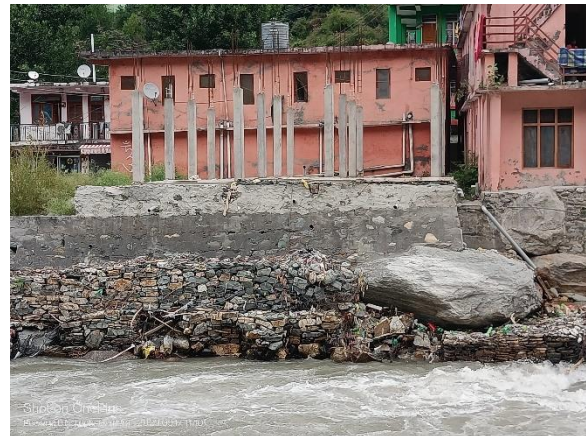
**Fig. 60.** a) People staying in damaged structure putting lives in risk, b) Bad construction practices continuing in new construction.
