**REPORT ON THE PRELIMINARY ASSESSMENT OF LANDSLIDE AT  
KULLU, BANJAR, MANALI AND ANNI SUB-DIVISION OF KULU  
DISTRICT HIMACHAL PRADESH**

Item Code No.: M4EGG/C/NR/SU-PHP/2023/46620

By  
Tripti Baba, Senior Geologist  
Weneikhro Krome, Geologist

राज्य इकाईपंजाब :, हरियाणा एवं हिमाचल प्रदेश / State Unit: Punjab, Haryana and Himachal pradesh  
उत्तरी क्षेत्र / Northern Region  
चंडीगढ़ / Chandigarh

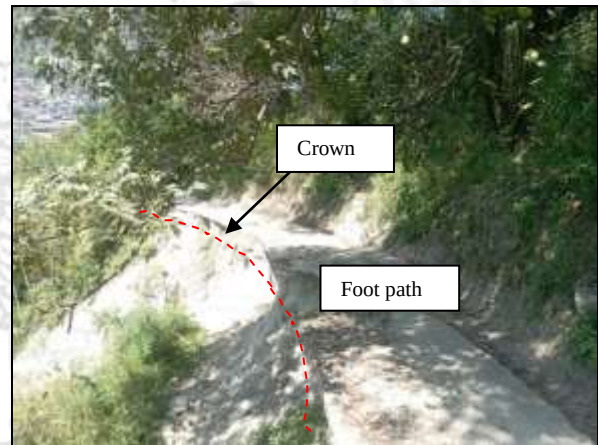
- At the failure affected site, the slope forming material consists mainly of fine to coarse grained loose unconsolidated soil and no *in-situ* rock were exposed.
- The crown of the slide was observed along the local footpath connecting Devdhar to Banontar.(Fig.8). The dimension of the landslide is  $\pm 55\text{m}$  length and  $\pm 50\text{ m}$  width and are retrogressive in nature, dripping to flowing hydrological conditions (Fig.9).
- No drainage system was observed to be present in and around the distressed zone.
- A set of retaining walls constructed on the hill side of petrol pump were observed tilted and displaced due to retrogressive in nature and few ground cracks were also observed near the crown of the slide, which poses more risk to petrol pump/ downslope structures in case of uneven/extreme weather conditions.

Fig.8; Crown of the landslide.

- It is suggested to construct an appropriately designed lined drainage parallel to contour above the crown of the slide to avoid surface water discharge on the distressed slope.
- The source area responsible for dripping water along the distressed slope need to be identified and pipes should be installed at the seepage/source zone for proper drainage management on the slope.
- Biotechnical stabilisation/ Plantation of suitably identified species that can hold the soil in the failure affected zone in consultation with Botanist/Forest dept.
- Immediate filling of ground cracks with appropriate impervious material immediately.
- Appropriately designed retention structures at suitably identified locations at lower levels as support to failing mass in consultation with design Engineers.

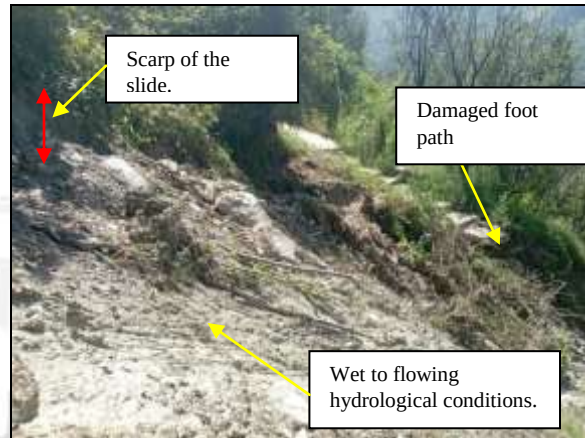
- At the time of field observations, the main scarp of the landslide is well exposed for about  $\sim 1\text{m}$ . The hydrology conditions of the slope is wet to flowing. (Fig.11).

- The affected slide has a dimension of  $\pm 35\text{m}$  length and  $\pm 40\text{m}$  width exhibiting retrogressive and widening in distribution.
- Retaining walls that were placed on the hill side of the NH-3 were observed to be damaged, partly tilted at places and the local foot path was completely wash out.

Fig.11; Main body of the landslide.

- In the present incidence, prima facie the slope failure does appear to be due to both anthropogenic and natural causes.
- Natural slope disturbances by way of steep excavation for road construction within unconsolidated debris material.
- Absence of proper drainage network in upslope and slope saturation due to excessive/ incessant rainfall spells in the area during June 2023 have drastically worsened the slope situation (Ref. Table 2 and fig 1.b)..

- The source area responsible for dripping water along the distressed slope need to be identified and pipes should be installed at the seepage/source zone for proper drainage management on the slope.
- Biotechnical stabilisation/ Plantation of suitably identified species that can hold the soil in the failure affected zone in consultation with Botanist/Forest dept.
- Appropriately designed retention structures at suitably identified locations at lower levels as support to failing mass in consultation with design Engineers.

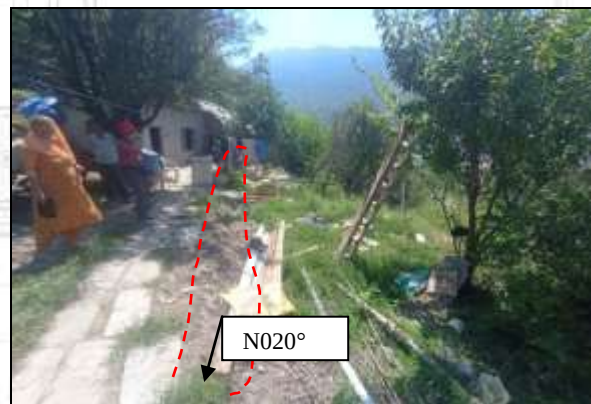
- Banontar Kharahal subsidence is located ( $31^{\circ}57'20.23''\text{N}$ ,  $77^{\circ}6'59.42''\text{E}$ .) on the upslope of NH-3 along transported mid slope of loose unconsolidated debris material with a slope inclination and direction of  $35^{\circ}\text{N}280^{\circ}$ .
- A subsidence that has affected 2 Houses in the form of wall cracks, ground subsidence, tilting and sinking of retaining walls.(Fig.13 and 14)
- Other instability signatures such as tilting of trees (Fig.15), ground cracks ( $\text{N}020^{\circ}$ ) (Fig.14), damaged and tilted retaining walls were also observed (16).
- This subsidence is active and poses risk to the slope in case of extreme weather events.

Fig.14; Ground cracks observed at Banontar Kharahal

- It is suggested to construct an appropriately designed lined drainage parallel to contours upslope to avoid surface water discharge on the distressed slope.
- Appropriately designed retention structures at suitably identified locations at lower levels as support to failing mass in consultation with site and design Engineers.
- Immediate filling of transverse and contour parallel tension cracks with appropriate impervious material immediately.

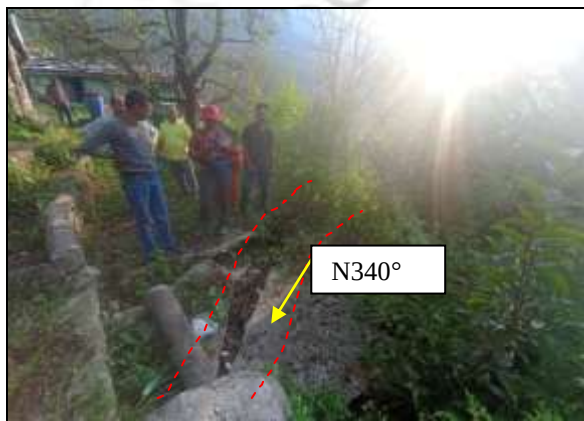
- During field visit/inspection it was observed that several houses were partially to fully damage in the form of cracks on walls and roof, lateral displacement of structures, ground cracks, tilting of houses and tilting of electric pole (Fig.18,19 and 20). A total nos. of 16 houses was damaged (as informed by local residence).

Fig.19; Ground cracks at Garsa village.

- The village is nestled on unconsolidated steep slope material. The incessant rainfall spells during the month of Jun-Aug 2023 lead to oversaturation of slope material (Ref. Table 2 and fig 1.b)..
- The hill slope is damp to wet due to presence of streamlets, Further infiltration during heavy rainfall induce the slope instability by increasing pore water pressure of the slope material and activating the streamlets and *nalas* trigger subsidence.
- Toe erosion by flowing *Nala* on the right flank of slope.
- Lack of drainage management on the slope.

- Appropriately designed retention structures at suitably identified locations at lower levels (in consultation with site Engineers) as support to failing mass.
- Immediate filling of transverse and contour parallel tension cracks with appropriate impervious material immediately.
- Avoid further loading, tampering of slope with heavy civil structures in/adjoining failure affected zone and in immediate vicinity of *nala* courses.
- Appropriately designed guide walls in consultation with design Engineers along the *nala* courses present on the right flank of the slope, to prevent further erosion and damage to civil structures present vicinity to it.

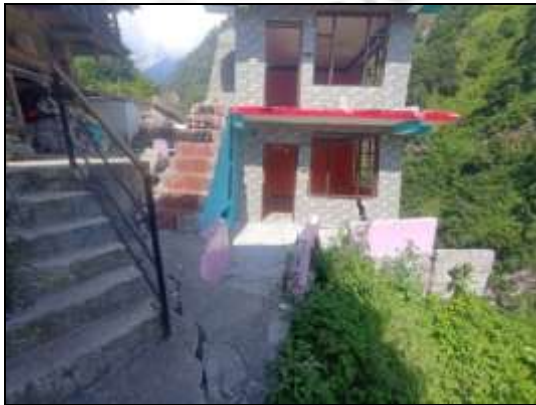
- During field visit/inspection it was observed that several houses including Mandir were damaged and developed cracks on walls and roof, lateral displacement of structures, ground cracks, tilting of houses and foundation damaged. (Fig 21,22,23 and 25).

Fig.23; Crack on civil structures at Barauna village

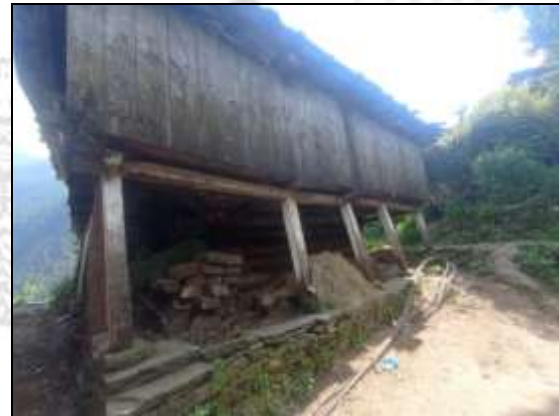
Fig.24; Tilting of houses at Barauna village.

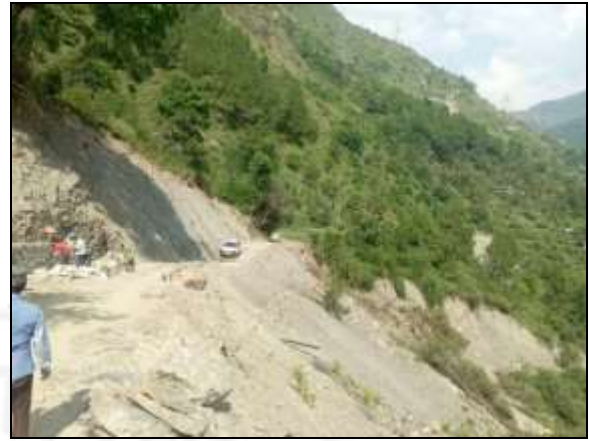
- No major casualties were reported from the affected site during field visit except road damaged (Fig.38) (informed by local residence and Tehsildar). However few houses are observed to be present on upslope/near the crown of the slide where traverse ground cracks (Fig.39) were present which may pose risk to settlement in case of extreme weather conditions.

Fig.38; Road subsidence along Machine *Nala* landslide.

- It is suggested to construct an appropriately designed contour parallel channelized lined drainage above crown of the slide to avoid ingress of surface water in the distressed slope.
- Appropriately designed retention structures along the hill and valley side of road with a provision of weep holes and hill side drainage.
- Immediate filling of ground cracks/tension cracks (Fig.39) with appropriate impervious material.
- Avoid further loading, tampering of slope in the adjoining failure affected zone.

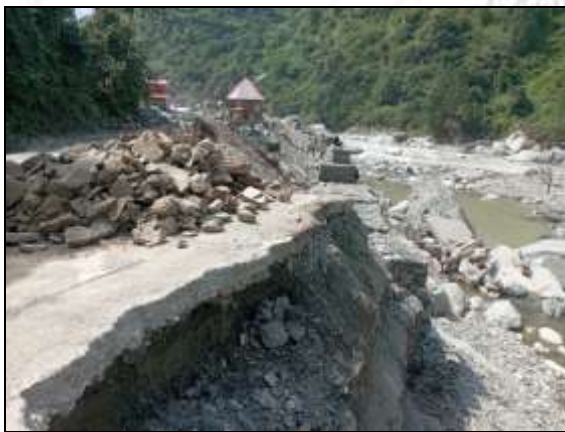
Fig.40; Severe road damaged near Thana Sainj.

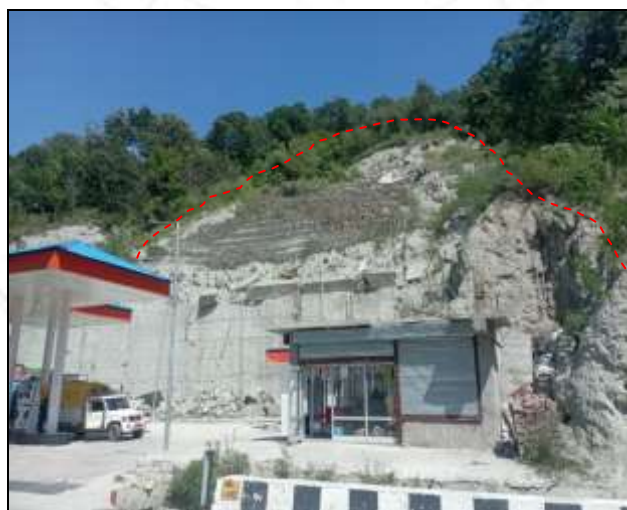
Fig.1. Debris slide on upslope of Indian oil petrol pump

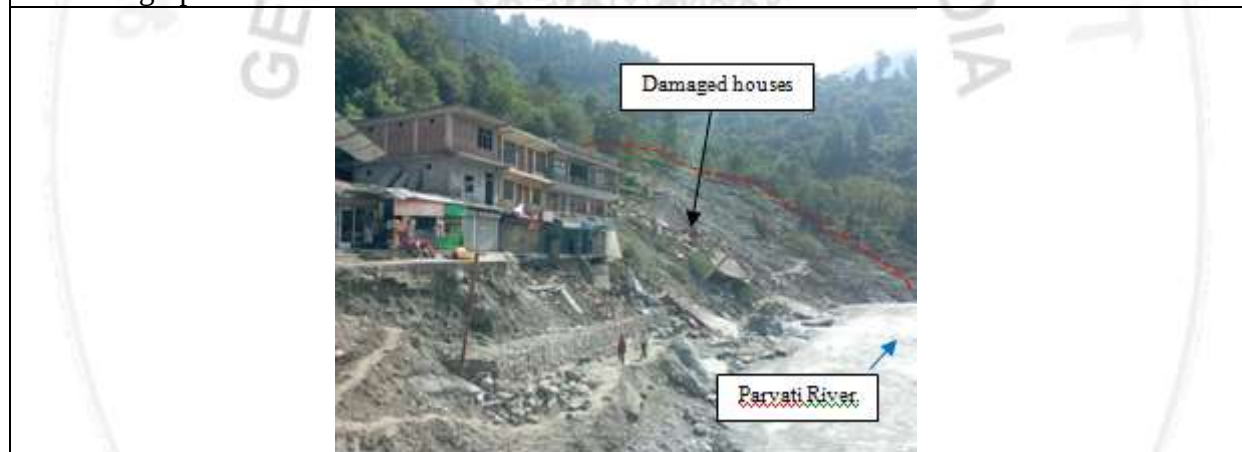
Fig.1. Main landslide affected are

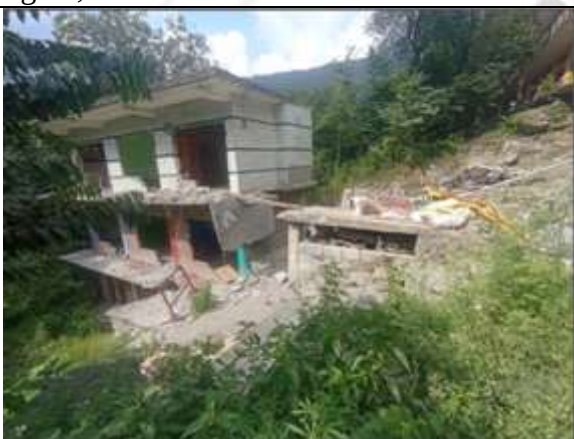
- As per information (received from local residence , SDM Banjar and field observation) a total 5 nos. of houses were damaged including Sarswati Vidya Mandir Sr.Sec, School located on the affected zone/slope. (Fig.53)

Fig.2. Damaged Sarswati Vidya Mandir  
Sr.Sec. School

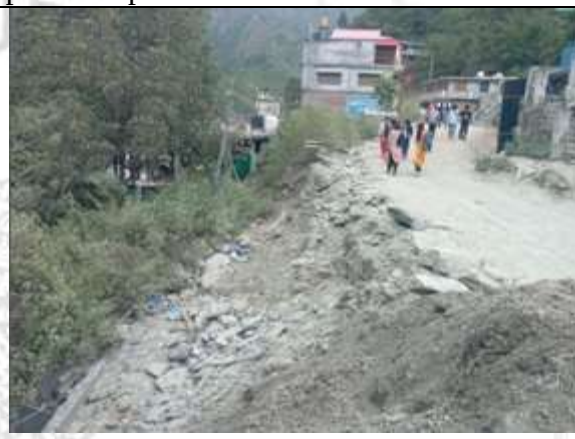
- It is observed that due to debris slide down the slope, the NH-305 road stretch of around  $\sim 40\text{ m}$  present just above the upslope of landslide has been subside for about  $\sim 5\text{m}$  (Fig.55).

Fig.3. Damaged road stretch
