**REPORT ON THE PRELIMINARY ASSESSMENT OF LANDSLIDE AT  
KULLU, BANJAR, MANALI AND ANNI SUB-DIVISION OF KULU  
DISTRICT HIMACHAL PRADESH**

Item Code No.: M4EGG/C/NR/SU-PHP/2023/46620

By  
Tripti Baba, Senior Geologist  
Weneikhro Krome, Geologist

राज्य इकाईपंजाब :, हरियाणा एवं हिमाचल प्रदेश / State Unit: Punjab, Haryana and Himachal pradesh  
उत्तरी क्षेत्र / Northern Region  
चंडीगढ़ / Chandigarh

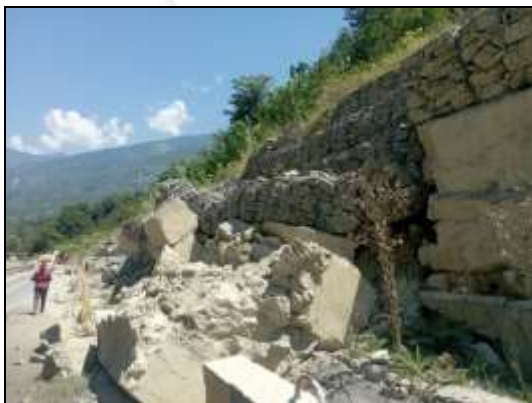
- Damaged on civil structures in the form of cracks on wall, retaining wall collapse, ground subsidence etc were observed. (Fig.3 and 4).
- Seasonal *nala* is observed on the right flank of the affected slope. Due to the side erosion of loose material by the *Nala* during incessant rainfall, instability signatures such as ground subsidence and tilting of trees is observed along the left flank/slope of the Nala/Khad. (Fig.5).

Fig.3; Damaged retaining walls towards the hill side along NH-3

- The unchannelized *nalas* and house hold sewage domestic water should be channelized systematically.
- Construct contour parallel drainage system in the upslope of the settlement.
- The damaged retaining wall along the hill side of NH-3 located down slope of the village should be repair/replaced with a provision of weep holes.
- Construction of appropriately designed guide walls is required along both the bank of *nala* located on the right flank of the affected area in consultation with design engineers to prevent further toe erosion and damage to civil structures present vicinity to it.
- Biotechnical stabilisation/ Plantation of suitably identified species that can hold the soil in the failure affected zone in consultation with Botanist/Forest dept.

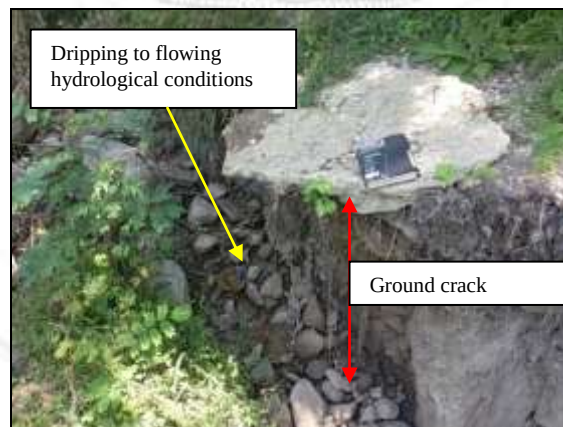
Fig.9; Seepage zone in flowing water conditions along ground cracks in the distressed slope.

- Concentration of pore water pressure in slope forming material due to damp and dripping hydrology condition coupled with further water saturation from surface runoff during incessant rainfall (Ref. Table 2 and fig 1.b).
- Disturbance of natural slope by road cutting and construction of petrol pump towards hill side leaving the slope steeper.
- Absence of proper drainage system on the upslope.

- It is suggested to construct an appropriately designed lined drainage parallel to contour above the crown of the slide to avoid surface water discharge on the distressed slope.
- The source area responsible for dripping water along the distressed slope need to be identified and pipes should be installed at the seepage/source zone for proper drainage management on the slope.
- Biotechnical stabilisation/ Plantation of suitably identified species that can hold the soil in the failure affected zone in consultation with Botanist/Forest dept.
- Immediate filling of ground cracks with appropriate impervious material immediately.
- Appropriately designed retention structures at suitably identified locations at lower levels as support to failing mass in consultation with design Engineers.

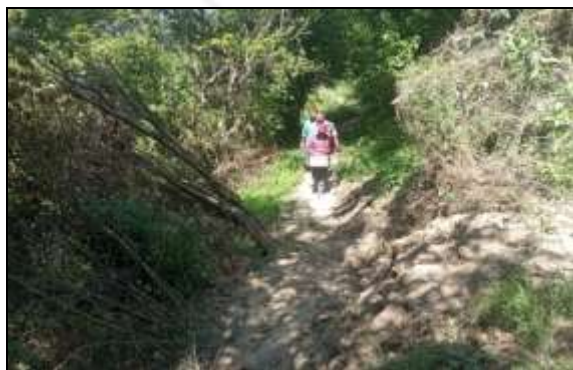
Fig.15; Tilting of trees along the valley side of foot path.

- It is suggested to construct an appropriately designed lined drainage parallel to contours upslope to avoid surface water discharge on the distressed slope.
- Appropriately designed retention structures at suitably identified locations at lower levels as support to failing mass in consultation with site and design Engineers.
- Immediate filling of transverse and contour parallel tension cracks with appropriate impervious material immediately.

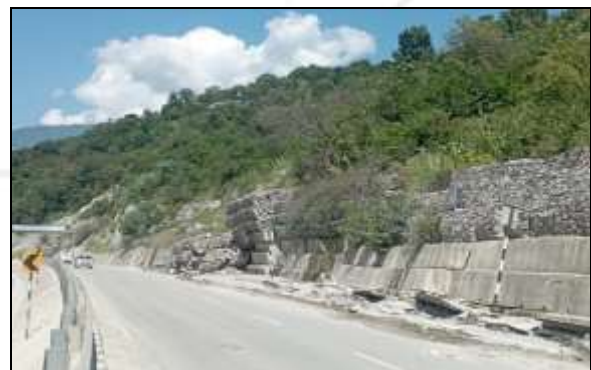
- Banontar Kharahal subsidence is located ( $31^{\circ}57'20.23''\text{N}$ ,  $77^{\circ}6'59.42''\text{E}$ .) on the upslope of NH-3 along transported mid slope of loose unconsolidated debris material with a slope inclination and direction of  $35^{\circ}\text{N}280^{\circ}$ .
- A subsidence that has affected 2 Houses in the form of wall cracks, ground subsidence, tilting and sinking of retaining walls.(Fig.13 and 14)
- Other instability signatures such as tilting of trees (Fig.15), ground cracks ( $\text{N}020^{\circ}$ ) (Fig.14), damaged and tilted retaining walls were also observed (16).
- This subsidence is active and poses risk to the slope in case of extreme weather events.

Fig.16; Damage retaining structures along NH-3 downslope of Banontar Kharahal .

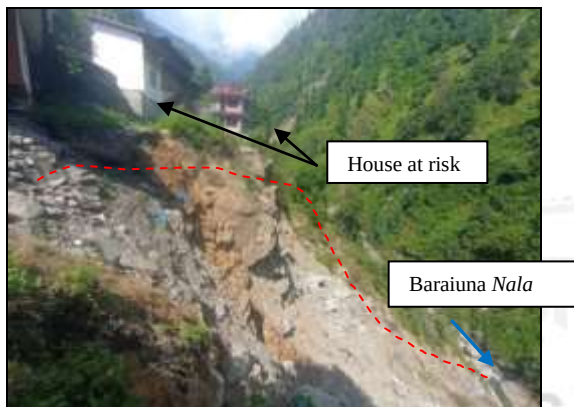
- During field visit/inspection it was observed that several houses including Mandir were damaged and developed cracks on walls and roof, lateral displacement of structures, ground cracks, tilting of houses and foundation damaged. (Fig 21,22,23 and 25).

- The slide is active and poses severe risk to life and properties that were present in immediate vicinity in the upslope near the crown of the landslide.

Fig.21; Crown of the slide along steep slope at Barauna village.

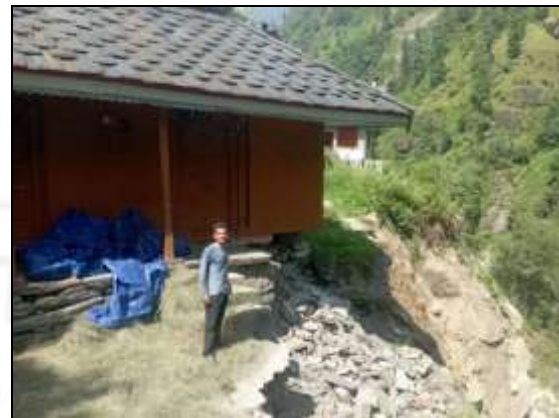
Fig.22; Mandir at risk located on the crown of the slide at Barauna village

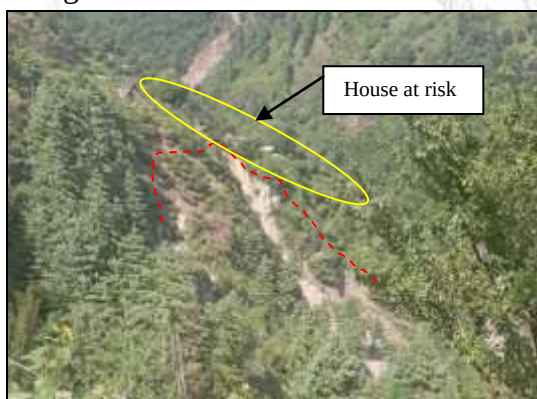
- Towards the right flank of the main slide area, several minor landslide incidences were also observed which has damaged the footpath completely that connect Manikaram- Barauna village and put several houses at risk (Fig.25 and 26).

Fig.25; Landslide on right flank slope of the Barauna village.

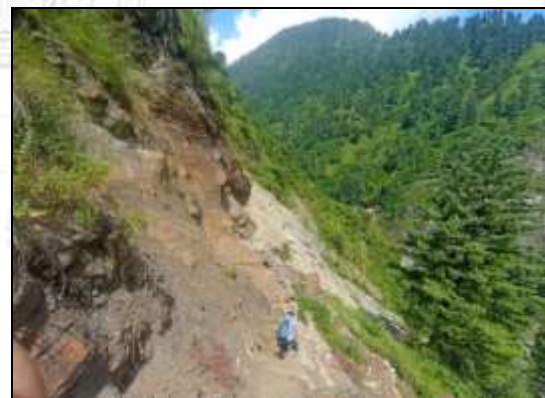
Fig.26 Footpath completely wash out/damaged due to landslide on right flank slope of Barauna village.

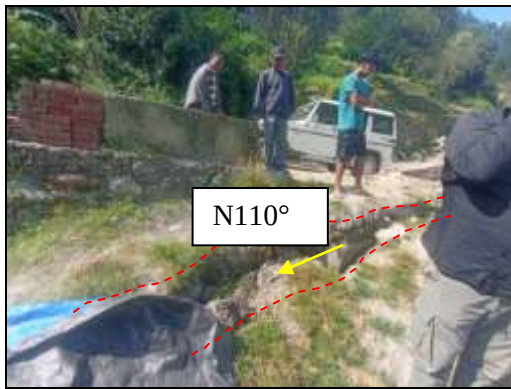
- The Hydrological conditions of the distressed slope are damp, wet and dripping at sporadic locations.
- At least three level of link road were passes along the distressed slope. Several severe instability signatures were observed along all the road level in the main distressed slope such as damages of retention structures (Fig.35), crack on civil structures, lateral ground displacement (Fig.30 and 32), damage houses, ground cracks (Fig.29), tilting of trees (Fig.34), uprooting and road subsidence for about 2-5 m mainly on topmost and middle road level (Fig.31).

Fig.29; Ground cracks along the lower most road level at Bandal.

- It is suggested to construct an appropriately designed channelized lined drainage to avoid surface water discharge on the distressed slope.
- Appropriately designed retention structures in consultation with design Engineers along the hill and valley side of road with a provision of weep holes and hill side drainage.
- Immediate filling of transverse and contour parallel tension cracks with appropriate impervious material immediately.
- Avoid further loading, tampering of slope with heavy civil structures in/adjoining failure affected zone.
- Based on the dimension of the slide, the importance of the affected road and houses located at the slide zone a detailed site specific study is recommended.

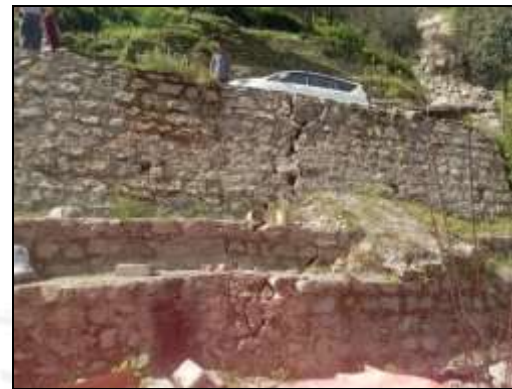
Fig.30 ; Damaged retaining wall towards valley side of lowermost road level.

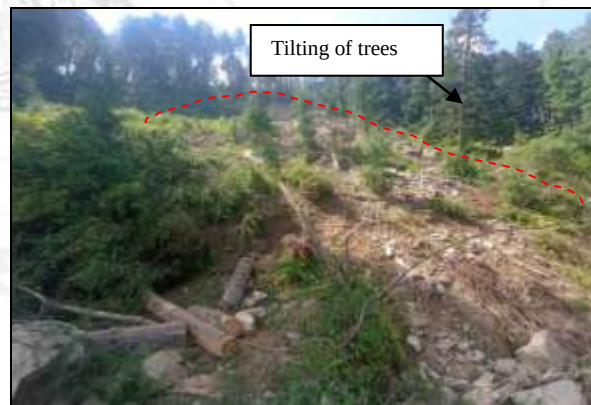
Fig.34; Tilting and uprooting of trees observed near the Scarp of the slide

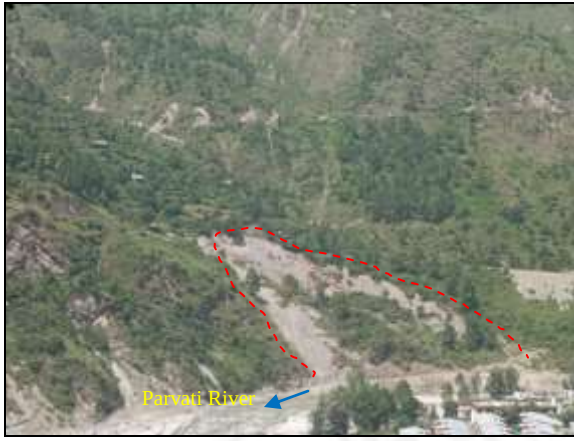
- Machine *nala* slide is located ( $31^{\circ}46'21.80''N$ ,  $77^{\circ}17'54.82''E$ ) to the right bank slope of Parvati river along moderate to steeply inclined hill slope with a general slope inclination and direction of  $60^{\circ}/N160$ . (Fig.37)

Fig.37; Machine *Nala* slide as discernable from the opposite slope of Parvati River.

- It is suggested to construct an appropriately designed contour parallel channelized lined drainage above crown of the slide to avoid ingress of surface water in the distressed slope.
- Appropriately designed retention structures along the hill and valley side of road with a provision of weep holes and hill side drainage.
- Immediate filling of ground cracks/tension cracks (Fig.39) with appropriate impervious material.
- Avoid further loading, tampering of slope in the adjoining failure affected zone.

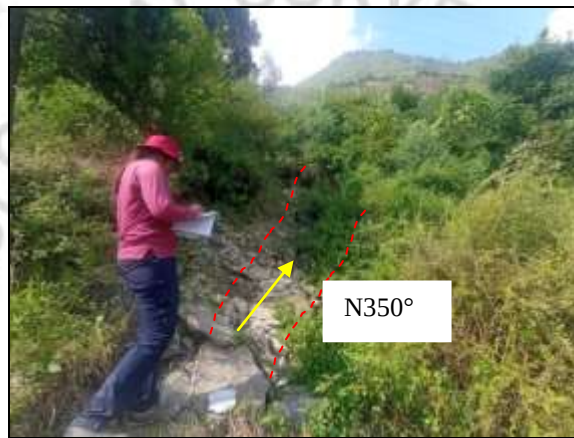
- No major casualties were reported from the affected site during field visit except road damaged (Fig.38) (informed by local residence and Tehsildar). However few houses are observed to be present on upslope/near the crown of the slide where traverse ground cracks (Fig.39) were present which may pose risk to settlement in case of extreme weather conditions.

Fig.39; Traverse ground crack on the right flank of landslide.

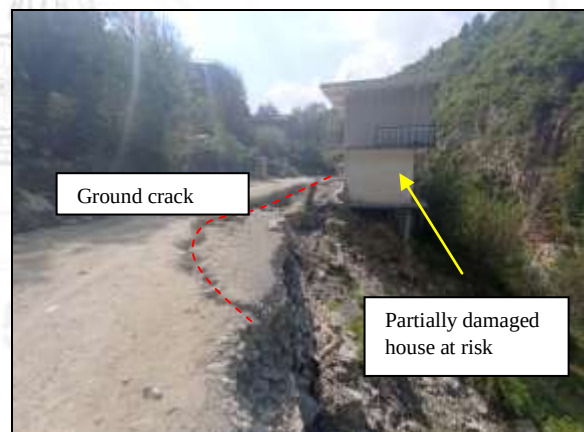
- Few houses that are constructed on valley side of affected road/very close to the river bank along steep slope ( $45^{\circ}/\text{N}005^{\circ}$ ) were found to be damaged and also poses risk to further damaged in case of uneven/extreme weather conditions (Fig.41).

Fig.41; Ground cracks and House at risk located towards valley side of the road along Thana Sainj to Taxi stand road stretch.

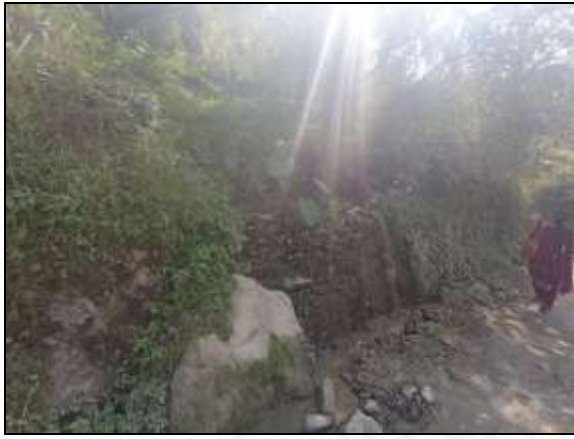
- The entire affected stretch is observed to be damp, having dripping and flowing hydrological conditions (Fig.42).

Fig.42 Flowing hydrological conditions along the hill side of the road stretch.

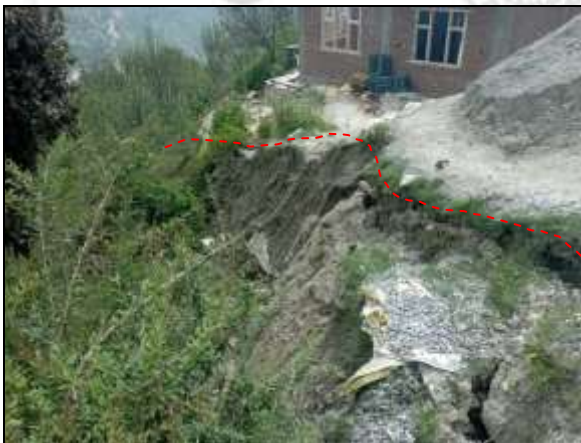
Fig.50: Houses at risk.

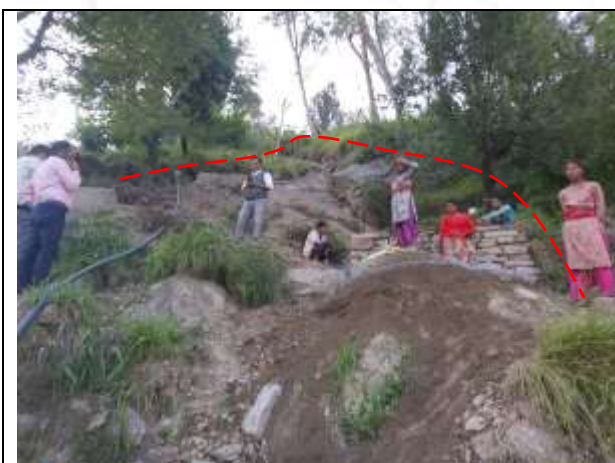
Fig.66. Construction of retaining wall carried out to protect the crown.

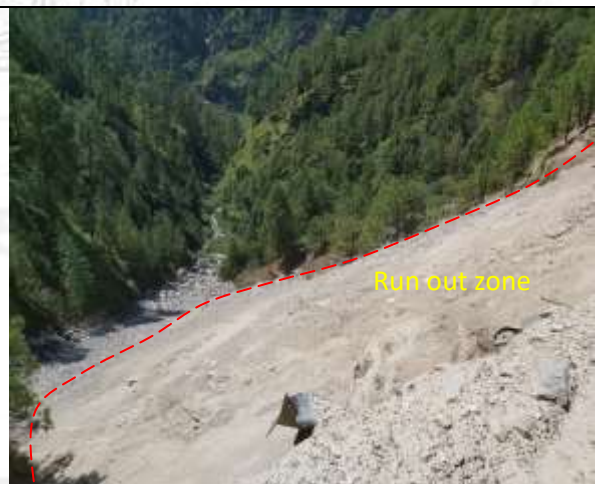
Fig.80.Run out materail of the slide as descereenable from the road

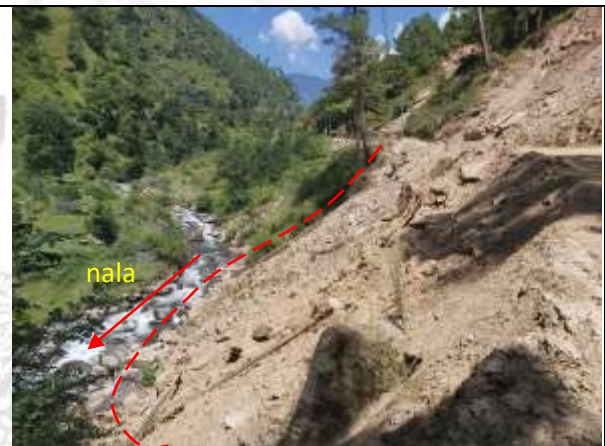
- Flowing water action during heavy precipitation cause extensive rill erosions and nala bank erosion.
- The loose and fragile rock/ debris material resting along slopes and nala side slopes gets eroded and trigger debris flows with surface run-off.
- Toe portion of the slide gets eroded by the flowing nala and weaken the lower portion (Fig.82).

Fig.82. Run off material of slide reaches up to the nala

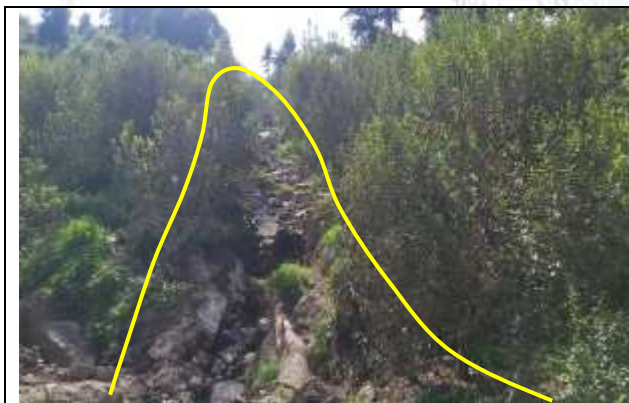
Fig. 85. Debris flow path along the course of seasonal Nala (about 150 m SW Shaleen Subsidence).

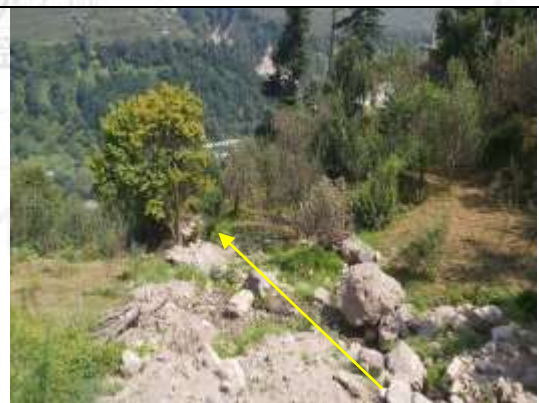
Fig.86. Run out debris material damaged the apple orchards located along the course of debris flow path (about 150 m SW Shaleen Subsidence)

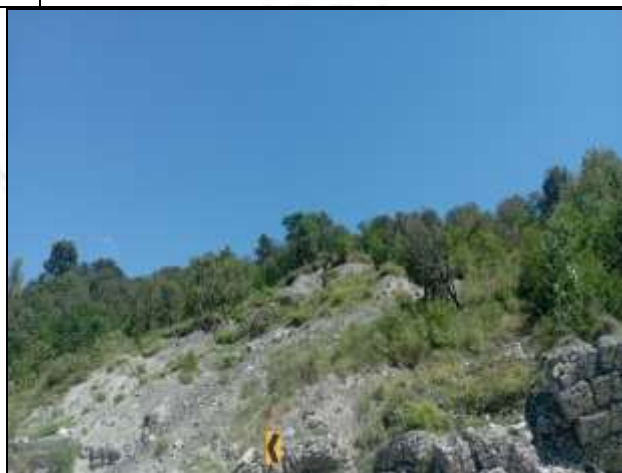
Fig.1. Debris slide as discernible from the left bank of Beas River.

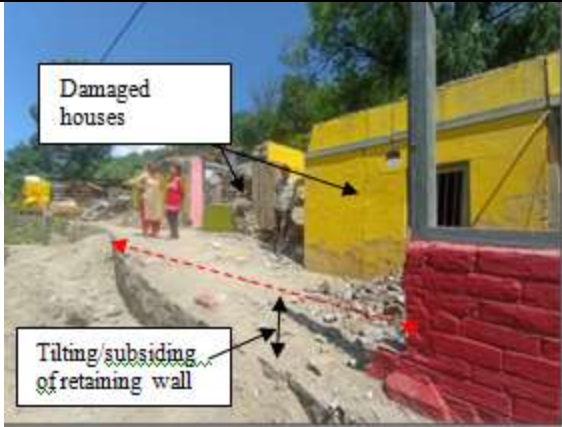
Fig.1. Damaged civil structures

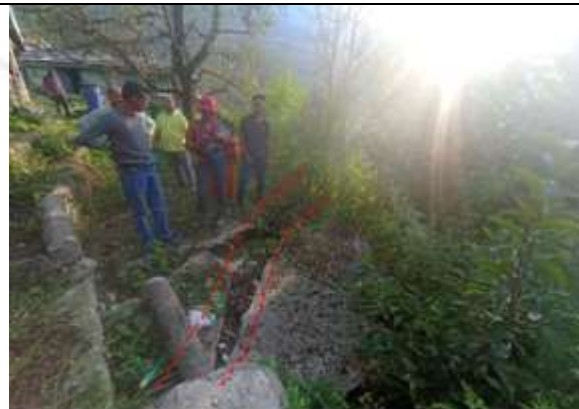
Fig.3 Ground crack

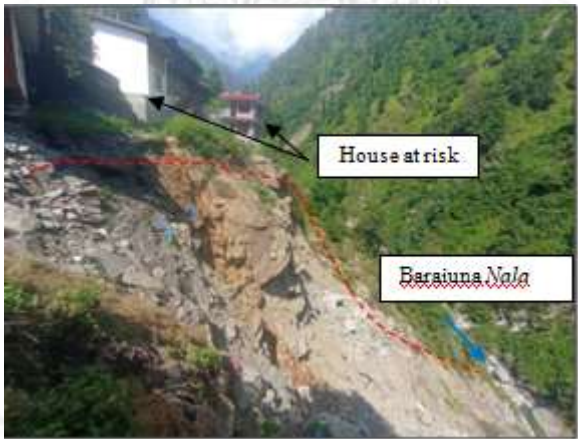
Fig.1. Crown of the slide along steep slope

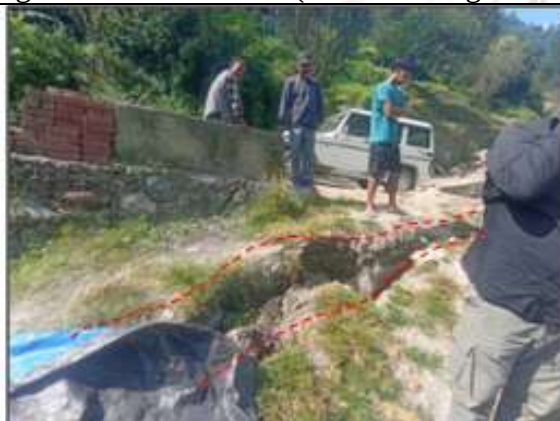
Fig.2. Ground cracks

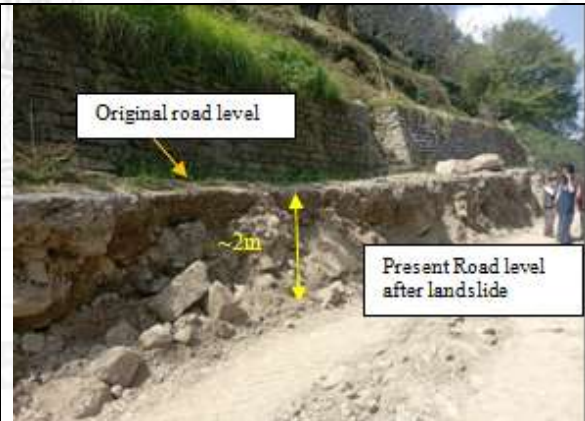
Fig.3. Road subsidence

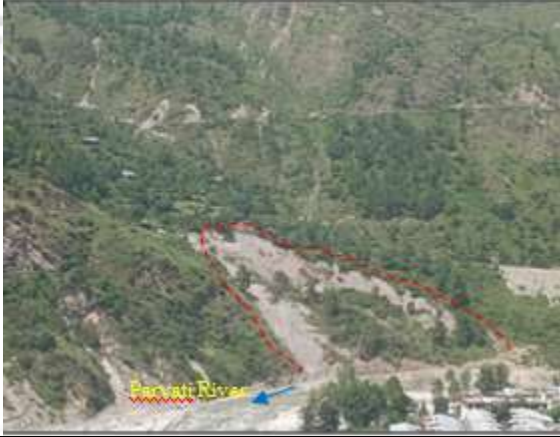
| 41 | Remarks | Settlement located on upslope/near the crown of the slide pose risk to life and properties in case of uneven weather conditions. |
| Fig.1. Machine <i>Nala</i> slide as discernable from the opposite slope of Parvati River. | | |

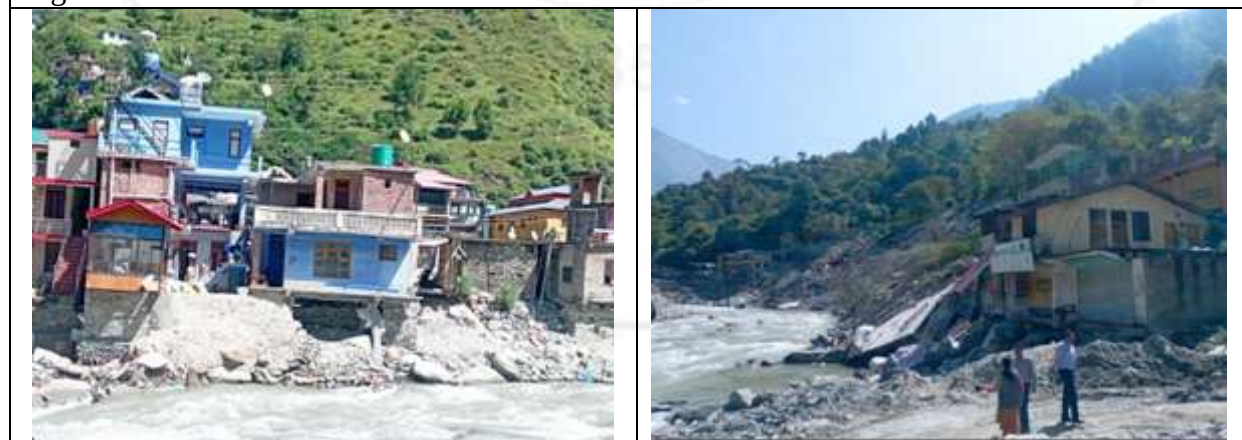
Fig.2. Houses at risk (Right bank of the river)

Fig.3. House at risk (left bank of the river)

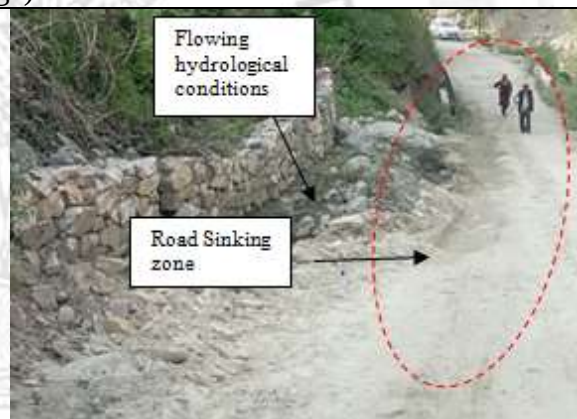
Fig.3. Road subsidence

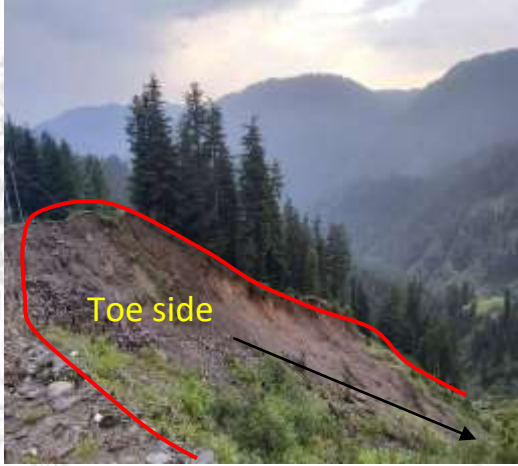
| Fig.1. Unstable crown observed in Mashnoo nala slide | | Fig.2. Toe observed in Mashnoo nala slide |

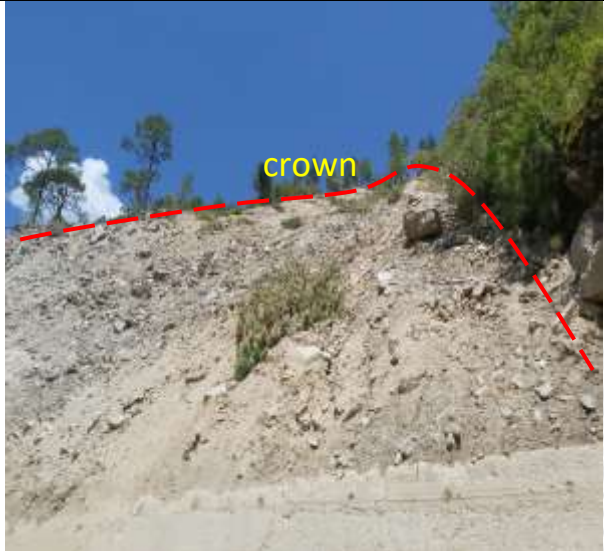
| 40 | Geoscientific causes | Oversaturation of slope area and surface run off water along steep slope.<br>Excessive erosion from upslope runoff water leading to development of rills and gully along the distressed zone.<br>Heavy rainfall is also a triggered factor for the slide. |

| | Fig.1. Excessive erosion from upslope runoff water leading to development of rills and gully along the distressed zone | Fig2. Run out material of the slide as descernable from the road |

| | | Biotechnical stabilisation/ Plantation of suitably identified species that can hold the soil in the failure affected zone in consultation with Botanist/Forest dept. |

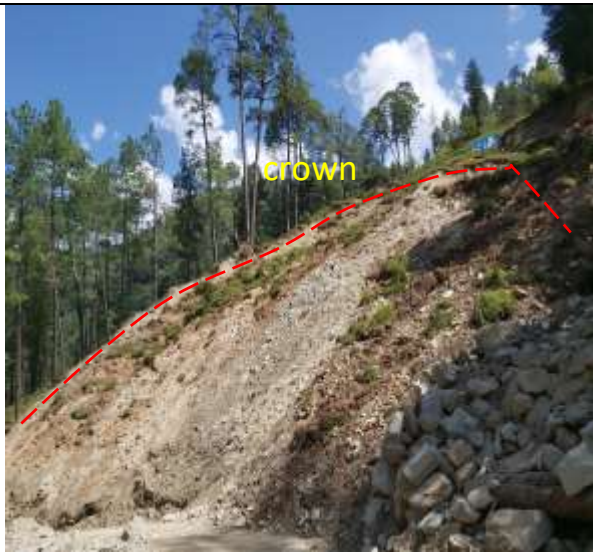
| 40 | Geoscientific causes | Presence of loose and fragile rock/ debris material in the upslope and along the side slopes of the nala. |
| | | Loose and fragile rock/ debris material resting along slopes and nala side slopes gets eroded and trigger debris flows with surface run-off. Heavy rainfall is also a triggered factor for the slide. |

| Fig.1. Crown portion covered with plastic sheets of slide | | Fig.2. Toe side of slide |

| 41 | Remedial measures, if any | Loose material along the major nala need to be removed manually/mechanically. |

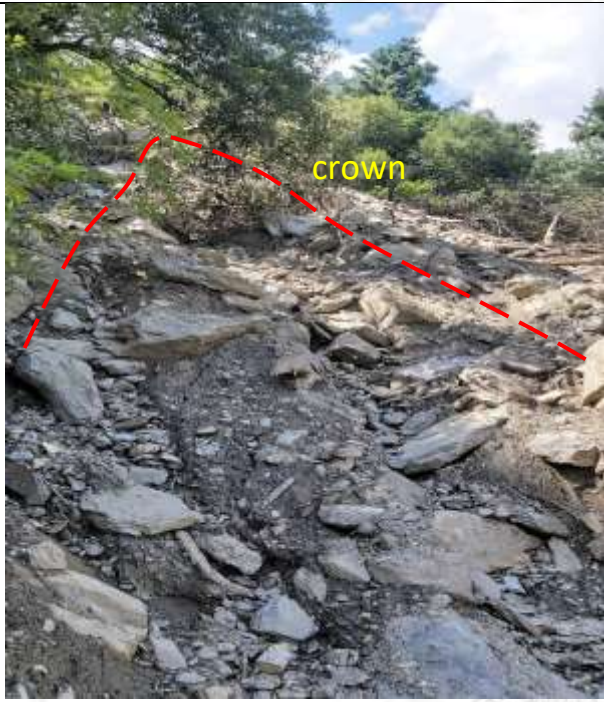
| 40 | Geoscientific causes | Saturation of water on loose debris material during heavy rainfall. |

| Fig.1. Unstable crown portion of Darsha slide | | Fig.2. Toe side of Darsha slide |

| | | Repair/replaced the damaged retaining wall along the valley side along the Manali-Darsha PMGSY Road. |
